SEA VIEW GOLF CLUB COMMITTEE MEETING – 29 JULY 2024

Sea View Golf Course

Clubhouse Site Condition Investigation Report

BUILDING SERVICES CONDITION REPORT ELECTRICAL, HYDRAULIC AND MECHANICAL SERVICES

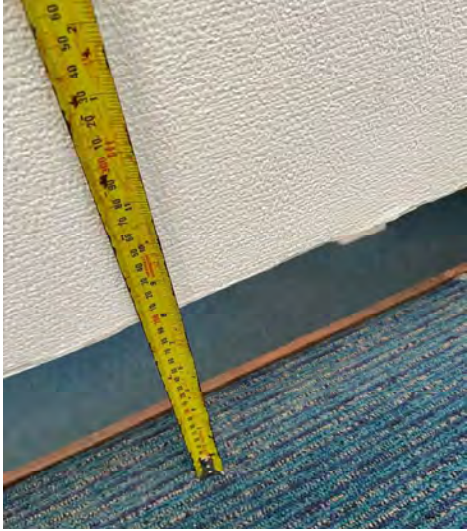
<p>200mm opening to base of stair balustrading</p>

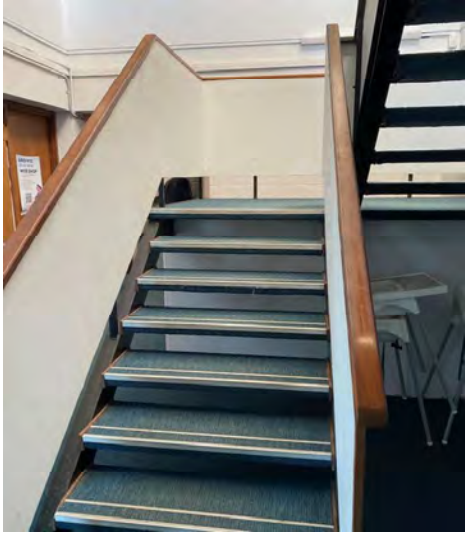
Existing stairs with opening in balustrade

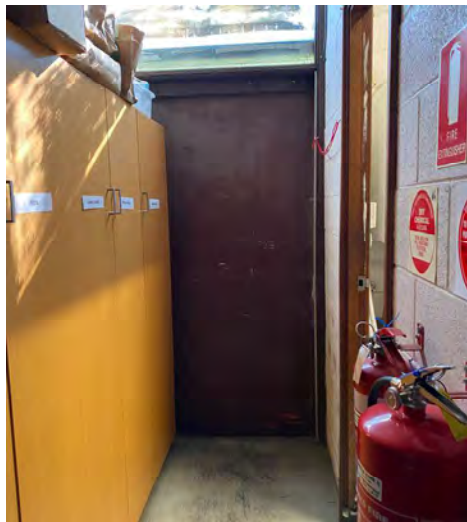
Passage with Laundry storage and sliding delivery door partially obscured

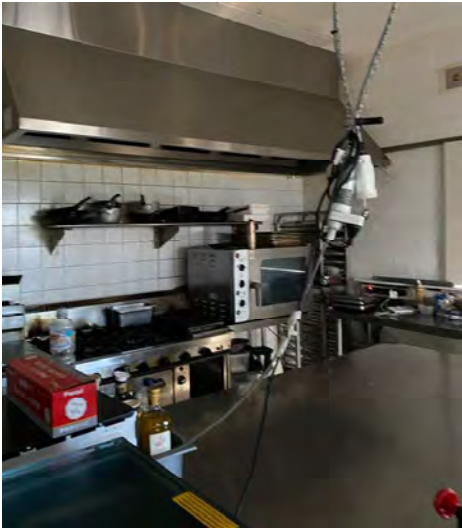
Electrical cables suspended over workbenches

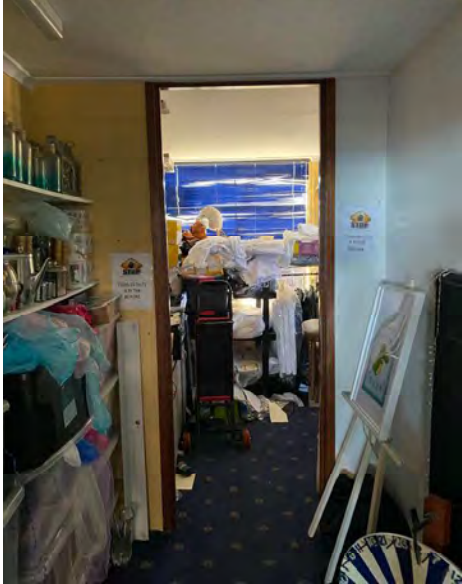
<p>Passage to Store being used for storage</p>

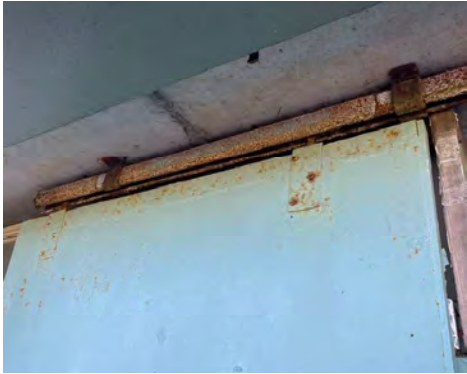
<p>Rusty sliding door mechanism to be replaced</p>

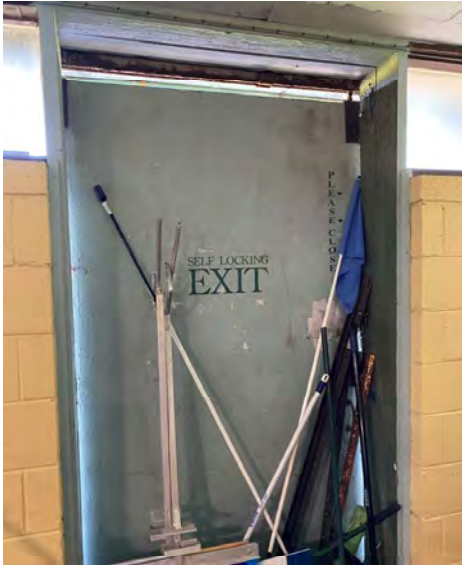
Sliding doors replaced with compliant exits

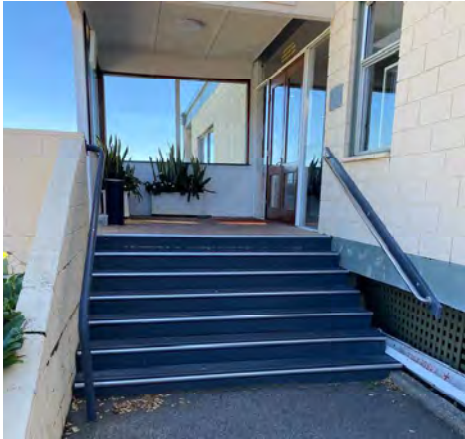
<p>Replace Entry stairs with new compliant stairs and accessible ramp</p>

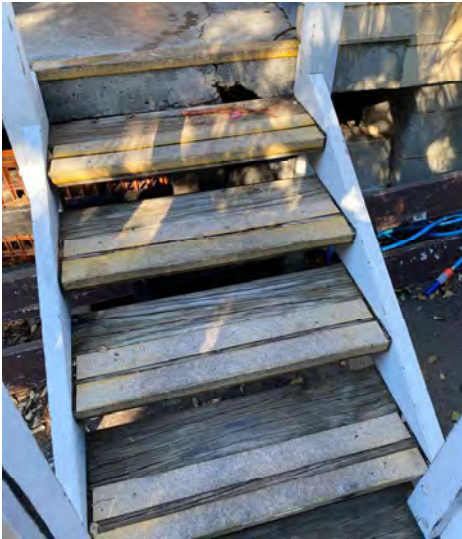
Stairs to Delivery Dock to be replaced with compliant stairs

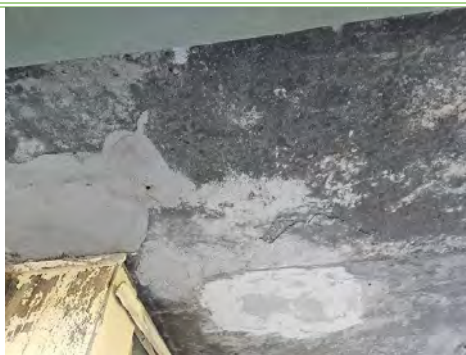
However, drummy and spalling concrete was evident on the first internal slab and beams where the soffit extends beyond the ground-floor external walls, indicating minor reinforcement corrosion. Patching on the slab soffit suggests that previous repairs have been carried out. The table below details the defects identified during the inspection.

Figure 2: Drummy slab soffit

It is recommended that drummy/spalled concrete sections be repaired in accordance with Section 4 – Repair methodology.

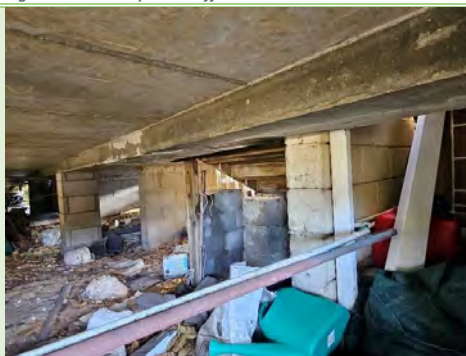
Figure 4: Concrete spalling on beam adjacent to the dock

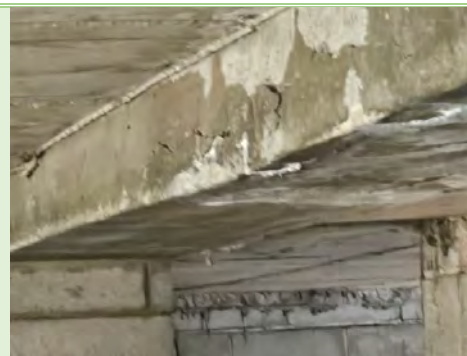
Figure 5: Close-up view of spalled concrete beam

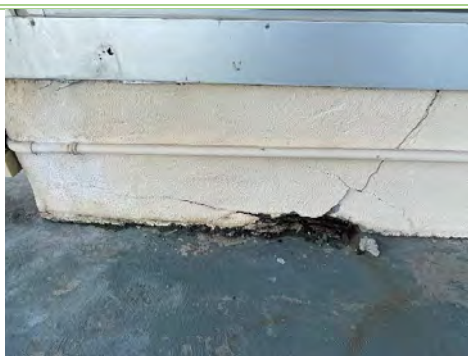
The concrete upstands for the raised dining area adjacent to the two balconies appear to be in poor condition. These upstands do not seem to be documented in the existing structural drawings, suggesting they are not part of the suspended slab system.

Figure 6: Upstand to Balcony 1

If the upstands are not integral to the suspended slab system, it is recommended to remove and rebuild them. Otherwise, the concrete upstands should be remediated according to Section 4 – Repair methodology.

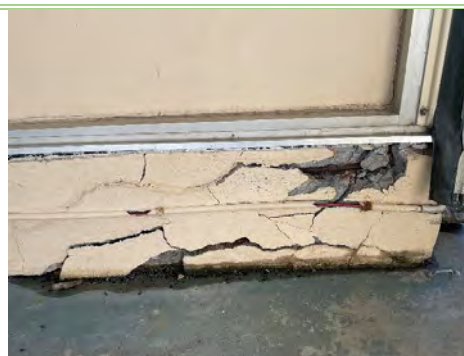
Figure 7: Upstand to Balcony 2

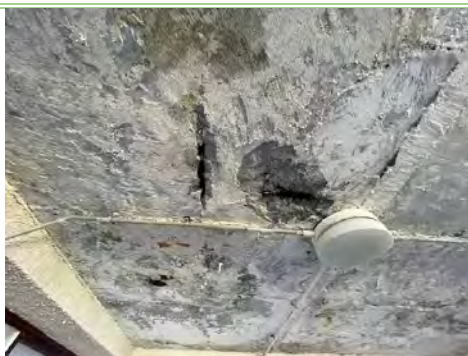
The suspended terrace slab above the store/entry appears to be in poor condition. Concrete spalling and corroded reinforcement were evident throughout the slab soffit. Additionally, structural cracks ranging from 1mm to 5mm in width were observed on the concrete downturn beam. There is also observable water leakage

Figure 8: Corroded reinforcement on slab soffit

It is recommended that drummy or cracked concrete section be repaired in accordance with Section 4 – Repair methodology.

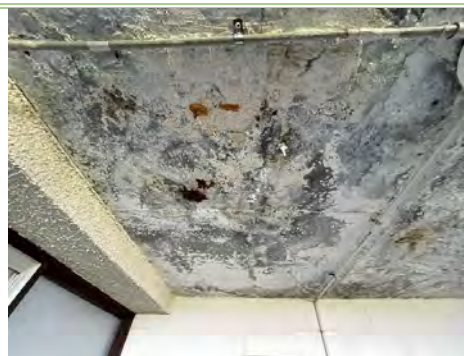
Figure 9: Drummy concrete and corrosion mark

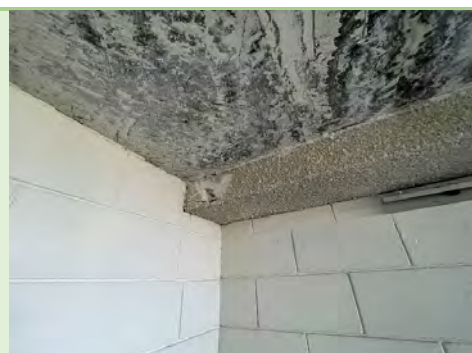
Figure 10: Concrete spalling on beam (Internal Face)

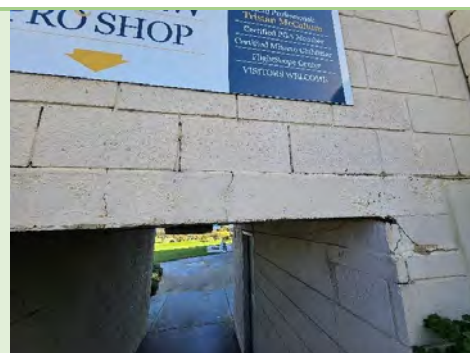
Figure 11: Concrete spalling on beam (external face)

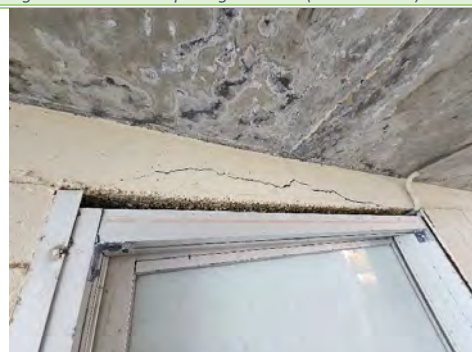
Figure 12: Beam cracks above door

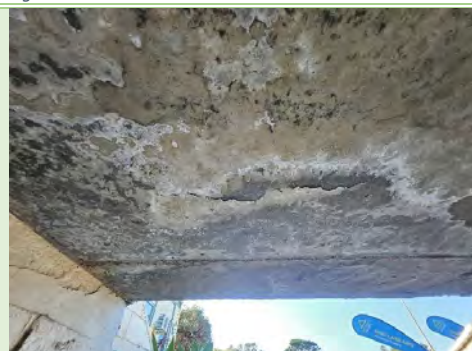
Figure 14: Drummy concrete to the slab soffit

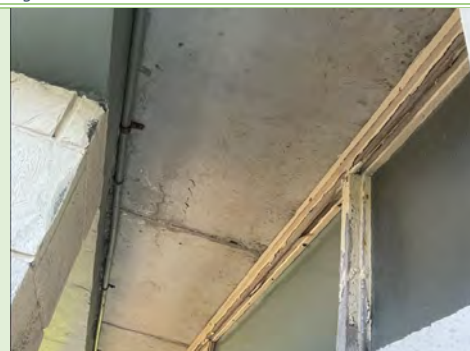
Figure 15: Drummy concrete to the slab soffit

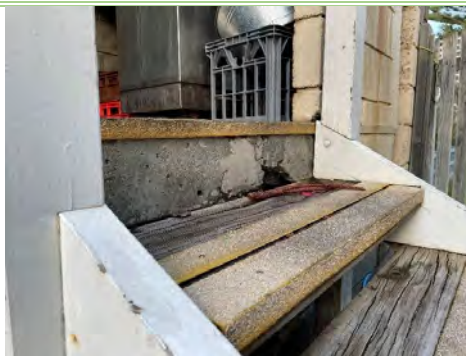
The suspended docking slab shows signs of fair to poor condition, with evident concrete spalling and corroded reinforcement observed at the stair location. Additionally, cracks were evident on top of the suspended slab.

Figure 16: Concrete spalling on slab

It is recommended to repair the drummy and cracked slab in accordance with the repair methodology outlined in Section 4 – Repair methodology.

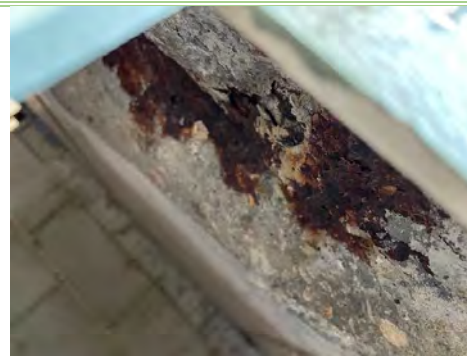
Figure 17: Slab soffit showing sign of corroded reinforcement

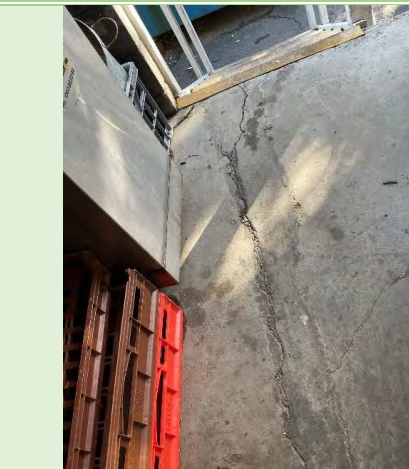
Figure 18: Crack evident on docking slab

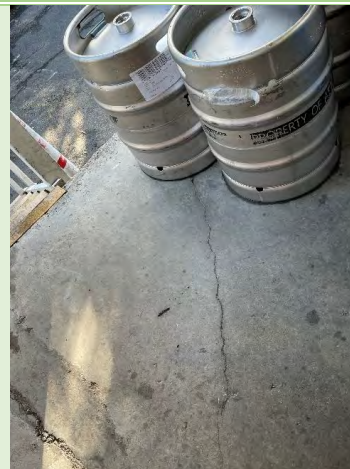
Figure 19: Crack evident on docking slab

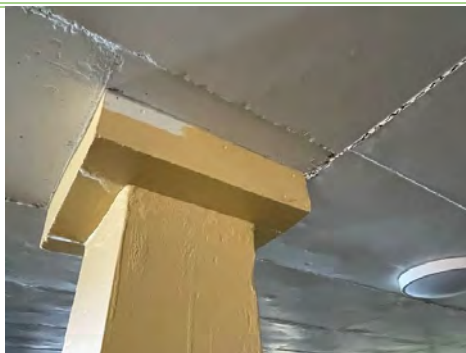
Figure 20: Internal concrete column in good condition.

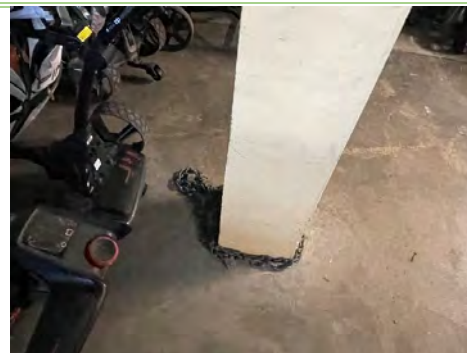
Figure 21: Internal concrete column in good condition.

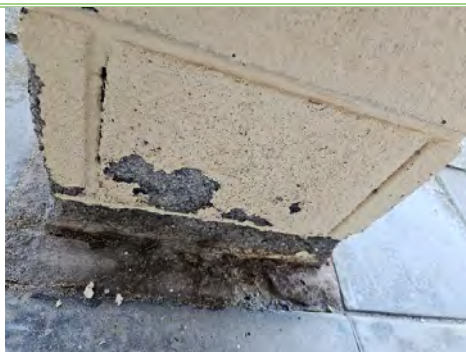
The existing concrete columns appear to be in a fair condition. No major cracking was evident during the inspection. Small number of the concrete masonry columns experienced surface deteriorating which can be resulted from mechanical or chemical damages. The scale of damages do not pose immediate structural concerns.

Figure 22: Deteriorating surface on concrete block columns.

It is recommended that deteriorated areas be patched with structural repair mortar after removing any loose materials and cleaning the surface.

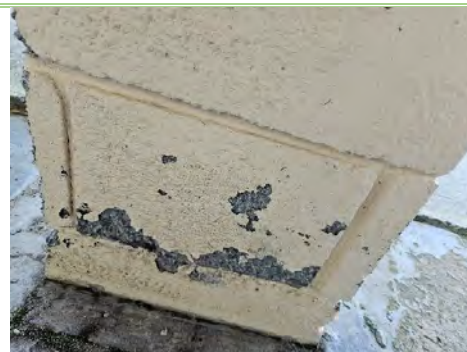
Figure 23: Deteriorating surface on concrete block columns

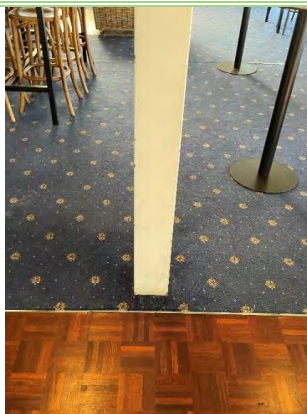
Figure 24: Internal steel column in good condition.

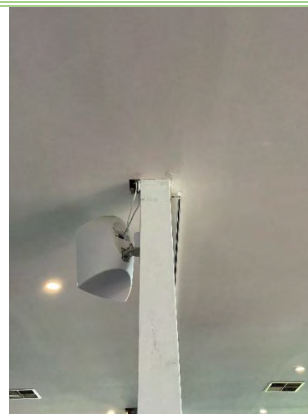
Figure 25: Internal steel column in good condition.

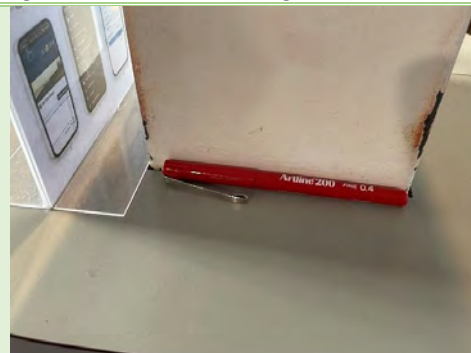
The steel columns on the first floor that support the roof structure are in good condition overall. There is minor surface corrosion noted in areas where the protective coating has been damaged by mechanical abrasion.

Figure 26: Minor surface corrosion

It is recommended to clean and treat minor surface corrosion on the columns with zinc-rich primer to ensure their longevity.

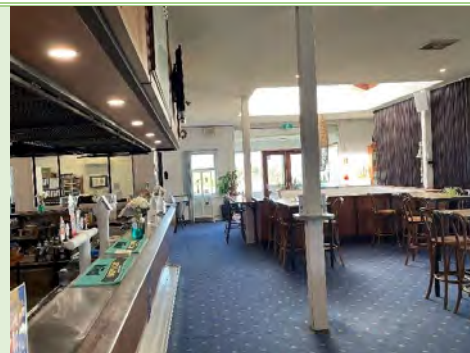
Figure 27: General view of internal columns

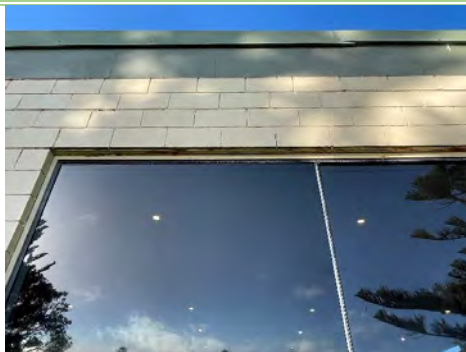
Figure 28: Lintel on North elevation - Moderate corrosion

The corroded lintels should undergo remediation following Section 4 – Repair methodology. As for the cracked windowsill panel, replacing it with lightweight steel or timber framing represents a practical and cost-effective solution.

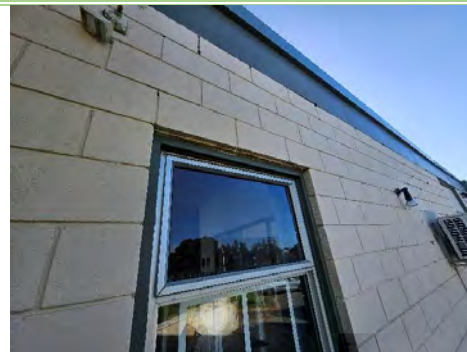
Figure 29: Lintel on South elevation - Moderate corrosion

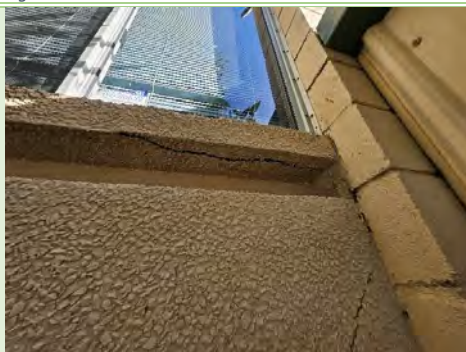
Additionally, significant cracking was observed on the windowsill concrete panel located at the Northeast corner. It is noted that this windowsill panel originally served as a precast balustrade panel as documented in the existing drawings.

Figure 30: Major cracks on windowsill panel

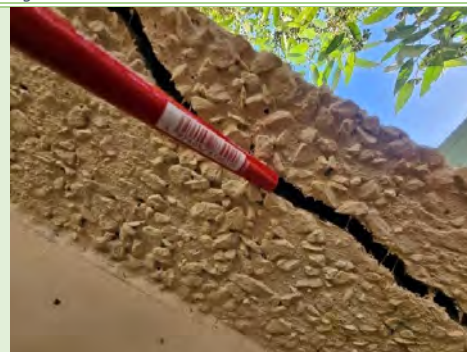
Figure 31: Windowsill panel crack width approx. 6mm

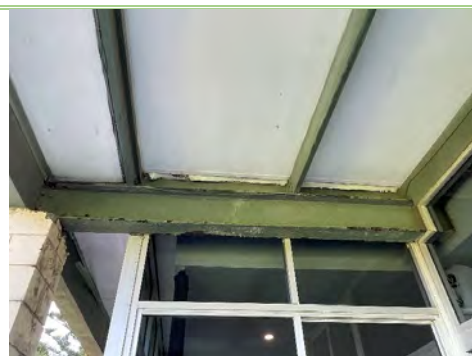
Figure 32: Balcony 1 exposed steel beam - Severe corrosion

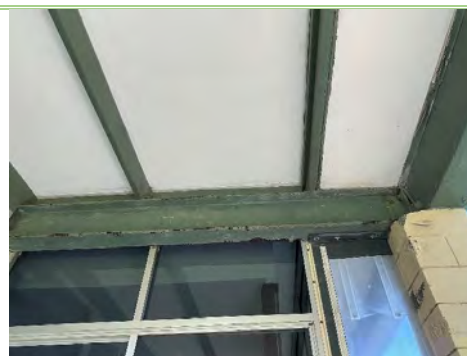
Figure 33: Balcony 2 exposed steel beam - Severe corrosion

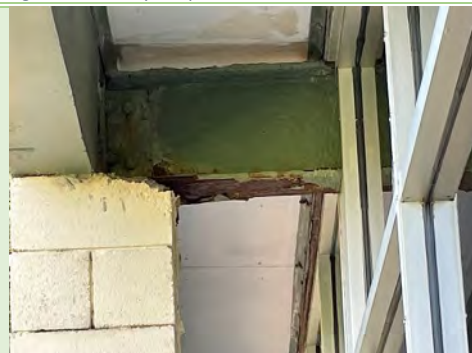
Figure 34: Steel beam on West Elevation - Severe corrosion

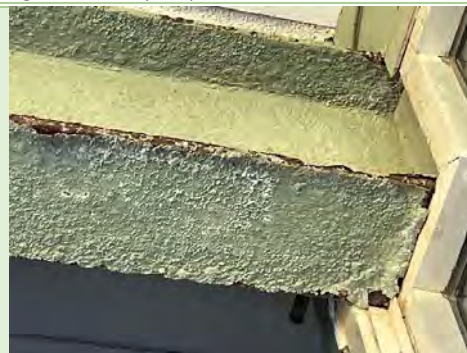
Figure 35: Steel beam on West Elevation - Severe corrosion

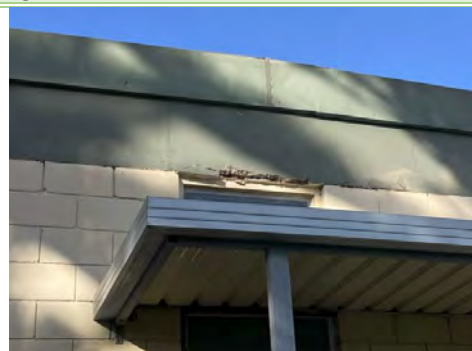
Figure 36: Concrete perimeter beam on North Elevation - Concrete spalling & corroded reinforcement

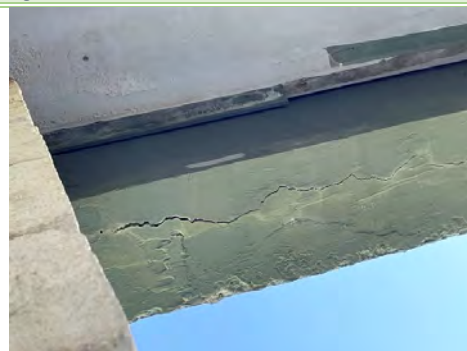
Figure 37: Concrete perimeter beam on North Elevation - Concrete Cracking

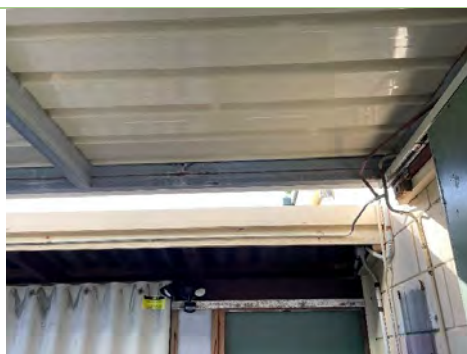
The canopy structures on the north elevation of the building have been constructed using Duragal hollow sections, with surface corrosion visible on these Duragal steel sections.

Figure 38: Surface corrosion on the canopy structure

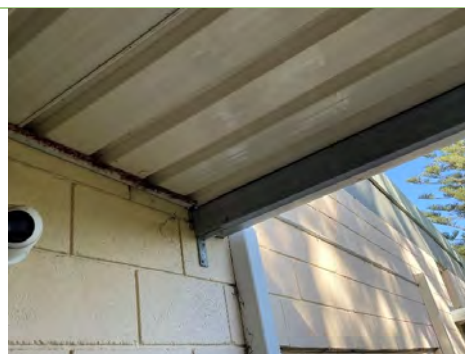
Figure 39: Surface corrosion on the canopy structure

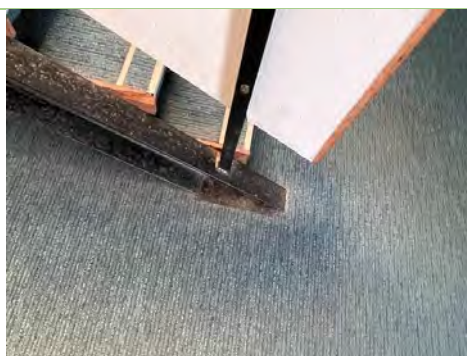
The steel stringers and landing beams for the internal stair appear to be in fair condition.

Figure 40: Stair Stringer

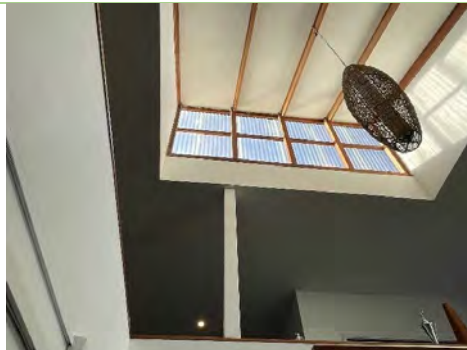
The timber structure forming the roof skylight appears to be in good condition.

Figure 42: Roof Skylight Timber Frames

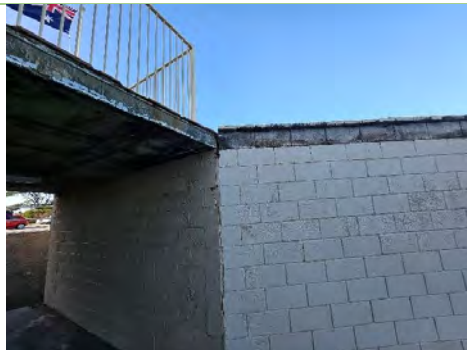
The concrete block retaining wall appears to be in fair condition. Minor cracking was observed at the angle joint, which does not raise structural concerns.

Figure 44: Crack at the joint

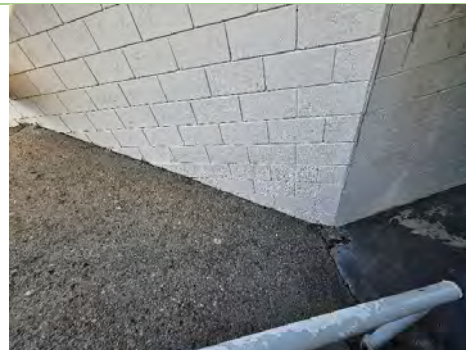
Figure 45: Crack at the joint

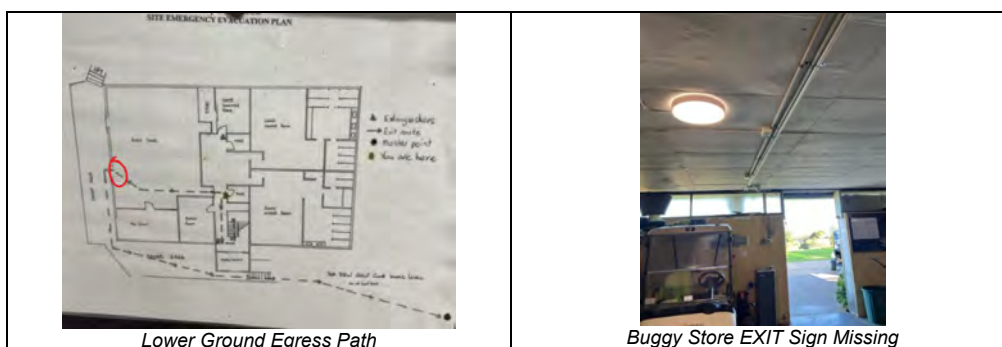
Lower Ground Egress Path

Clevertronics Exit and Emergency lights are installed, and it appears that all the exit signs were recently upgraded. It is noted that Exit and Emergency lights are missing in a few areas. A centralised system for monitoring and testing the Emergency and Exit lights was not evident during the site inspection.

Buggy Store EXIT Sign Missing

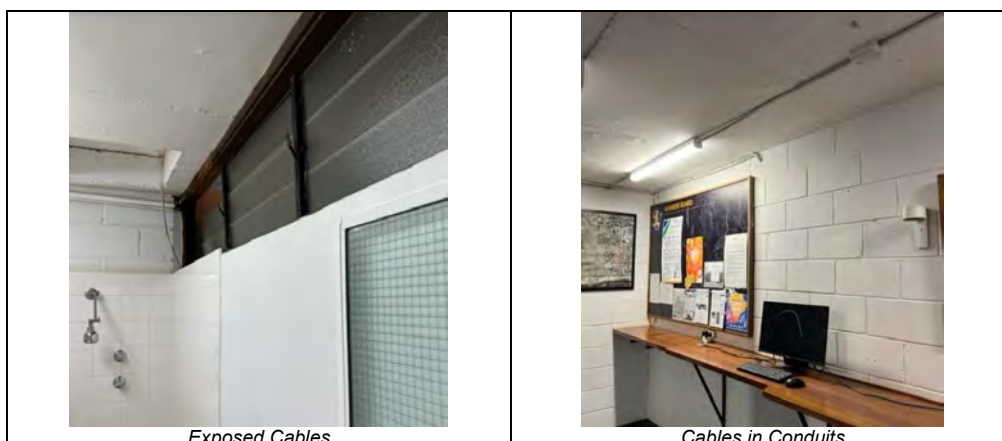
Exposed Cables

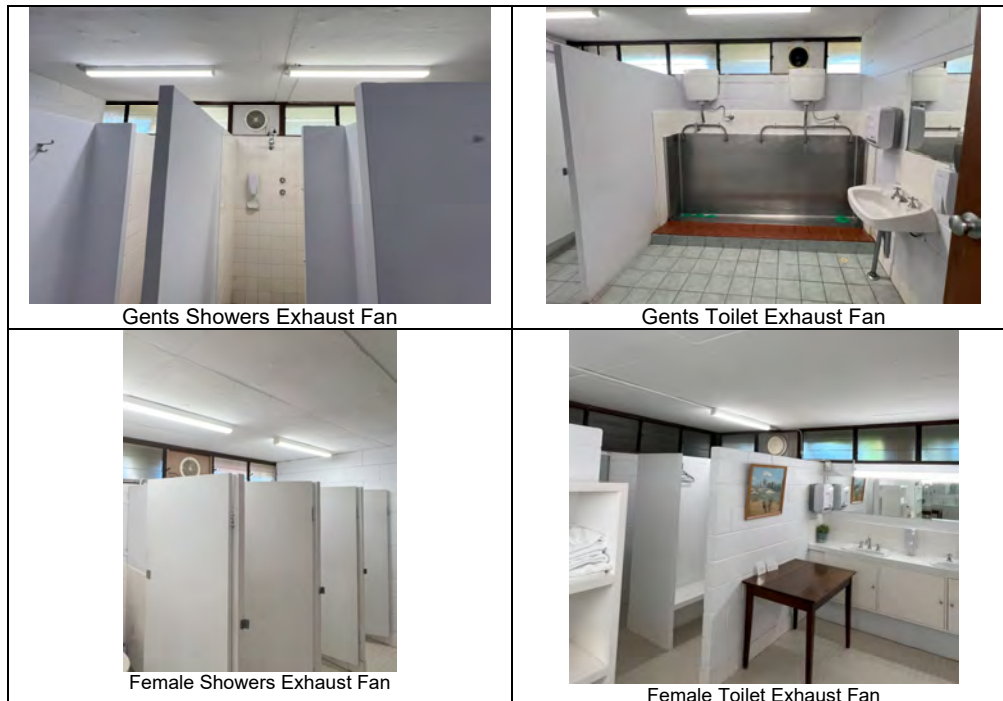
The exhaust fans provided in the Toilet and Shower areas are undersized and also found non-functional during the site inspection.
