## Appendix 4 - Visual Inspection of Retaining Walls Report

Prepared for  
Town of Cottesloe  
27 July 2016

CW933000-ST-R001  
Visual Inspection of Retaining Walls Along Cottesloe Foreshore

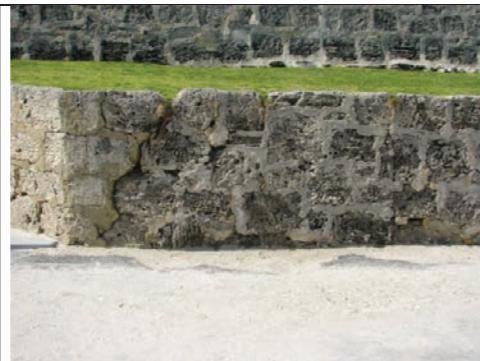
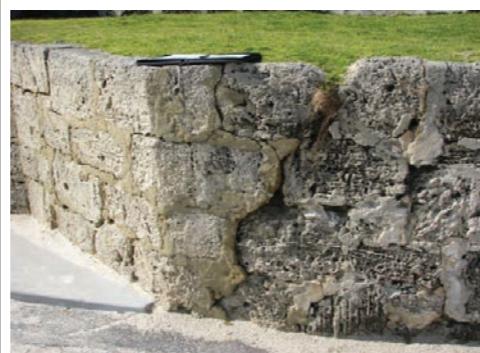
Vertical Crack at the corner of RW4

Vertical crack along the height of the wall were observed at some location. Though it seems that those cracks were not excessive, and have been addressed on previous repairs, it is recommended that they should be kept under observation to identify further movement.

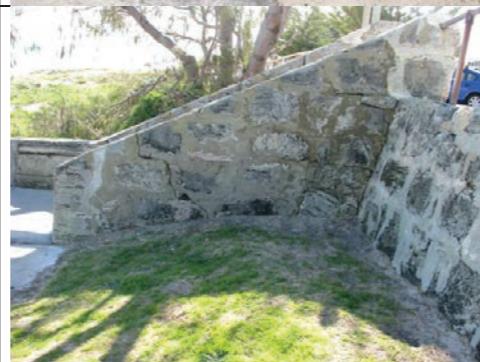
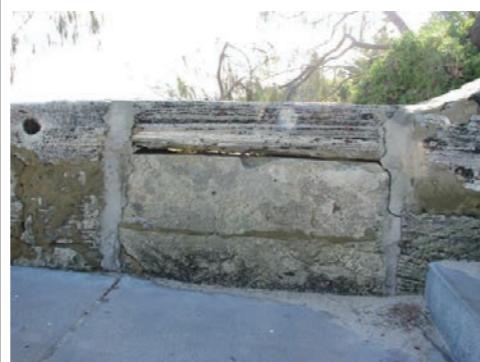
Vertical crack at RW6

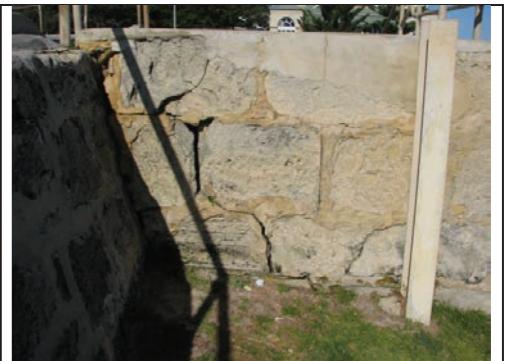
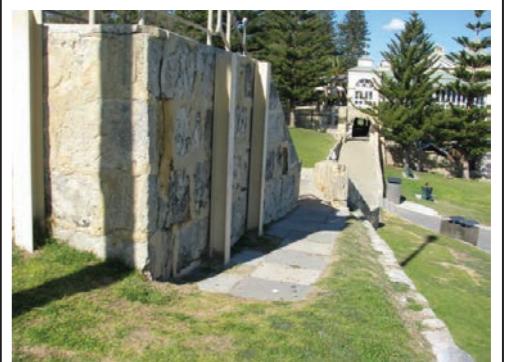
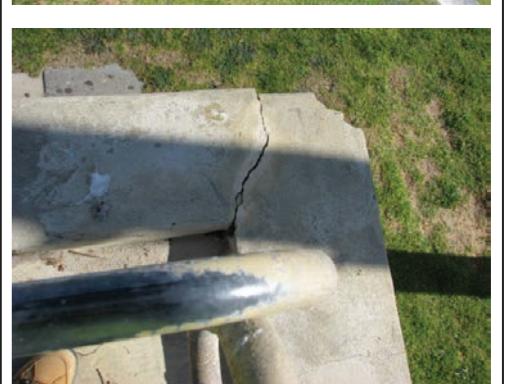
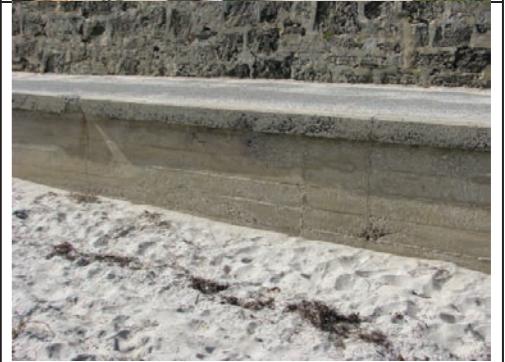
Vertical Crack through RW7, near the corner with RW1. We believe that those cracks were caused by soil pressure at the back of retaining wall. It seems that those cracks have been observed previously, and the steel cantilever columns have been installed to prevent further movement of the wall.

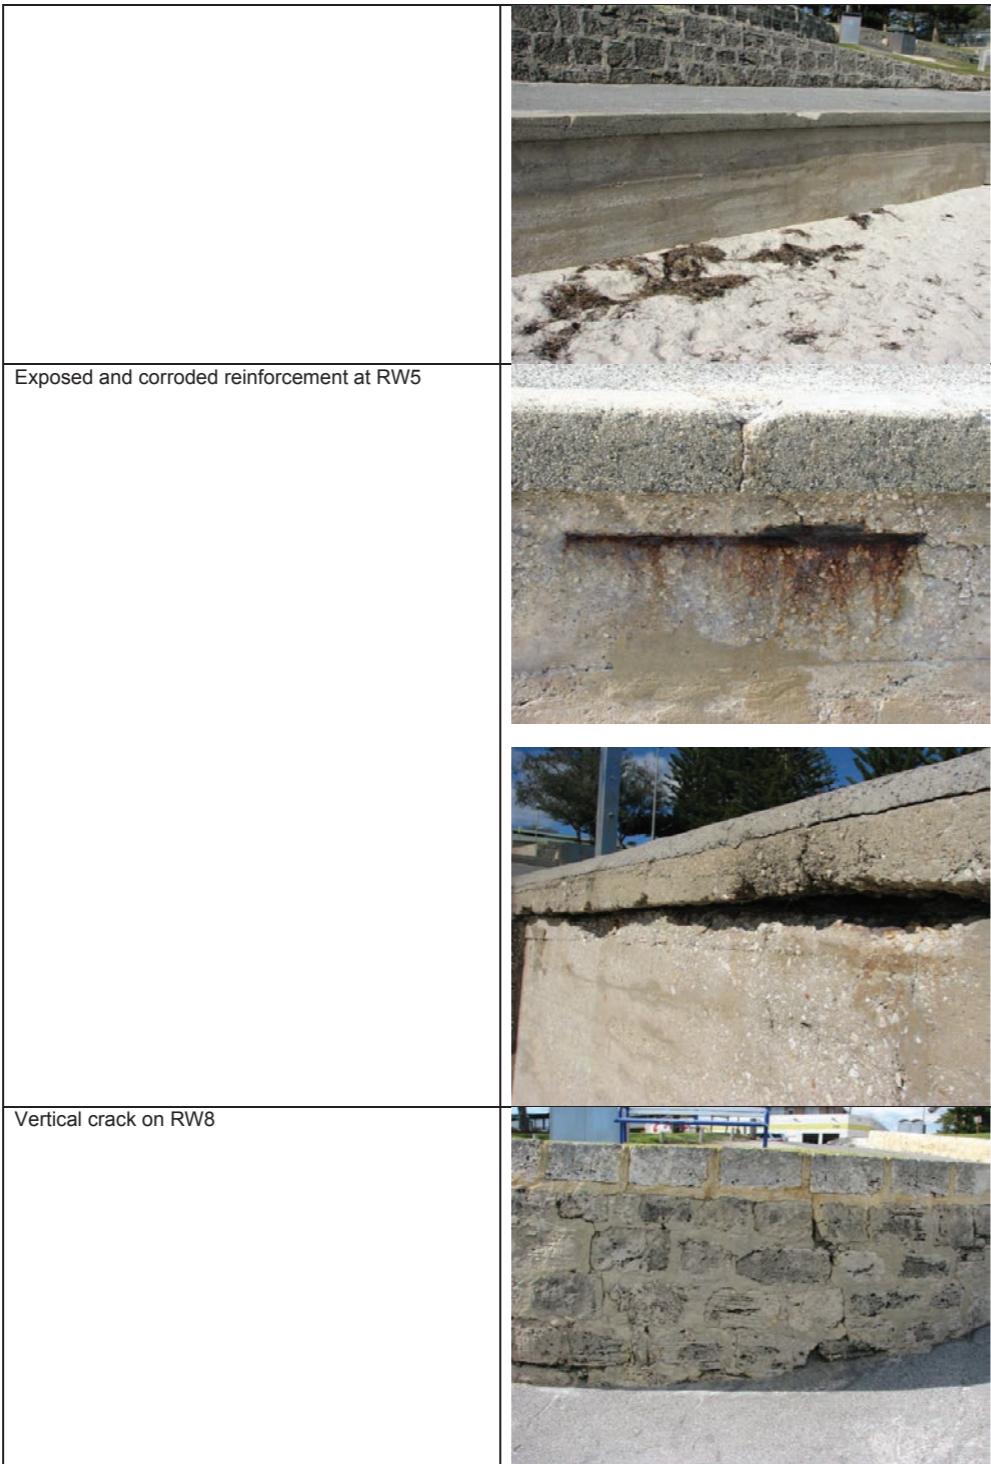
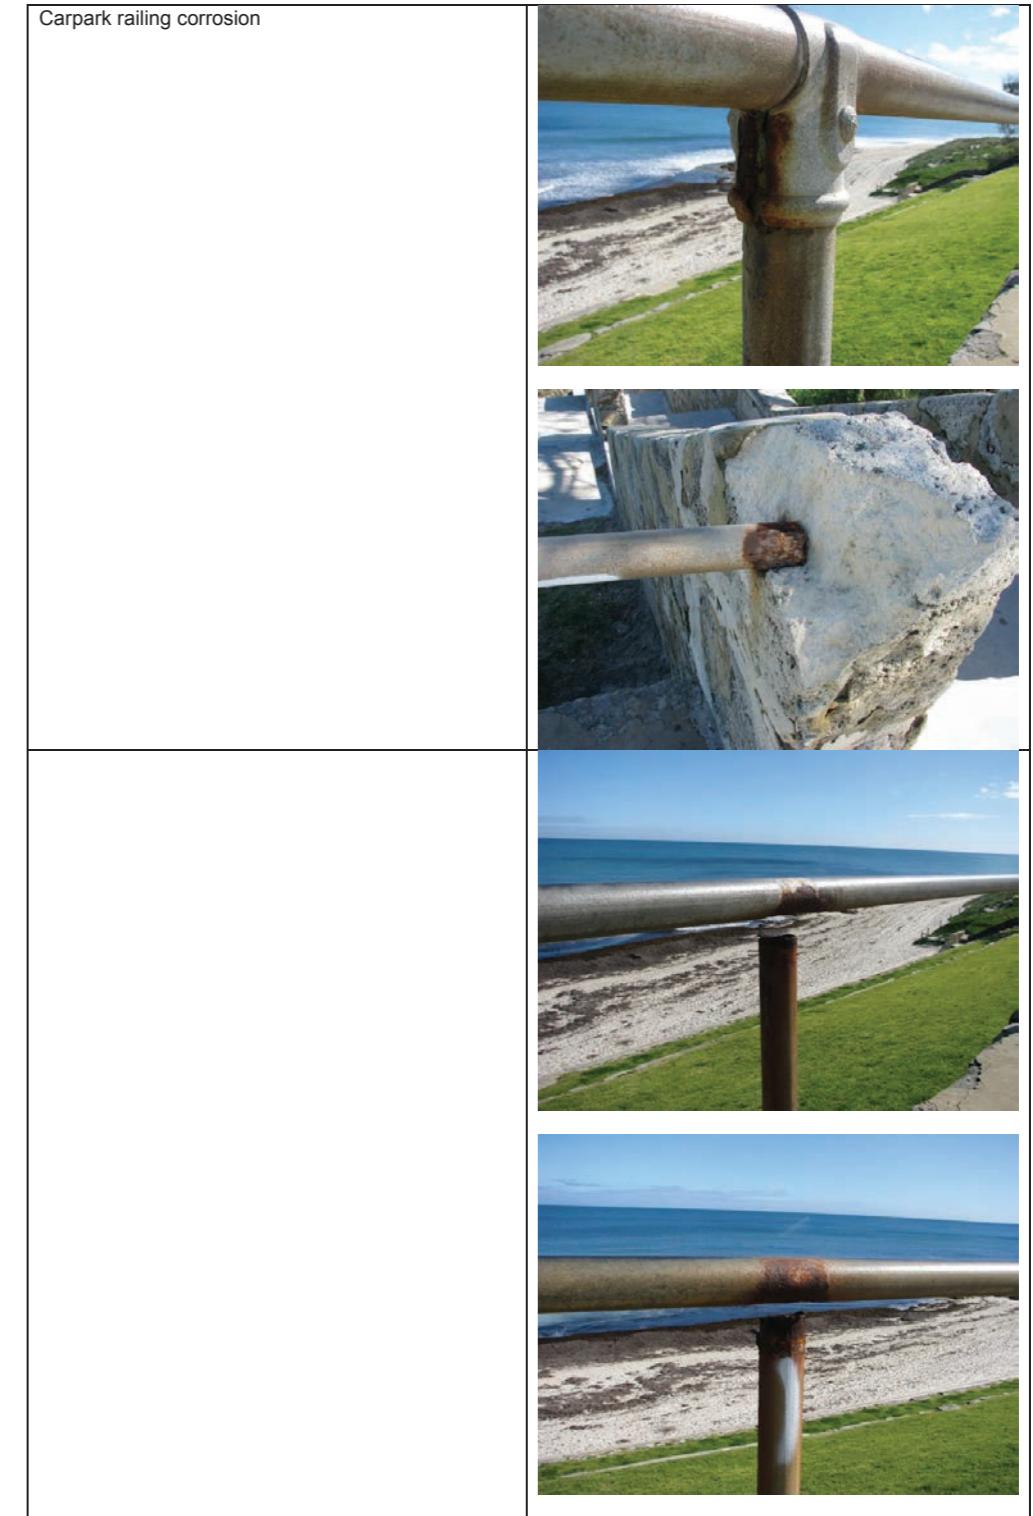
Typical Shrinkage crack on concrete retaining wall RW5

The concrete retaining wall RW5 was generally in good condition. Shrinkage cracks were observed along the height of the wall at regular intervals. Exposed reinforcement was observed at some location. This reinforcement is badly corroded and need to be replaced, and covered.
