Arborist Assessment and Report

Subject: Row of 15 Claret Ash (Fraxinus angustifolia 'Raywood')

Location: Napoleon Street, Cottesloe

Date: 20/06/2016

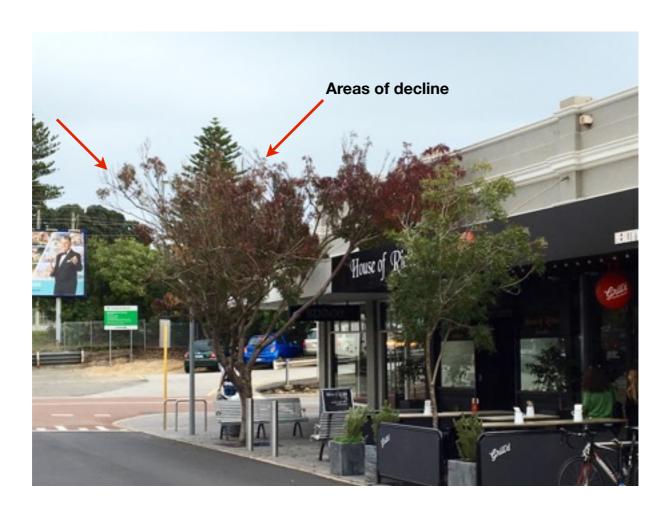
Generally the majority of the trees fit into the category of fair to average condition showing signs of stable peripheral growth with reasonable internode spacing. Some decline in the mature trees is evident, this is prevalent amongst this species within the Perth metropolitan area.

The decline in the upper canopy of these trees will always be present as the trees are planted on the edge of their preferred natural range. The parent species originate from the northern hemisphere with a preferred cooler climate.

Our intense dry heat during summer causes stress and decline in the upper canopy and in this condition they can be susceptible to the fungus botryosphaeria

See image below illustrating evidence of decline.

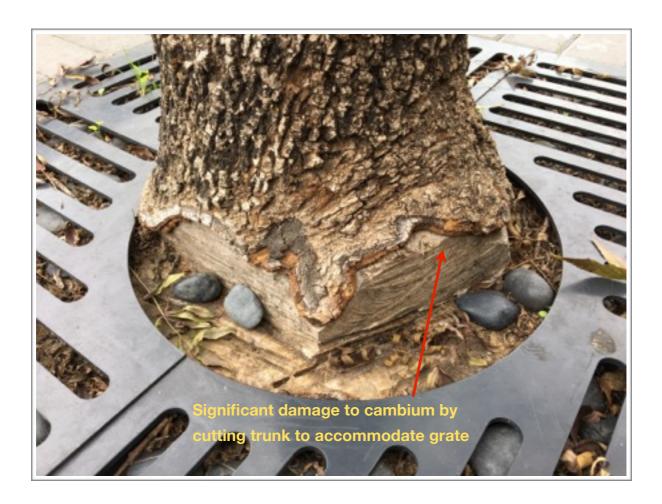
These trees, although considered a desirable ornamental deciduous tree will find it difficult to maintain a full and lush canopy given the above mentioned factors. If the planted environment remains the same they will struggle with vitality. Furthermore, the surrounding grates will continue to interfere with the lower trunk cambium.

See image below illustrating damage to cambium layer to allow for grates:

- Pruning to best arboricultural practice to clear building facias in regard to damaging the limbs.
- Removal of deadwood throughout the canopy on an annual basis to reduce pest and disease
- Expansion of grates around the trees instead of pruning the trunks which removes vital cambium severely detrimental to the trees' vascular system.

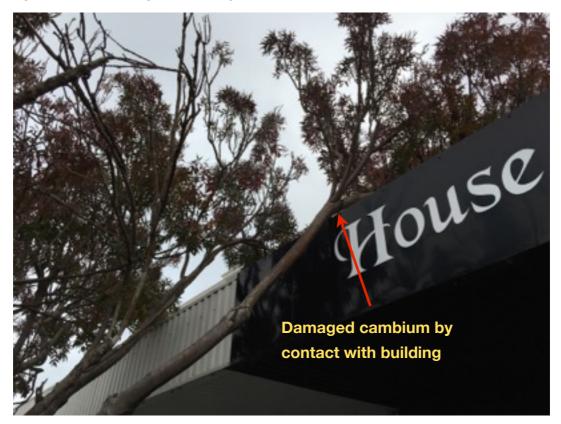
Some significant and varying types of damage is evident in both the newer plantings and mature trees. This ranges from vehicular damage through to severe weather and pruning damage. Given the extent of some of this damage and the average form of the majority of the trees, it will take some time to recover the exposed heartwood with cambium. This will therefore expose the trees for an extended period of time to a greater risk of pest and disease.

Image below illustrating limb damage:
