P7984 Cottesloe Beach Pylon Conservation Management Plan

Prepared for
The Town of Cottesloe
By

April 2019

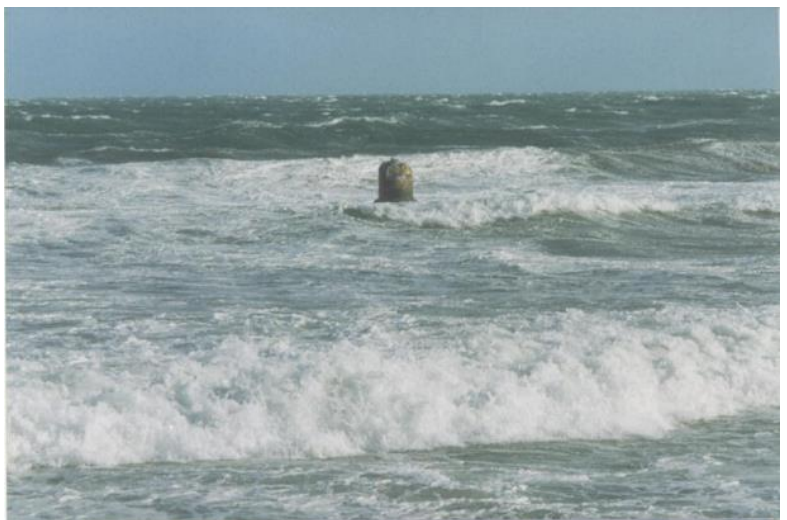
A severe storm on the night of 7 June 1995 broke off the top section of the northern pylon. A new mast was fitted to Cottesloe Beach Pylon on 10 December 1996³⁵ with a stainless steel cone attached to the mast to prevent access to the peak and stop the addition of car tyres as elevated diving platforms. Council has also removed protruding metal lugs, which provided an anchor point for climbing ropes, and staff regularly removed new ropes as they appeared.

Figure 17: Cottesloe Beach Pylon, 1995 after a severe storm removed the mast.
Courtesy The Grove Library, image CPM02344.

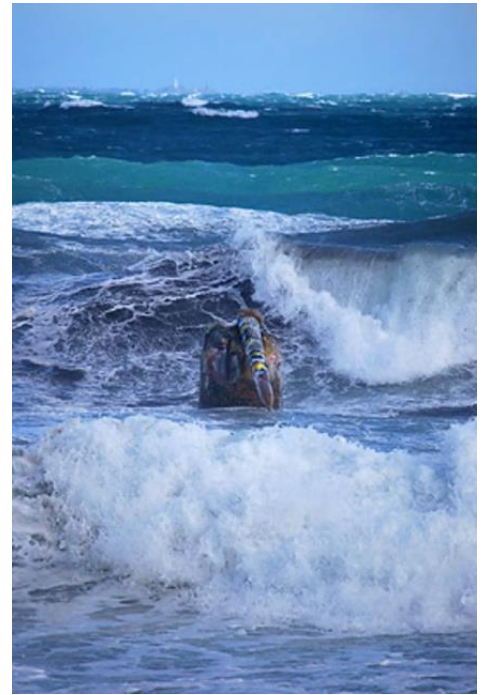
Figure 19: View of Pylon, 2009 showing the mast toppled after a storm.
Courtesy Sydney Morning Herald, 22 May 2009.

The mast was again toppled in May 2009 following storm damage. The community concern over the popular landmark saw the Town of Cottesloe undertake reconstruction of the mast. Funding for the project was assisted by a contribution of \$122,000 from the Federal Government and \$50,000 from Lotterywest. These works also rebuilt the eroded shoulders of the base, which provided the opportunity build a stronger base for the mast. These works did not include significant works for the structure below the water line.

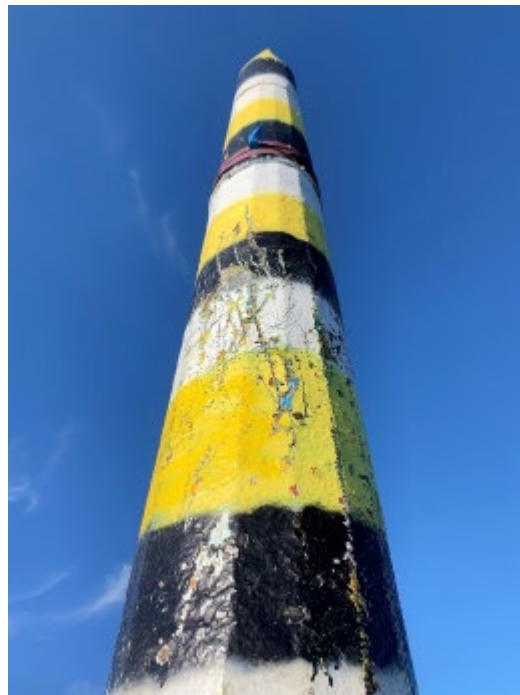
Figure 23: Painted precast concrete mast

The precast concrete mast was found to be in a reasonable condition with no obvious signs of deterioration. The connection to the upper section appeared well adhered and stable. Nevertheless, ongoing deterioration to the upper sections of the pylon may eventually compromise the connection detail with the mast.

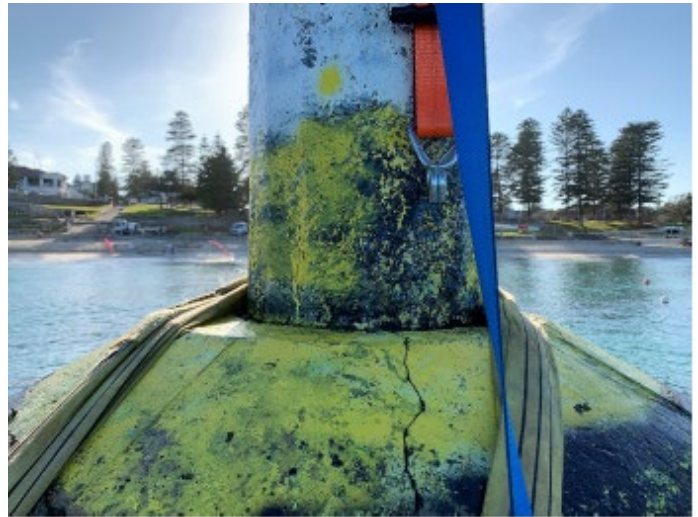
Figure 24: Upper section of the concrete pylon and bottom of the concrete mast

It was apparent that large areas from the upper section of the Pylon had spalled, exposing the reinforcement. Significant cracking was also observed on all elevations of the sloped surface and the upper part of the vertical face. The lack of reinforcement within the upper most section of the pylon indicates that most of the cracking was due to thermal expansion and contraction of the concrete repair at the time of construction and not due to the corrosion of the reinforcement. Subsequently, these large cracks provided a rapid route for oxygen, water, and chlorides to reach the reinforcement leading to the eventual corrosion and spalling. The lack of suitable reinforcing or pinning into the original pylon may have also resulted in the concrete being unstable, and subject to physical damaged from the wind and wave action.

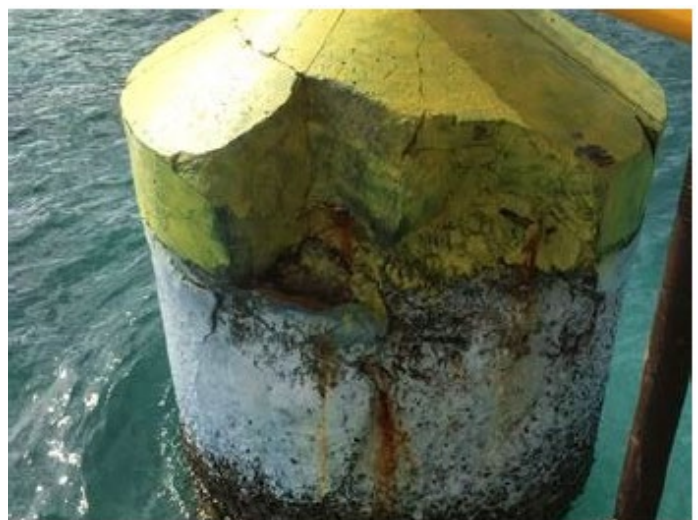
Figure 25: Standoff of the west elevation

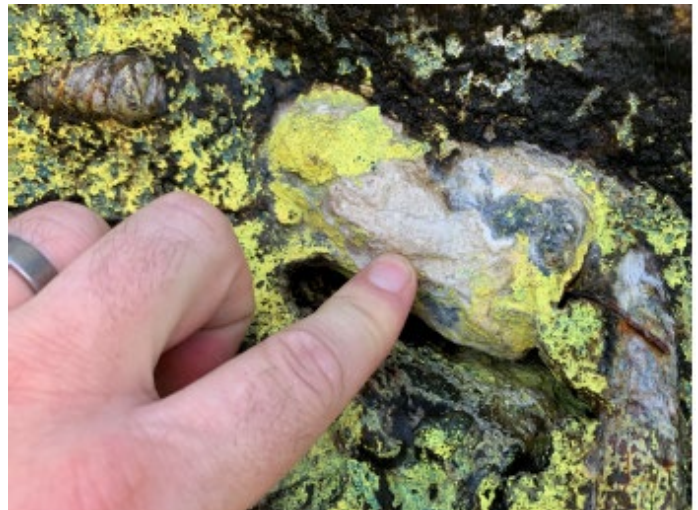
Figure 26: Possible evidence of embedded sacrificial anodes near exposed reinforcement.

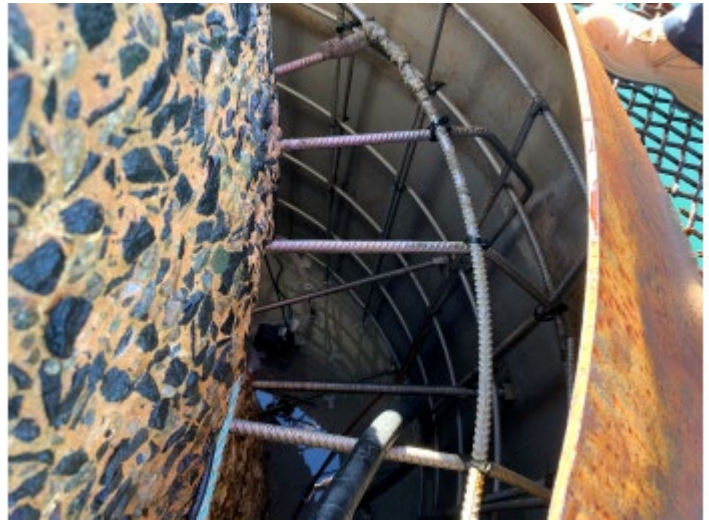
Figure 27: Stainless steel reinforcement prior to concrete pour

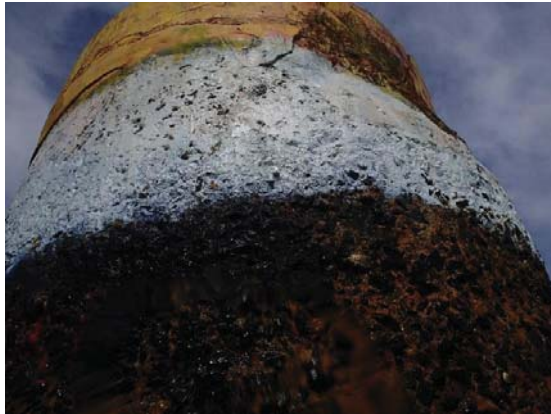
The top section of the pylon that typically sits above the height of the water is relatively uniform as a cylindrical shape with a circumference of 4.8 m (Figure 2-1). There is some cracking though this top section however there are no areas of significant concrete loss. It appears that a repair to the upper part of this section may have been previously undertaken. Where the pylon meets the waterline there are significant apparent losses of concrete resulting in a scalloped appearance to the pylon through this section. The losses are not uniform, but it appears that on the whole the concrete has cracked away down to a layer of re-enforcing bar (rebar) that was originally embedded around 200 to 250 mm below the surface of the concrete. Although not entirely uniform, the result is that the pylon roughly tapers from a circumference of 4.8 m above the waterline, to a circumference of 4.3 m 600 mm below the waterline. Please note that for ease of reference in this report the area where the pylon transitions from sectional concrete loss to no sectional loss has been referred to as "the surface". The following photographs (Figure 2-2 through Figure 2-4) illustrate these concrete losses at the waterline and resulting scalloping of the pylon.

Figure 2-1 Pylon above waterline

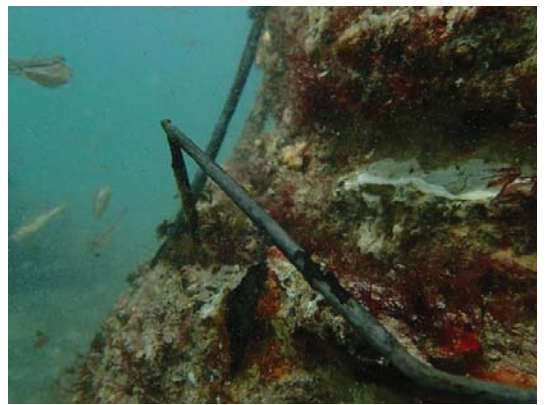
Figure 2-10 Rebar through top of tapered section

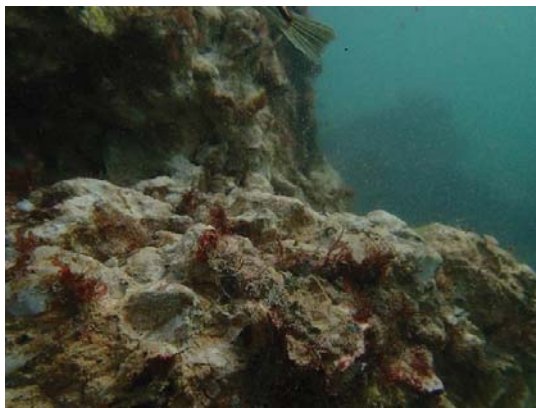
Figure 2-11 Crumbling concrete on taper

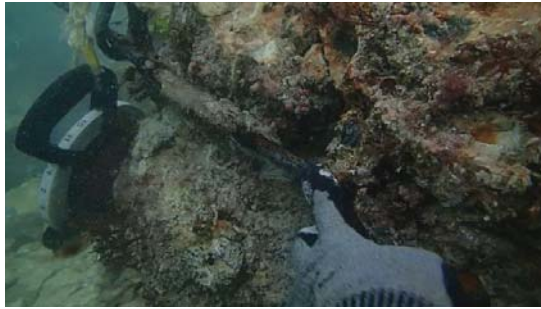
Figure 2-15 Part of ring visible at base of taper

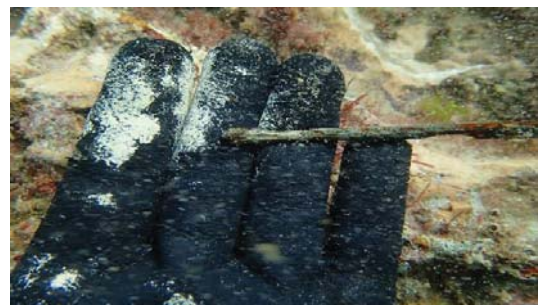
Figure 2-20 Broken ring cylindrical section

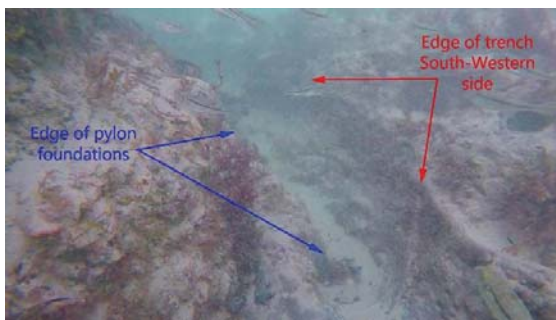
Figure 2-21 Trench South-Western side

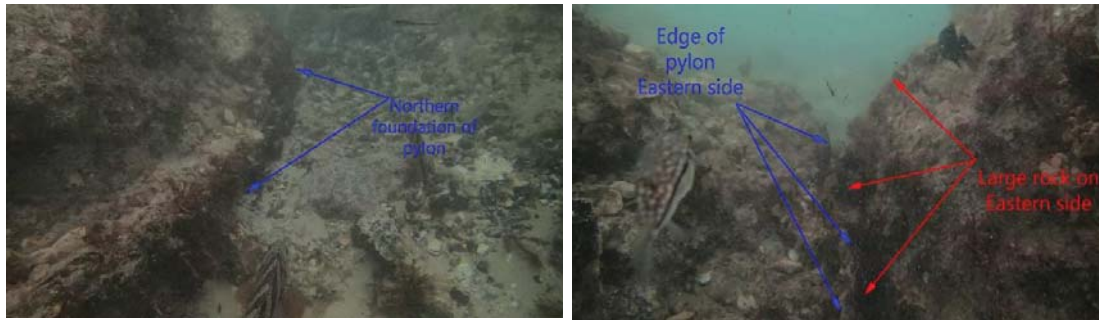
Figure 2-25 Trench poorly defined Northern side Figure 2-26 Large rock on Eastern side

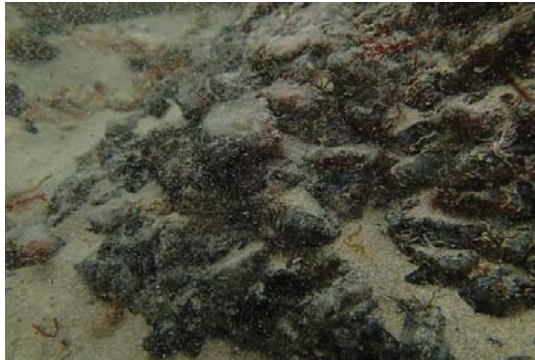
Figure 2-27 Bound blue metal South-Western side

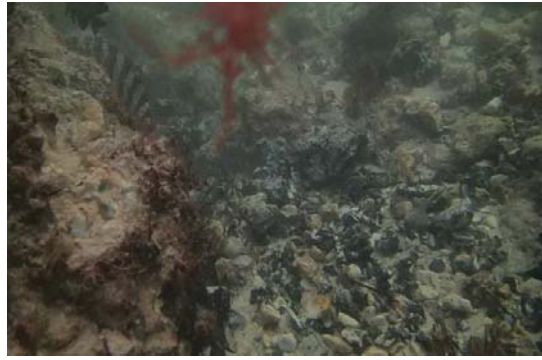
Figure 2-28 Loose blue metal Northern side

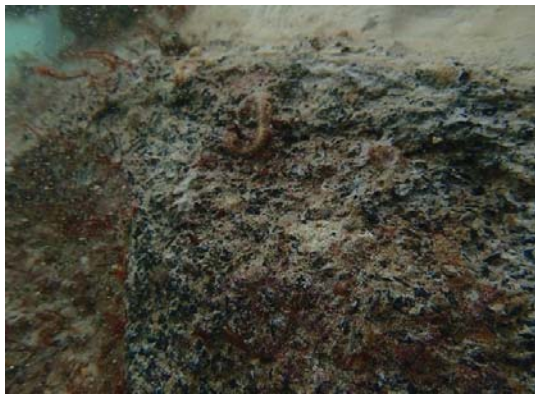
Figure 2-29 Cream mortar small stones South-Western side

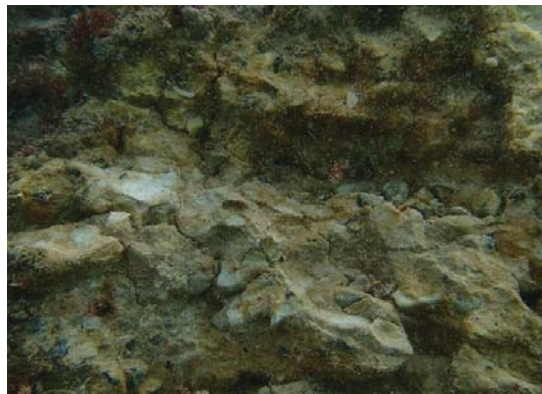
Figure 2-30 Cream mortar large stones showing cracking South-Eastern side

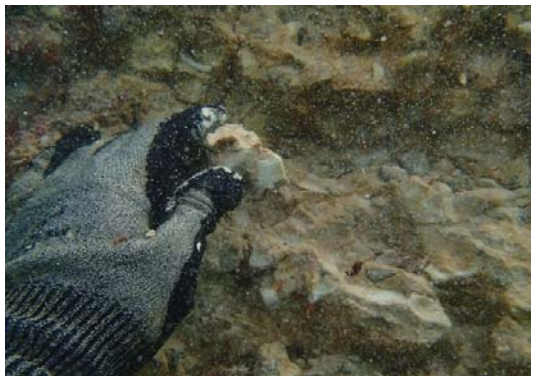
Figure 2-31 Cream mortar large stones diver removes aggregate by hand

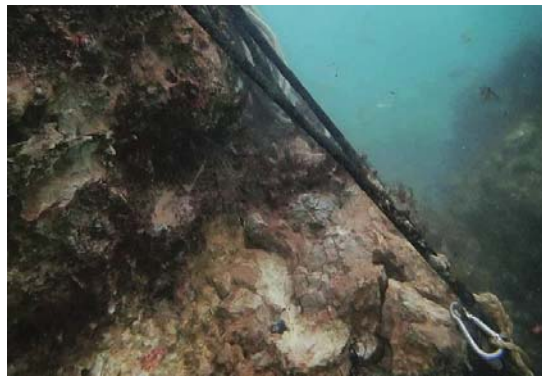
Figure 2-32 Cream mortar large stones degraded through rebar taper section

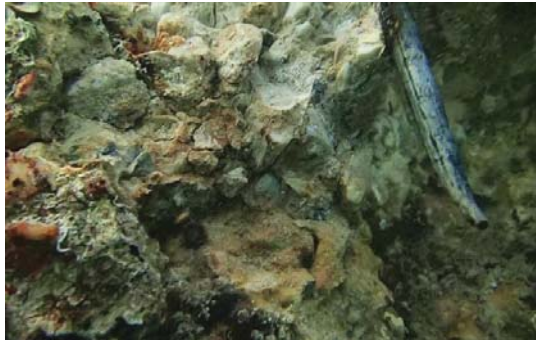
Figure 2-33 Cream mortar large stones degraded through rebar taper section

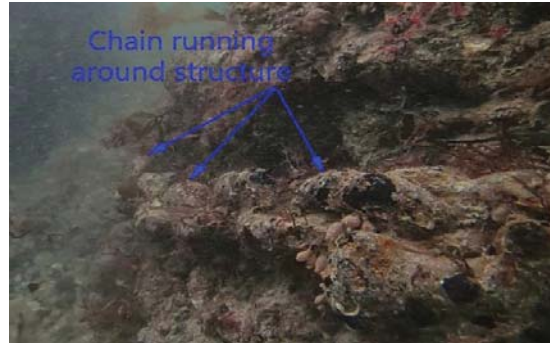
Figure 2-34 Chain running around base of structure

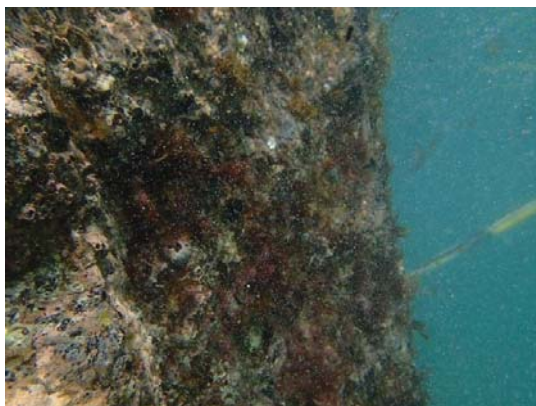
Above the rebar taper, the pylon appears to be homogenous in construction. It is constructed from a creamy coloured mortar with large (25 to 40 mm) blue metal aggregate. As previously mentioned, the concrete has cracked away underwater to form a roughly cylindrical section bounded on all sides by the original internal rebar cage. The concrete through this section appeared relatively solid, although significant force was not applied. There is a small section just below the waterline on the North-Western side where the concrete appears to stick out to its original width. Above the surface the concrete has some cracking but appears to be at its original diameter. There is some minor erosion on all sides above the waterline showing exposed aggregate. The divers could not find any soft sections of concrete above the rebar taper, suggesting that this section may have been constructed as a single pour, or the method of tying in the cold joints in the concrete together was different to those employed lower down on the pylon.

Figure 2-35 Pylon above rebar taper

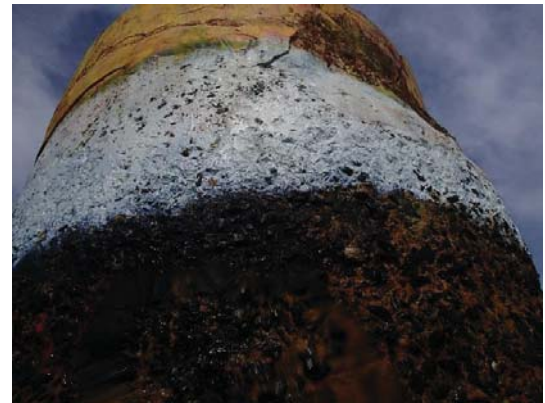
Figure 2-40 Pylon above waterline

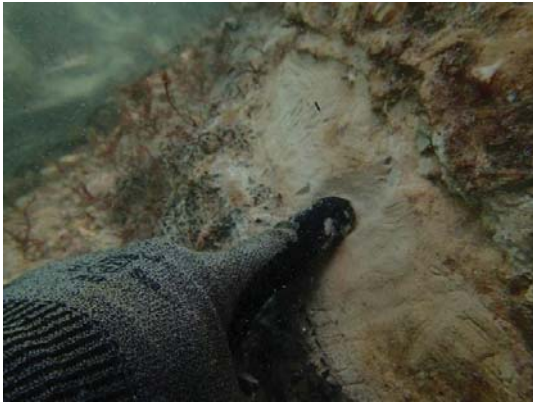
soft foundations that are already heavily eroded with minimal rebar to reinforce it. The following photographs (Figure 2-41 through Figure 2-46 below) illustrate the nature and extent of these areas of soft concrete.

Figure 2-41 Soft clay-like material above blue metal section

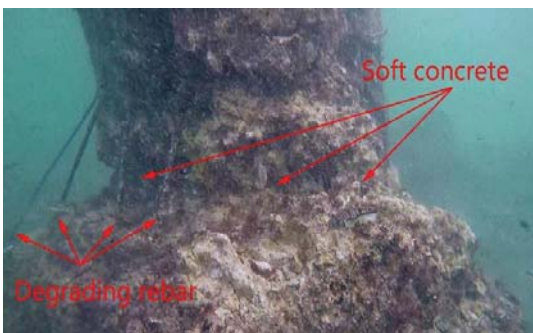
Figure 2-45 Soft clay-like material through rebar tapered section and degraded rebar

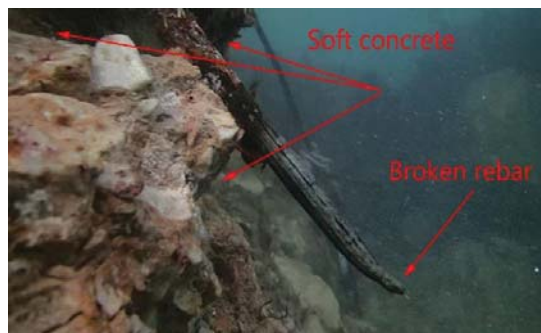
Figure 2-46 Soft clay-like material through rebar tapered section and broken rebar

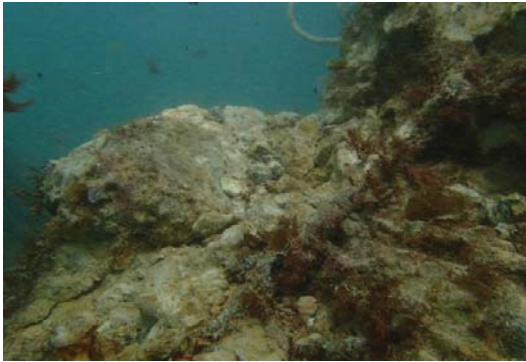
**Figure 2-47 Uneven nature of foundations
Eastern side**

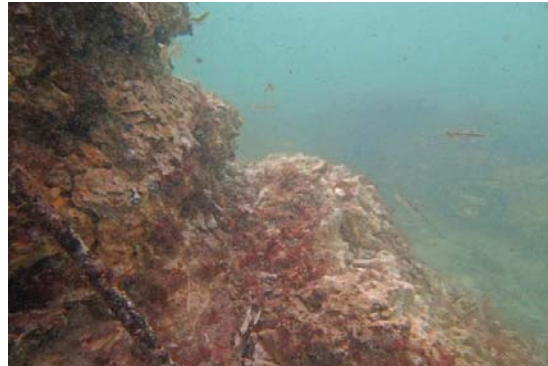
**Figure 2-48 Uneven nature of foundations
North-Eastern side**
