COTTESLOE FORESHORE RENEWAL  
INFRASTRUCTURE REDUCTION STRATEGY

August 2017  
Revision A

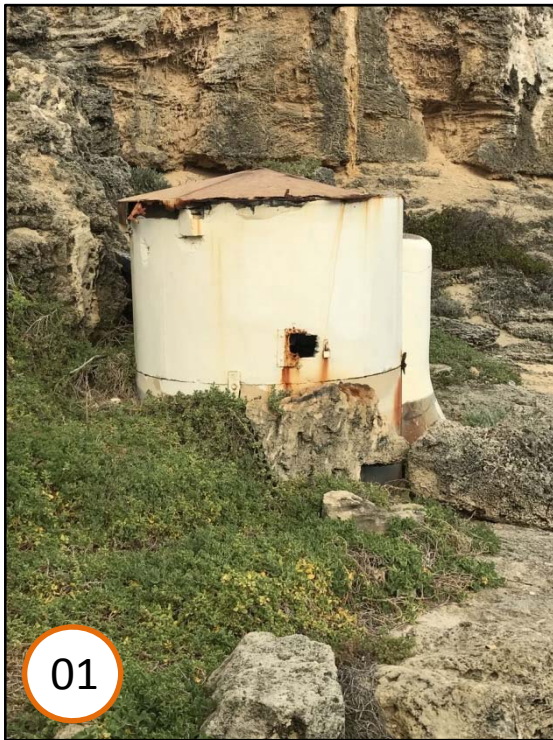
01

#### SHARK TOWER BASE

The base of the former shark tower installed in the 1940s and consists of concrete and steel reinforcing located within the rock headland zone.

- a) The preference is to immediately remove it all completely and blend over it with natural looking rock, OR
- b) An option is to remove most of it, retain a remnant small footprint and install explanatory educational signage and a photo image on the nearby groyne footpath.

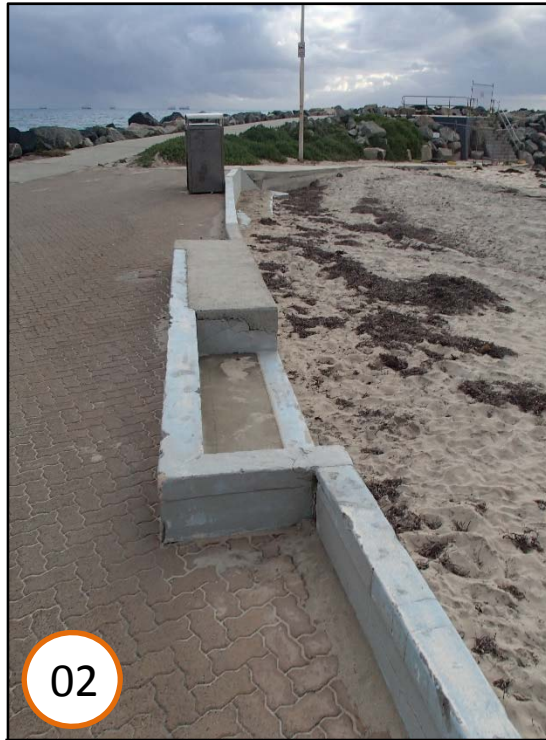
02

#### SPLASH POOL

The walls to the former toddler splash pool were previously functional, however currently serves no function apart from minor retaining of the footpath.

The wall will be removed as part of the beach access works. Imagery of the former pool and other historic beach structures can be included elsewhere in the project.

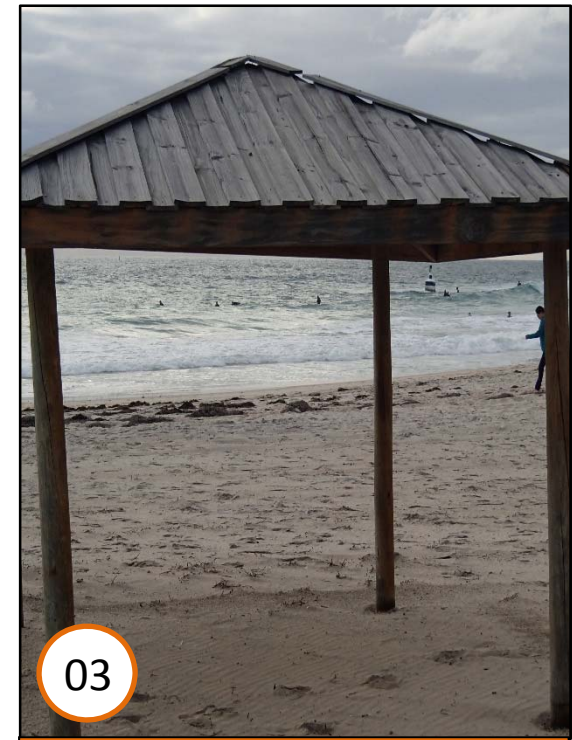
03

#### TIMBER BEACH SHELTERS

The timber beach shelters serve an important function in the provision of shade however are dated and present maintenance and safety issues.

The shelters be removed as part of the beach access works and a new form of shade be designed and included in this location.

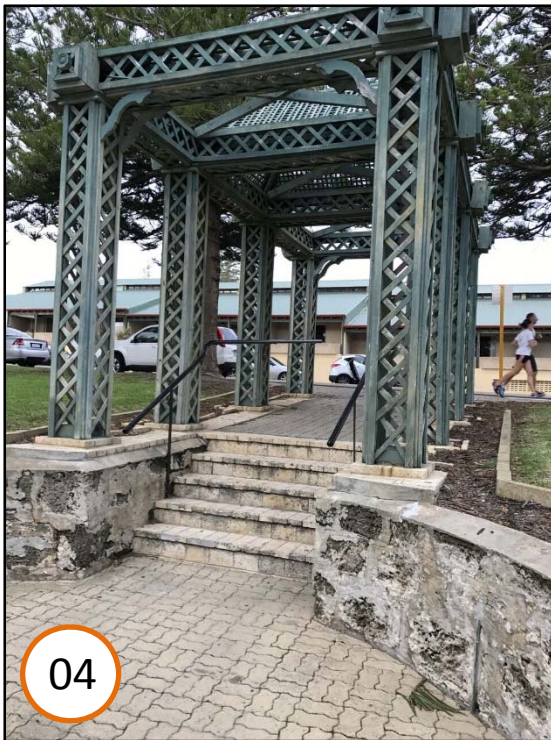
04

#### INDIANAS PERGOLA

The existing timber lattice pergola forms part of the entry into Indianas. The timber is old and becoming rickety and more difficult to maintain, the structure is not utilised for any particular purpose. It does provide an entry element which could be undertaken in another way if necessary.

The pergola be removed in full.

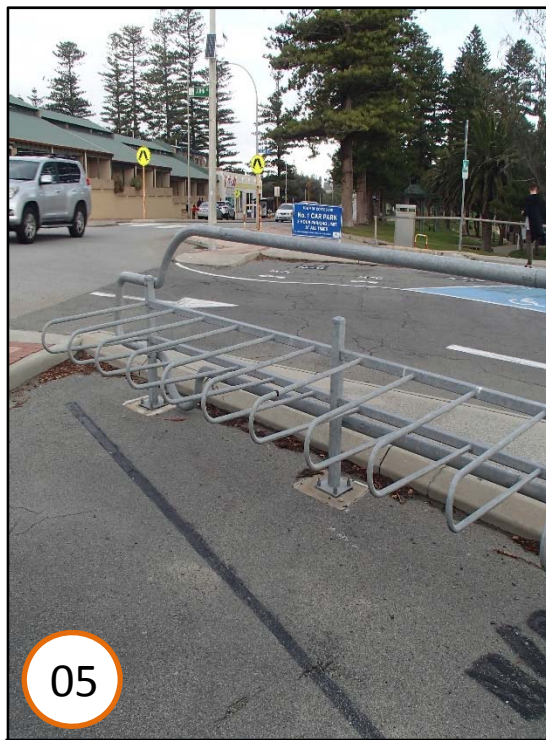
05

#### BIKE RACK

The bicycle rack at the southern point of the beach front car park is large and bulky at a key view location. It has served its purpose in demonstrating the need for bike racks however the location should be reviewed.

The bike rack to be removed and an alternate location is to be considered for this particular fixing, note that some modifications may also be required to prevent it being used by motor scooters. Smaller bike racks to be considered in regular locations.

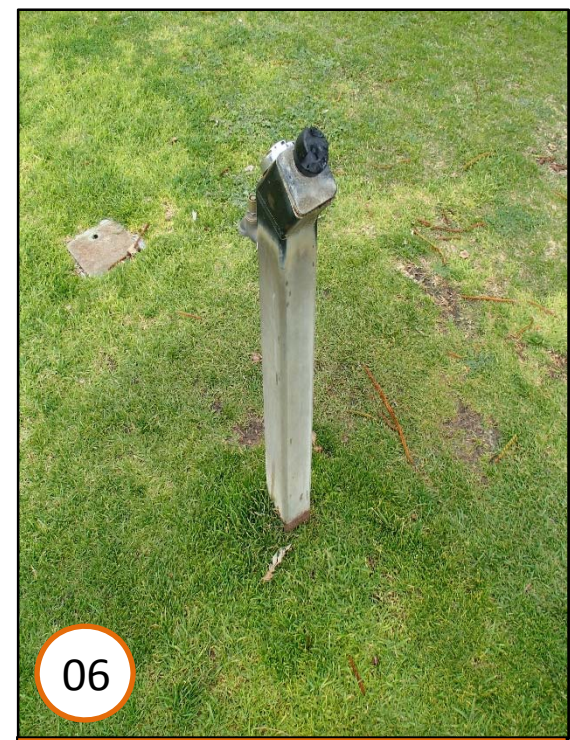
06

#### DRINKING FOUNTAIN

This drinking fountain provides a valuable resource particularly in summer. We note that it requires maintenance around its base, resulting from water overspill and it currently does not function.

The item be temporarily removed, fixed and reinstalled in a more suitable location.

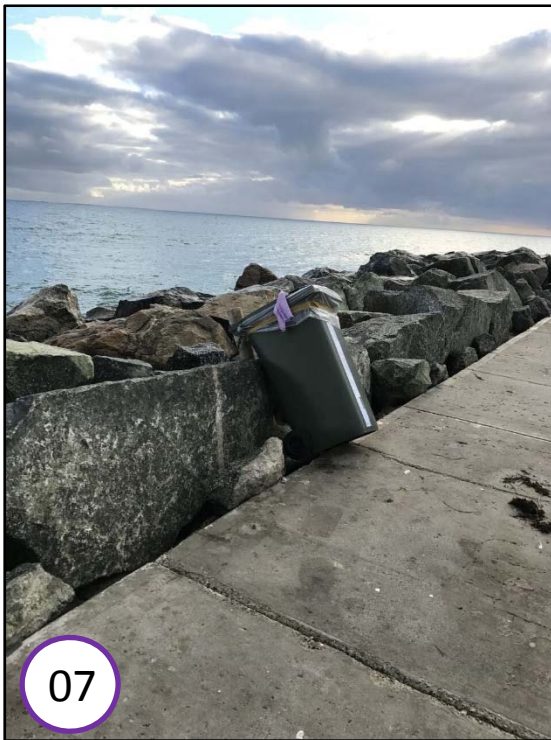
#### PLASTIC WHEELIE BINS

The large 180litre green plastic wheelie bins form an important part of the Councils maintenance cost efficiency and provide an important community benefit and message. The bins however are unattractive, look temporary and may be more functionally located near higher use areas and access ways.

The wheelie bins be housed in robust bin enclosures which will be designed to be in keeping with the foreshore upgrade.

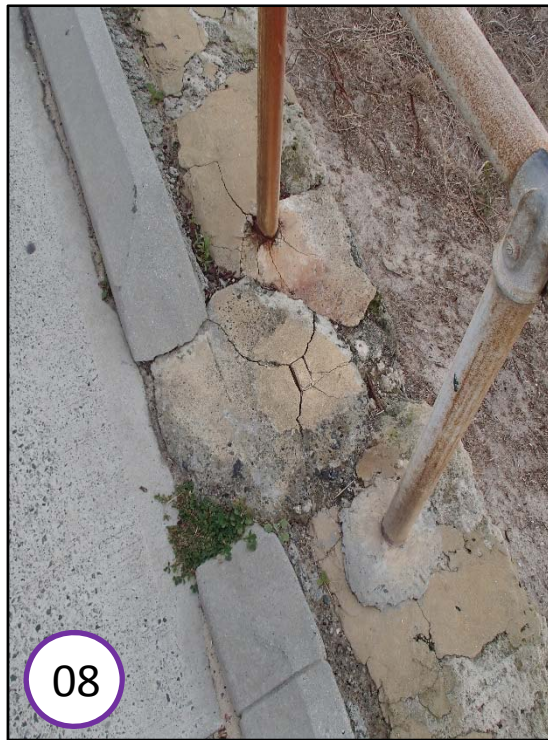
#### BALUSTRADE TO TERRACE

The balustrade to the top of the grass terrace is weathered and degraded.

The balustrade is reviewed by a structural engineer to assess if there are any safety issues. Ultimately this is to be replaced potentially with a more attractive balustrade that ties in with the Cottesloe character.

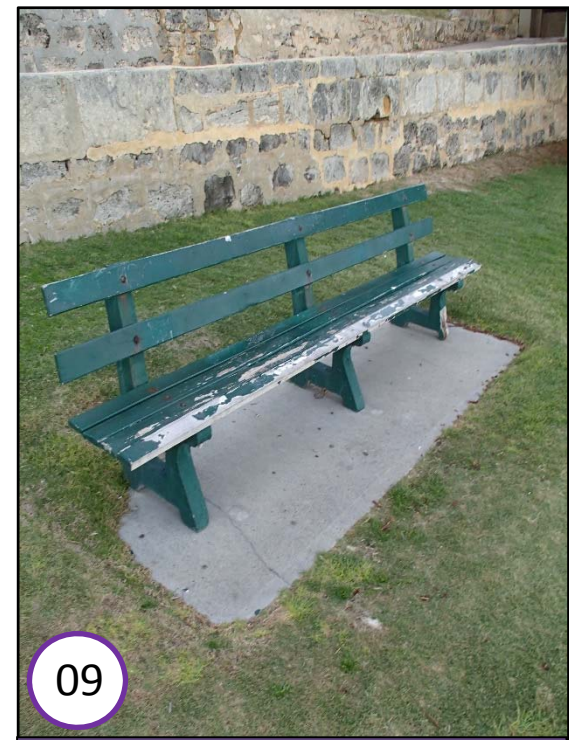
#### GREEN BENCH SEATS

Green painted timber bench seats similar to those adjacent to Indianas are worn and splintering in places. The concrete base is cracked and grass is growing over part of the plinth making maintenance harder.

The seats are to be immediately sanded and re-painted. Ultimately to be replaced by a new Cottesloe character based furniture suite.

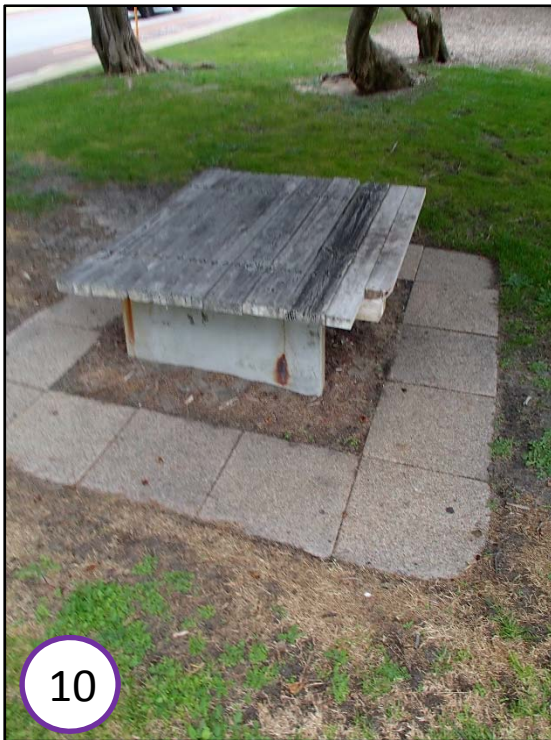
10

#### TIMBER TABLES

The timber tables are broken in places, worn and splintering. These tables also require users to bring adequate seating.

To have any broken planks replaced and to be immediately sanded and re-painted. Ultimately to be replaced by a new Cottesloe character based furniture suite.

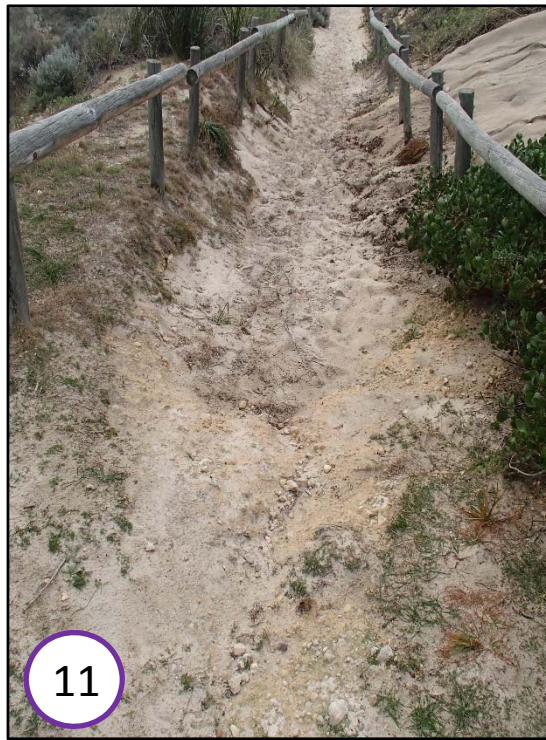
11

#### BEACH ACCESS

Selected areas of beach access and adjacent dunes are eroding and unstable.

Use levels of the relevant paths to be assessed. If the path is well used and suitable for retention then stabilisation and additional sand may be required. If the relevant paths are underused they may be considered for closing and revegetation.

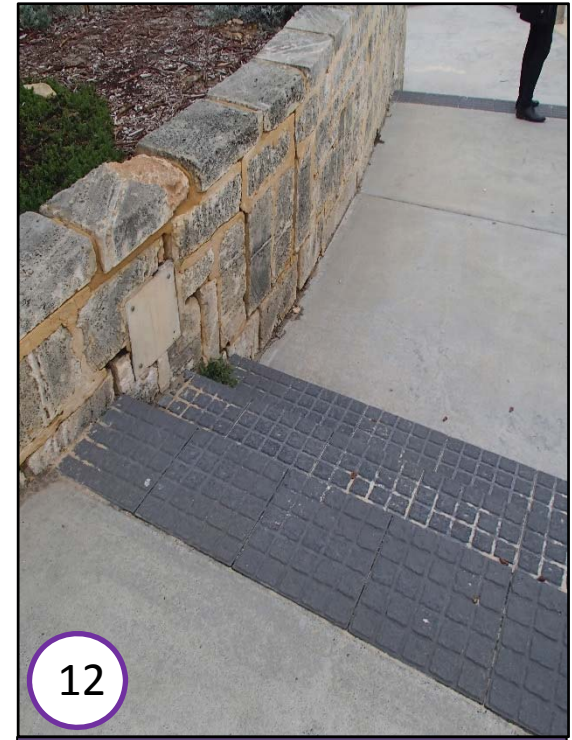
12

#### LIMESTONE RETAINING WALL

Limestone retaining walls that have loose blockwork and crumbling mortar and may be unsafe in part.

The wall is to be reviewed by a structural engineer to assess if there is any safety issues.

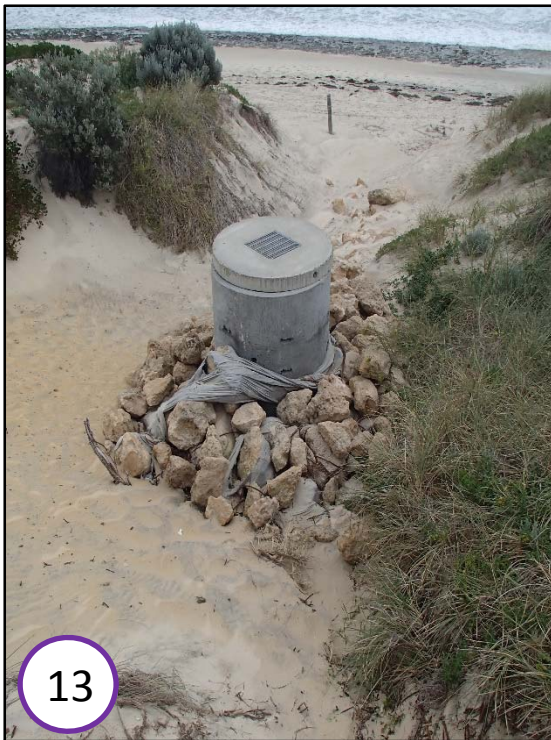
#### SOAKWELLS

The stormwater overflow is eroding the adjacent dune area and the limestone pitching is partly functional but unsightly.

Additional sand is to be installed and stone pitching to be rectified and revegetation with dune and sedge planting to stabilise the immediate area.

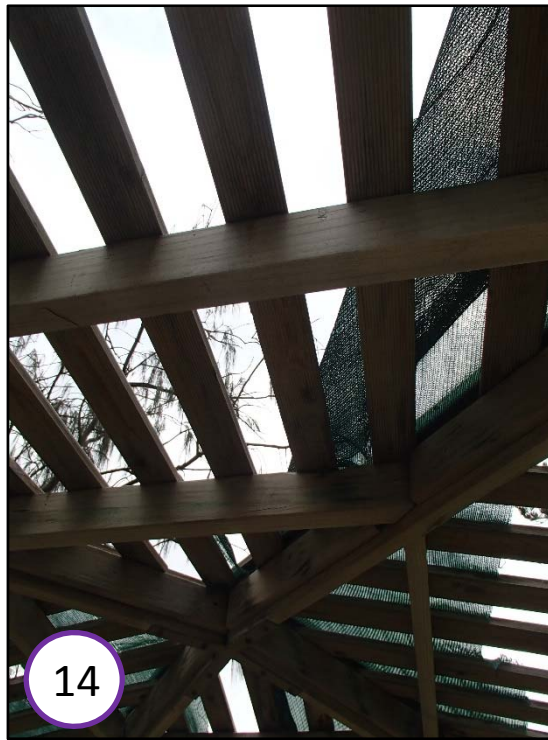
#### GRASS BANK SHELTERS

The shelters are worn and also the timber presents an ongoing maintenance issue. Shade cloth has been added to help provide shelter to the structure however the shade cloth is loose. The adjacent pines provide significant shade.

A more durable shade material is to be added in the short term to the shelters. Ultimately the shelters are to be removed or relocated.

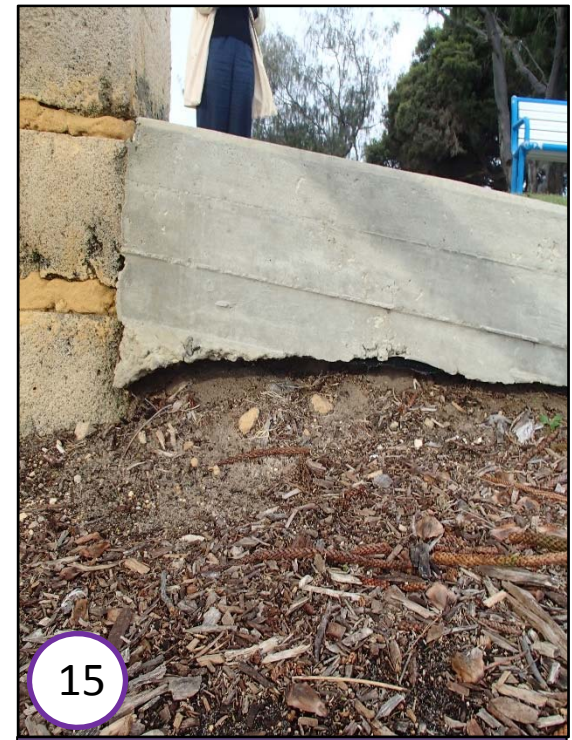
#### CONCRETE RAMP

Erosion is evident around base of the concrete ramp leading toward the surf club. Aspects of the ramp edge could potentially be unsafe.

The ramp is to be reviewed by a structural engineer to assess if there are any safety issues. The edge of the ramp is to be landscaped and disguised.

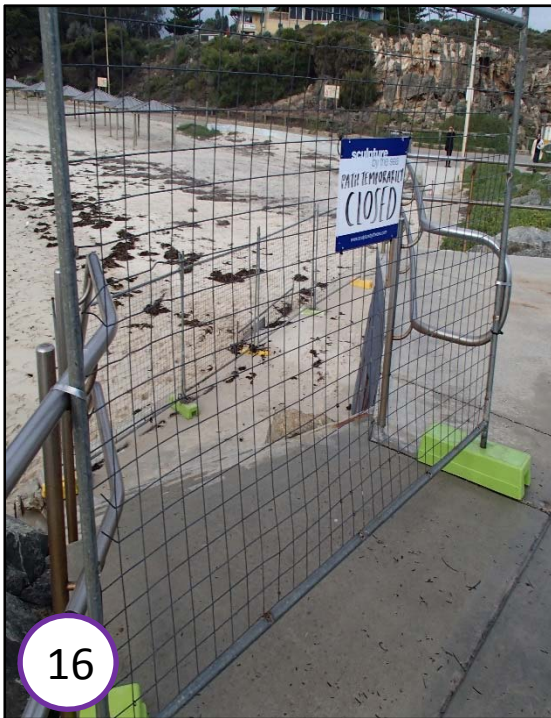
16

### GROYNE ACCESS

Stair access leading from the beach up to the groyne is temporarily closed.

Stair access to be rectified as part of beach access works.

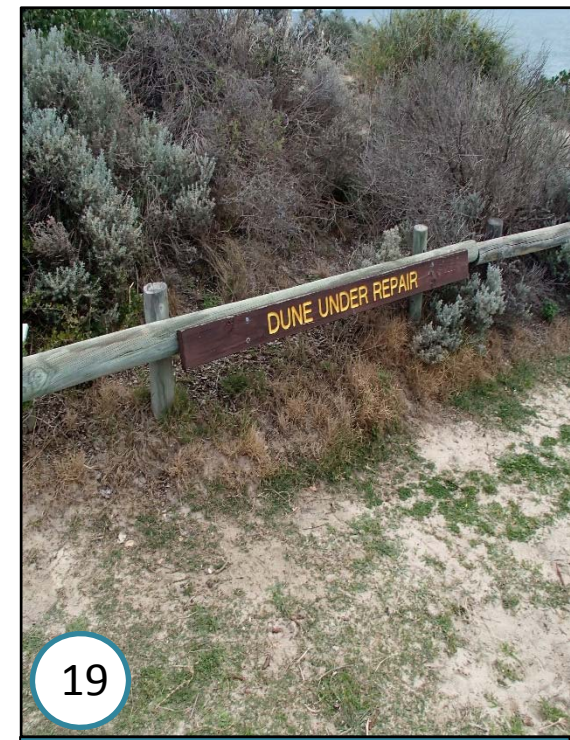
19

#### DUNE SIGNAGE

Dune signage is functional but dated and worn.

Dune signage to be reconsidered with consistent message and materials linked to a broader signage suite.

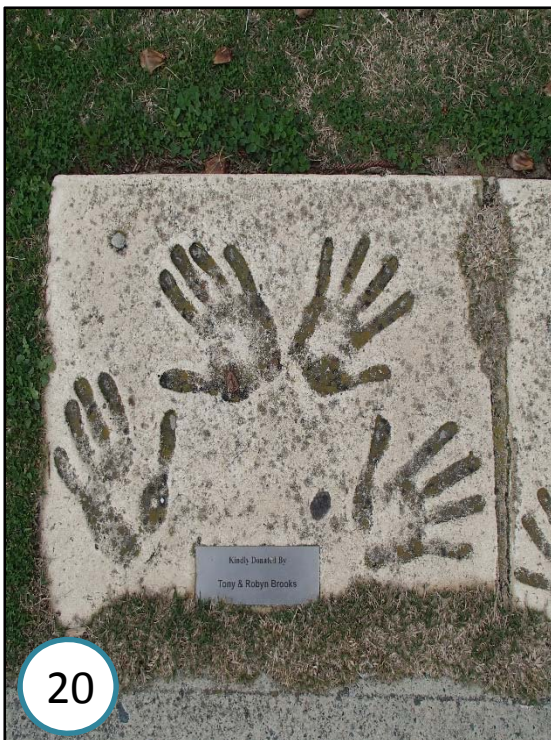
20

**PUBLIC ART**

It is acknowledged that past donors be continually recognised for their contribution and involvement. It is noted however that the pavers are dated and worn and have become difficult to maintain around in some areas.

Names of donors are proposed to be potentially re-incorporated into future signage/artwork via less obtrusive listed text. Pavers may also be offered back to their donors or relocated into other areas in the foreshore.

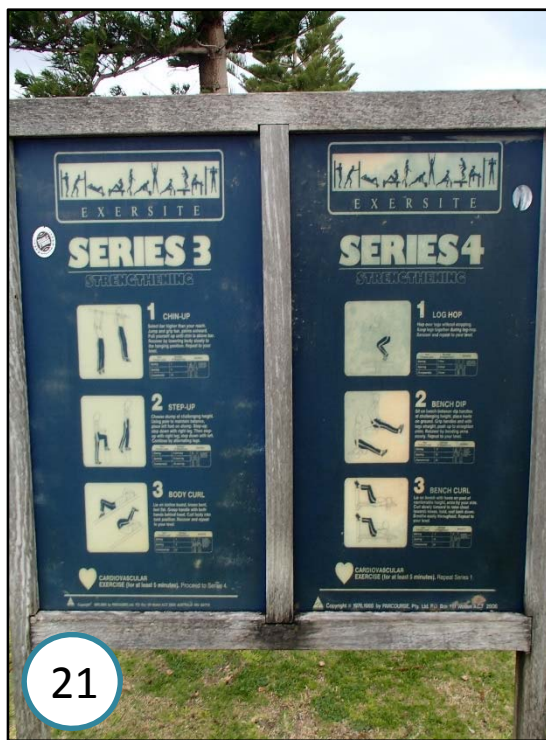
21

**FITNESS SIGNAGE**

The fitness equipment is popular and is to be retained and upgraded. Signage is worn and dated.

Signage to be updated to incorporate broader range of exercises as well as tie into proposed signage theming. Potential for interactive smartphone bar codes and geo-caching will provide fitness information and track the users personal fitness progress.

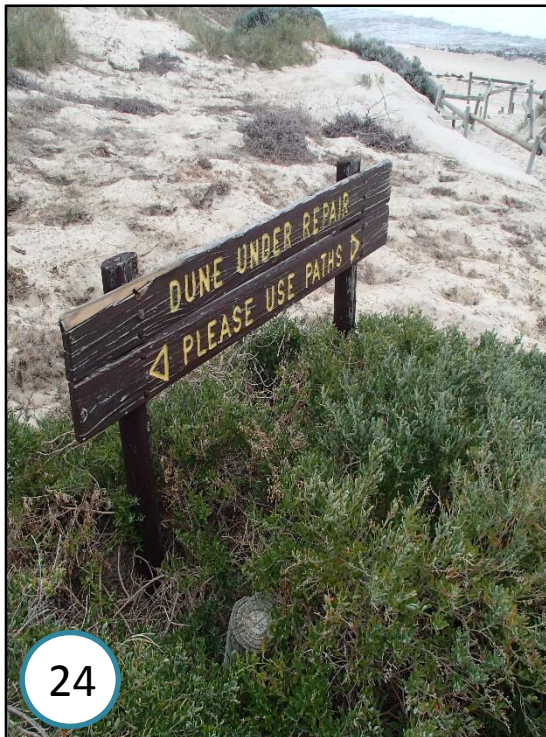
24

**DUNE SIGNAGE**

Dune signage is dated and worn.

The dune signage is to be consolidated with consistent message and materials/theming. There is the potential to incorporate messaging from Coast Care and Council including educational text regarding dune systems, species, fauna and habitat.

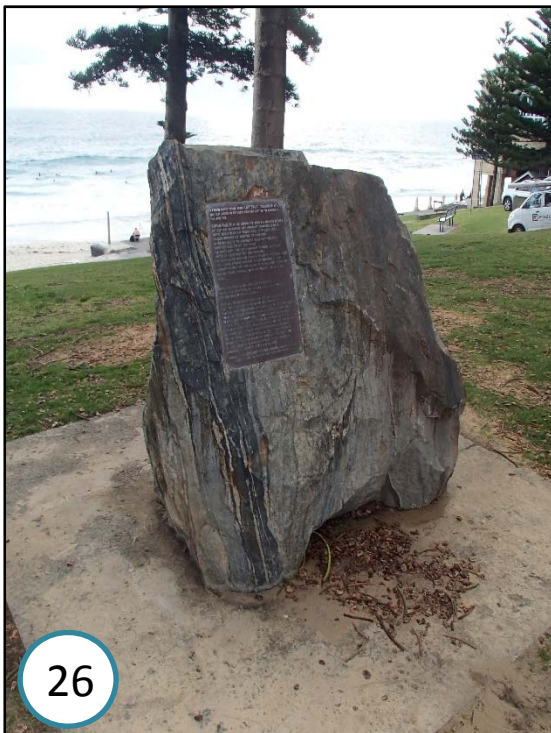
26

#### HISTORIC SIGNAGE

Plaque and information to be retained however it is not clear the relevance of the rock in which it is placed. The physical rock is obtrusive and not local limestone.

The significance of the actual rock is to be investigated. The plaque is to be relocated while remaining accessible and visible.

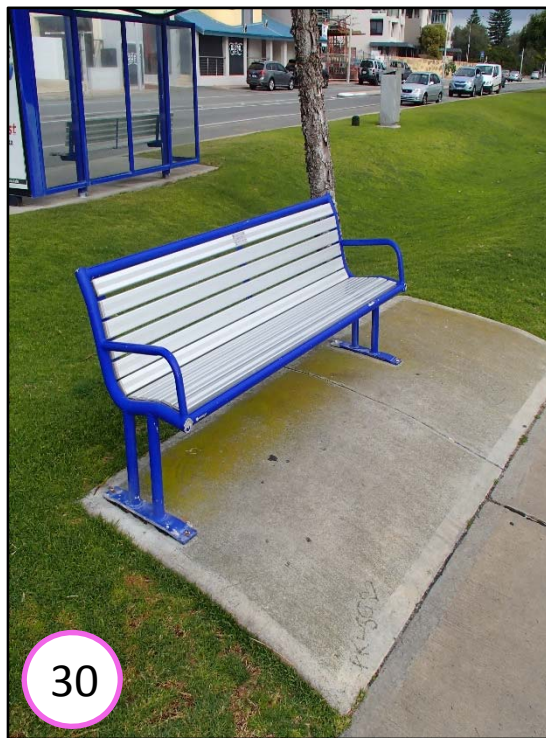
30

**BENCH SEATING**

The aluminium bench seating is functional and resilient however it is dated in its design.

The bench seating is to eventually be reconsidered as part of a local Cottesloe based character furniture suite. The commemorative plaques are to be retained within the foreshore.

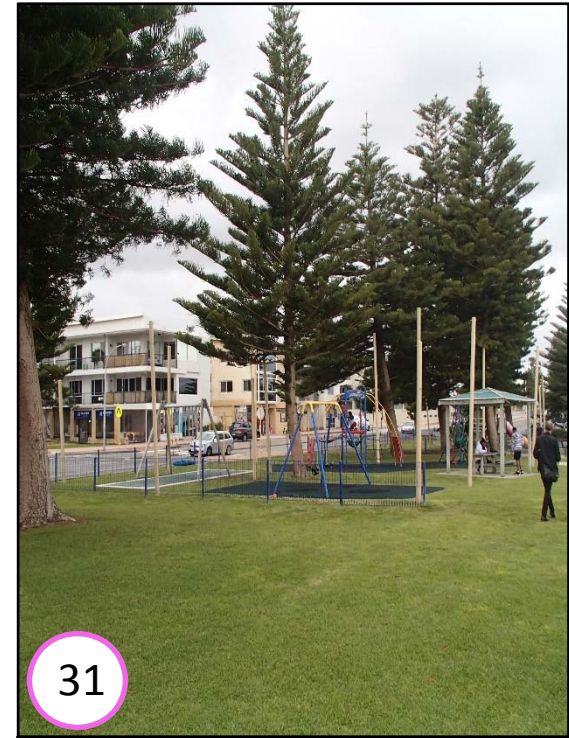
31

**PLAYGROUND EQUIPMENT**

Playground equipment is popular however its contents are currently only targeted at young children. The finishes and components are dated and worn.

Play equipment design and contents are to be reviewed to target a larger mix of age and abilities groups. The possibility of a more informal nature play finish is to be considered with inbuilt shade elements rather than shade sails and their maintenance requirements.

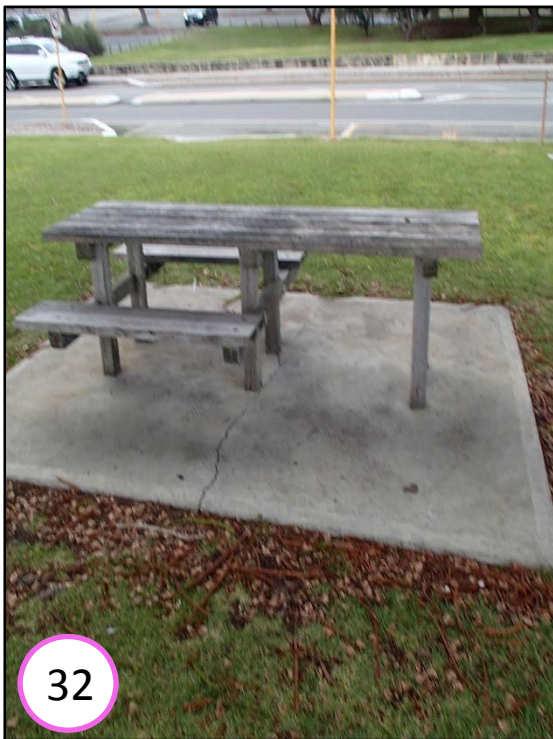
#### TIMBER PICNIC TABLE

The timber picnic setting is old, stained and worn and splintering in places. The design is dated and worn and the concrete pad is cracked.

To be replaced with a more durable piece of furniture better suited to coastal conditions and Cottesloe character.

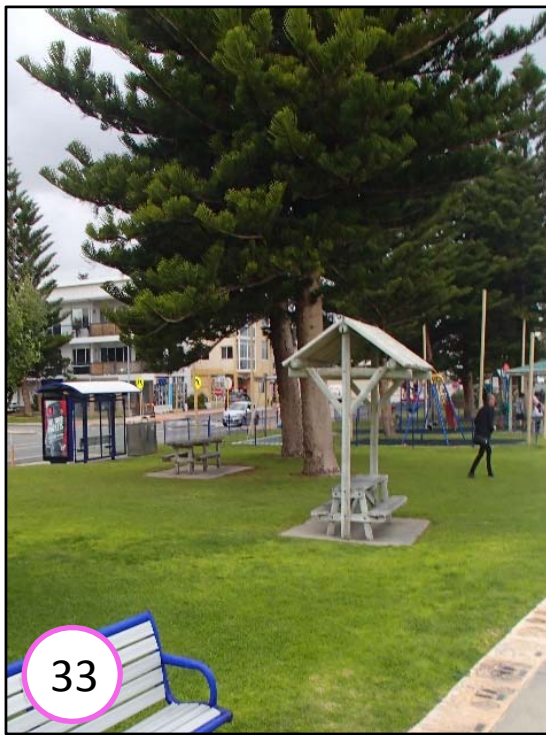
#### TIMBER SHADE STRUCTURE

The existing timber shelters are dated in their design and worn in their materials. The roof element provides limited shade.

To be replaced with a more durable shelter with broader shade provisions that is better suited to coastal conditions and Cottesloe character.

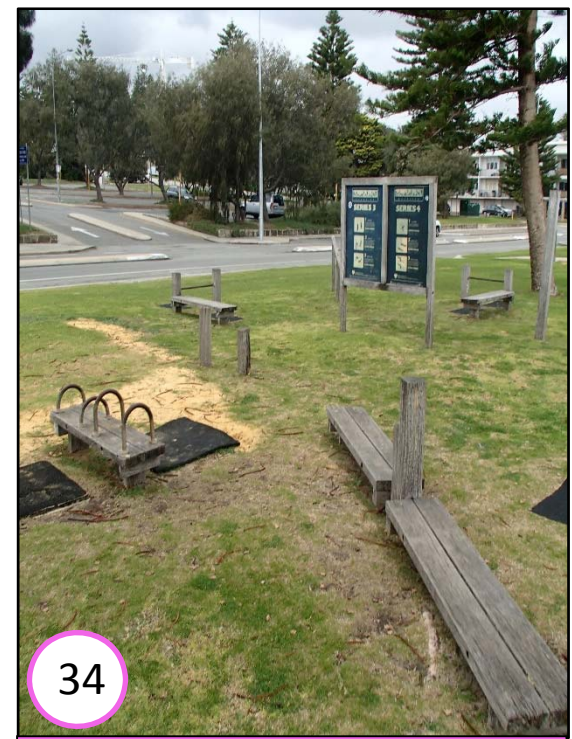
#### FITNESS EQUIPMENT

Fitness equipment is popular however equipment itself is dated and worn.

To be replaced with more durable fitness equipment with broader shade provisions that is better suited to coastal conditions and Cottesloe character.

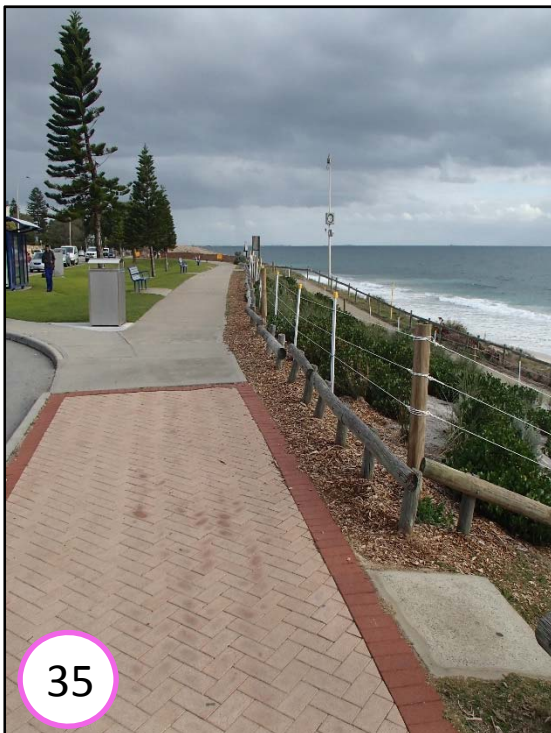
35

**PAVING**

The variety of paving materials is inconsistent along the foreshore promenade. The segmental brick paving is dated in its colour and form.

The paving materials are to be reviewed to provide easy access, consistency of material and a clear path hierarchy for users to avoid collisions or disputes.

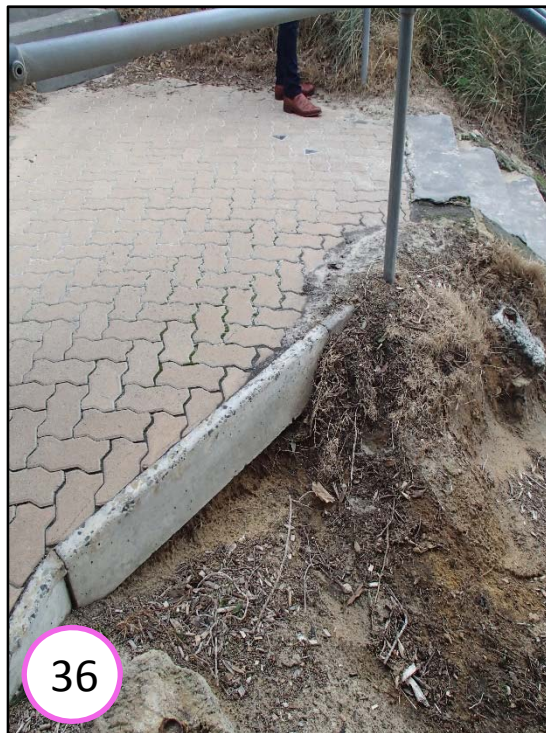
36

**PAVING**

The variety of paving materials is inconsistent along the foreshore promenade. The segmental brick paving is dated in its colour and form.

The paving materials are to be reviewed to provide easy access, consistency of material and a clear path hierarchy for users to avoid collisions or disputes. The paving in this instance is to be reviewed by structural engineer to assess if it presents any safety or erosion issues.

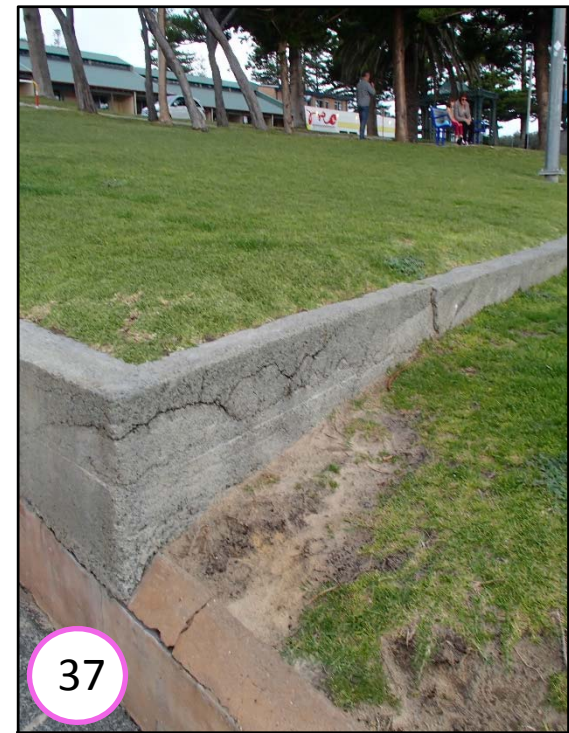
37

**LOW RETAINING WALL**

Reconsideration of some retaining walls that are not necessarily required is to be undertaken. In this instance the turf can be regraded to remove the requirement for wall altogether to reduce barriers and maintenance.

Consider removing this wall and re-grading the turf batter into an even smooth informal seating slope.

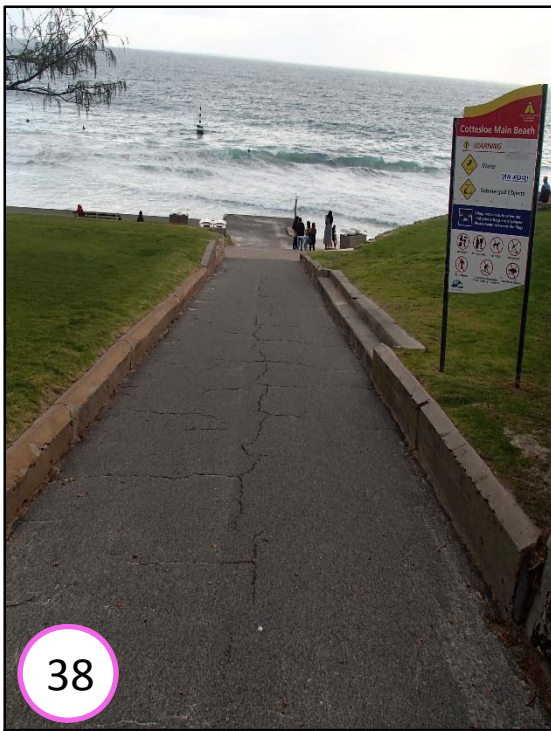
### ASPHALT PAVING

The black asphalt path is cracked and is rough and hot on bare feet approaching the beach. Asphalt is not necessarily required as this path is pedestrian traffic only and does not take vehicles.

Reconsider the width of access path and material to tie into overall path network and promote local Cottesloe character.

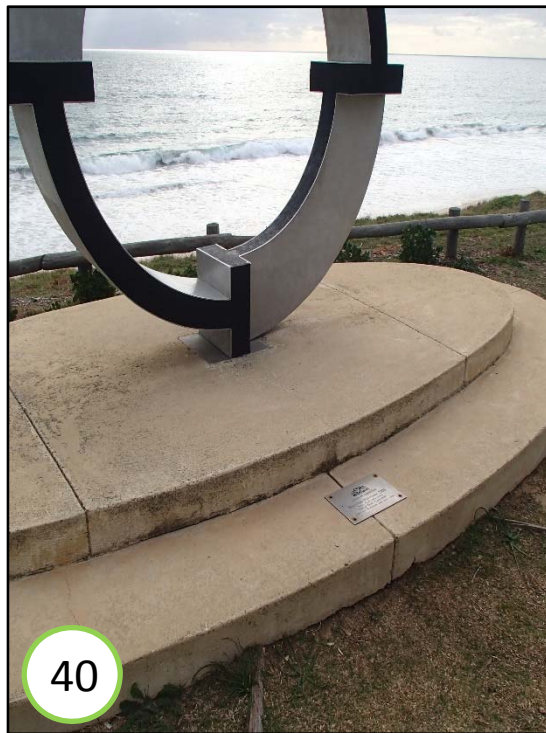
### SCULPTURE

Significant piece of public art frames views to ocean and appears popular among the local community.

The sculpture is to be retained for use. The levels finish around the plinth is to be rectified. An improved location could be potentially considered to maximise visual interaction with this sculpture.

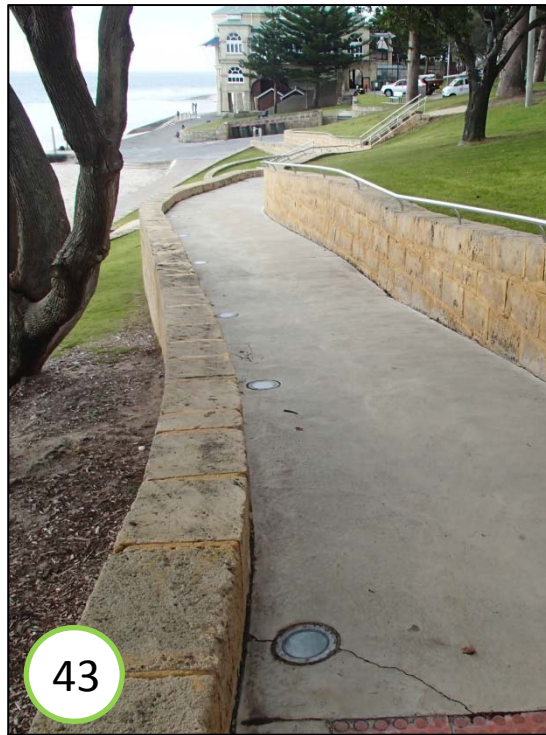
### DISABILITY ACCESS RAMP

Disability access to the beach and surf club has recently been installed.

The disability access ramp is to be retained. Consideration of the transition at either end is to be undertaken to ensure suitable disability access. Connection at bottom to be addressed to ensure better integration with levels.
