*Assessment of Trees; Western verge of Railway Street opposite North
Cottesloe Primary School*

Town of Cottesloe

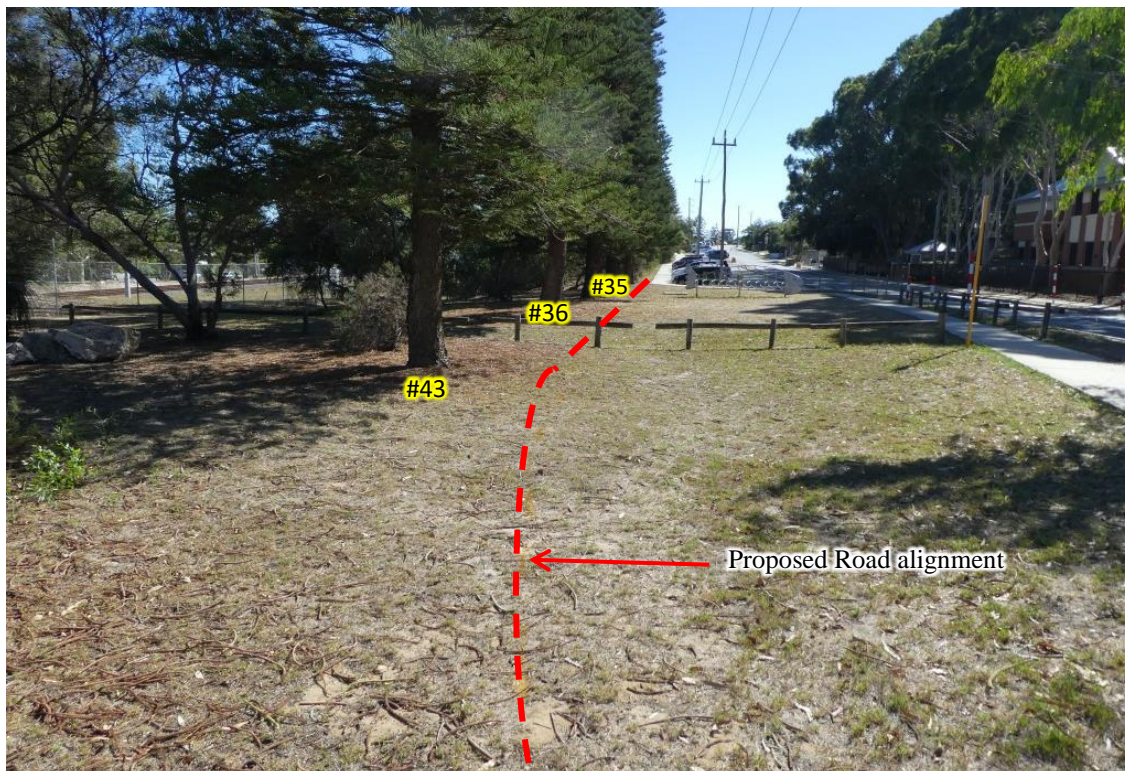
6.1.2 Potentially significant impact from the construction of the Road looks likely to occur to Trees #1, #7, #23, #24, #27, #28, #35, #36, and #43; particularly Trees #27, #28, #35, #36, and #43 given the proximity of the proposed road pavement and level of excavation anticipated to be required.

Trees #1, #7, #23 and #24 may have already been subject to some degree of root zone disturbance and possibly loss of root mass when the current existing car parking area was installed, so impact to these Trees may actually be less than to the others.

- a) Some exploratory excavation works are recommended to be undertaken to verify the actual root spread from each of these Tree along the alignment of the proposed excavation for the Road; from which a more informed opinion on the potential impact to the Trees can then be provided.

This is recommended to be undertaken by way of vacuum excavation to open a 100mm wide slot trench to the depth of any 'box-out'/excavation required to enable viewing of any roots that are present.
