Arborist Assessment and Report

Subject: Tree: Norfolk Island Pine (*Araucaria heterophylla*)

Location: Out side 52 Forrest St Cottesloe

Date : 21/1/2014

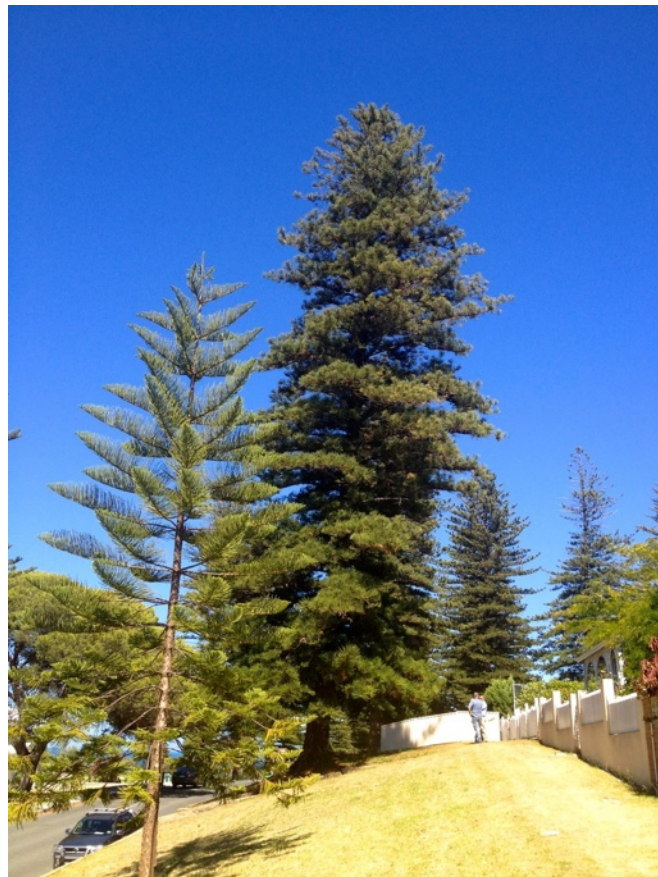
The structural form of this tree shows a lean to the north up to 20 m and then for the remaining 8 m or so of the top is vertical. This vertical growth habit is a correction at some point in the trees life and is evident in the photo.

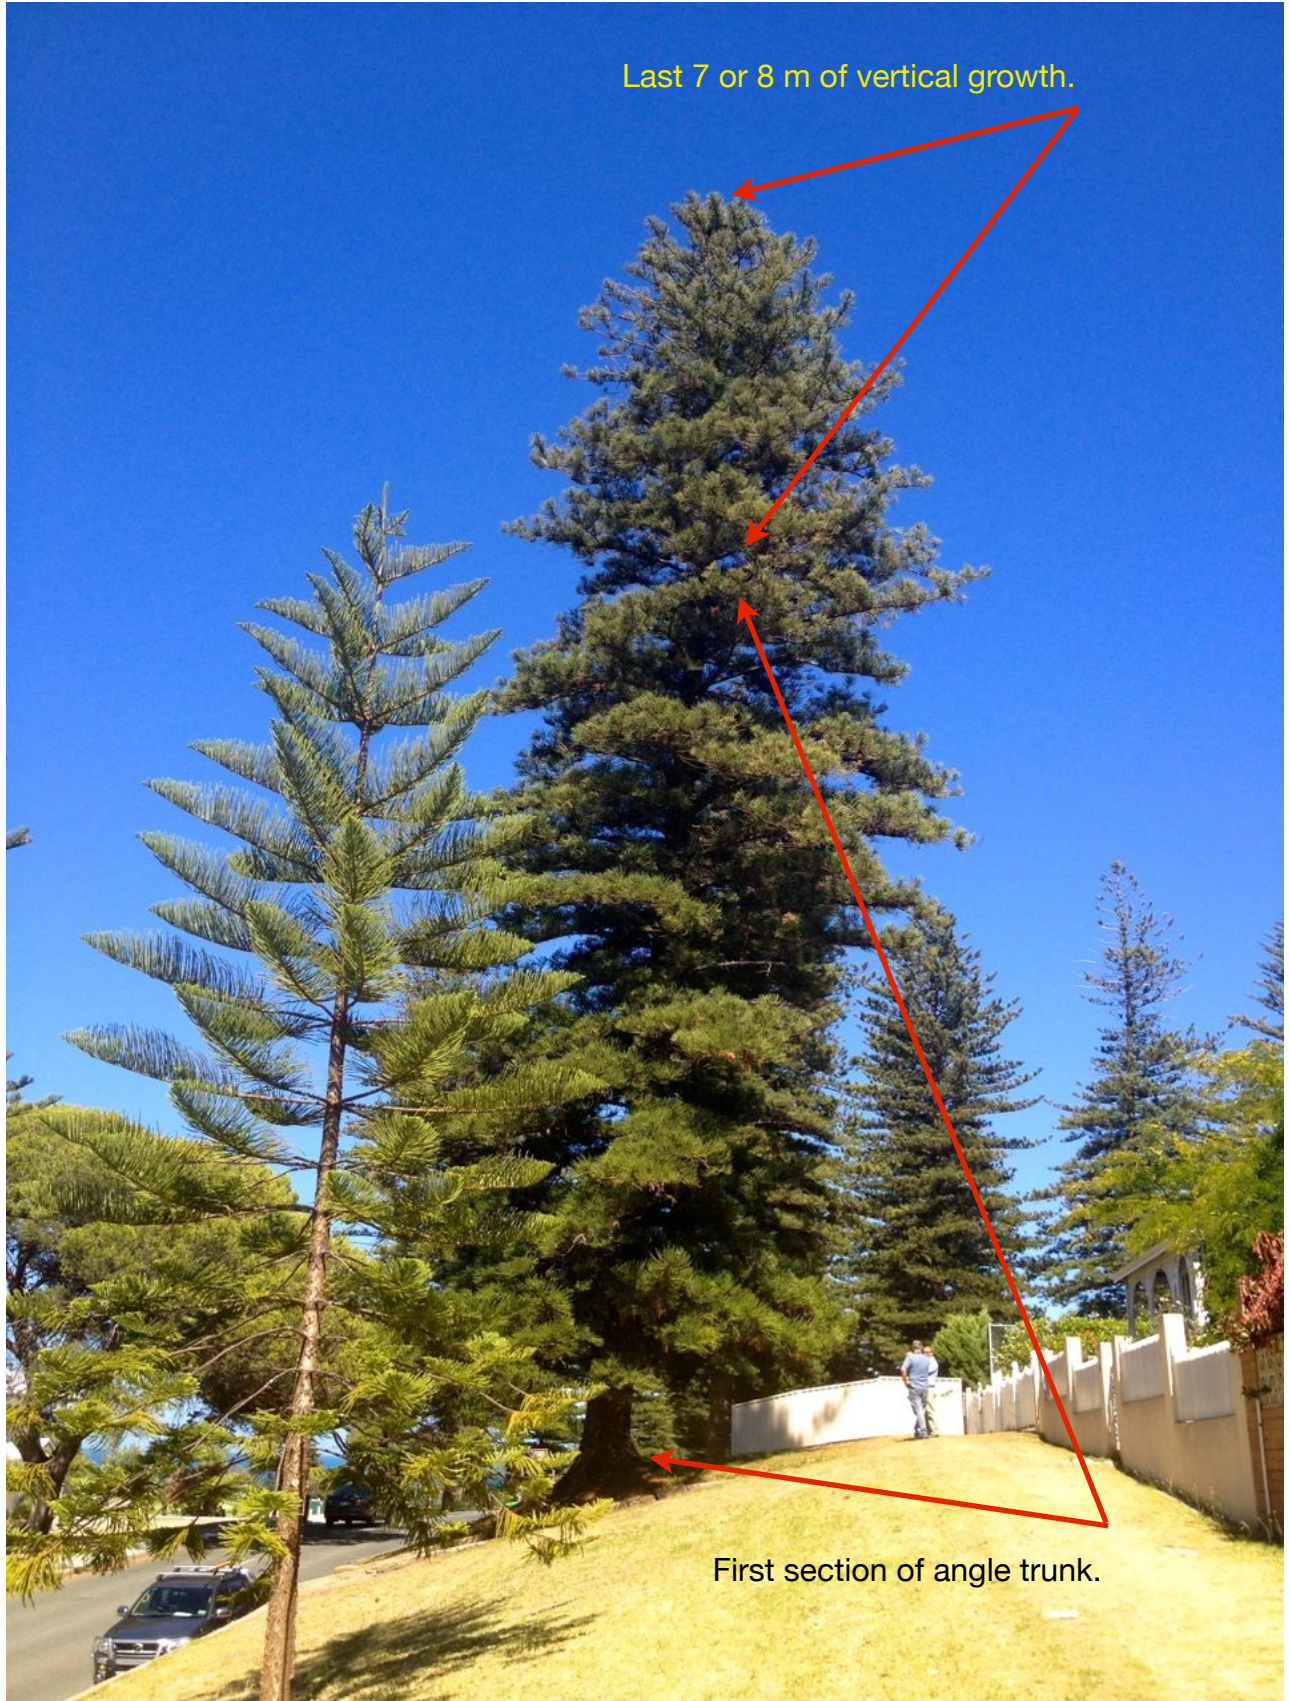
The complete integrity of the root zone around the trees is unknown however going by the health and vigour of the canopy it would suggest a healthy vascular system and in turn a healthy root system. Evidence of this can be taken from large expansion cracks in the adjacent walls and path caused by the expanding root system.

Accelerometer or tilt sensor would need to be fitted to this tree and one of the neighbouring trees in the street of the same basic dimensions as a direct comparison.

This would be to assess if the tree or root plate is moving excessively and would normally be conducted during a strong wind event over a 24-hour period.

Based on my observations there appears to be no recent movement in the soil regarding compaction on one side and or heave on the other however further investigation of the immediate root plate should be undertaken. Further assessment over a number of set appointments and measurements will assist in determining if there is excessive root plate movement. Static point photos will also assist in monitoring any movement.

Re Inspect this tree for health and vigour on a six-month basis.
