Arboricultural Report

Tree Survey, Arboricultural Impact Assessment and Tree Protection Plan

Site Address: **(Lot 506), No. 20A Deane Street, Cottesloe W.A.**

Report Date: **20th January 2021**

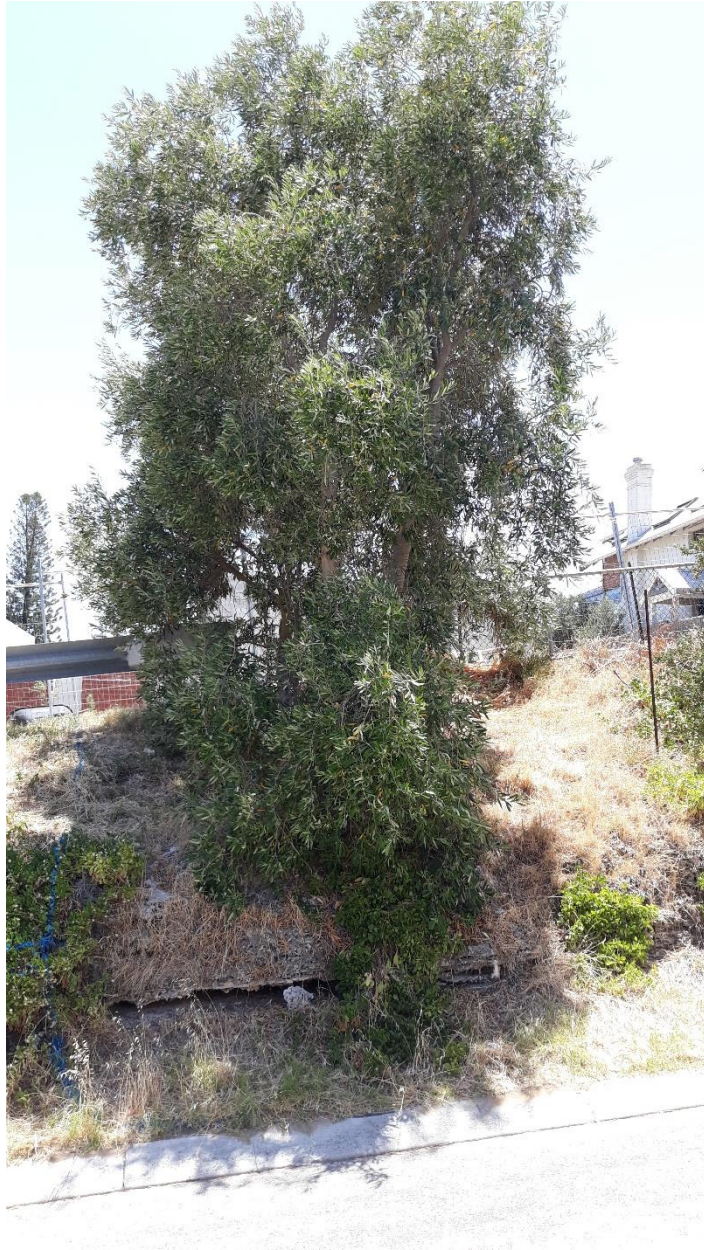
The Olive tree

Tree No	Botanical Name	Tree Height (m)	Canopy Spread N-S (m)	Canopy Spread E-W (m)	Trunk DAB (m)	SRZ (m)	Trunk DBH (m)	TPZ (m)	Tree life stage	Tree Health	Tree Structural Condition	ULE	Tree Retention
1	<i>Olea europaea</i>	6.3	4.5	4	0.28	1.94	0.22	2.64	Semi Mature	Fair	Poor	20-50 years	Retain

Tree Number	Tree Problems
1	<p>Bark wound at base: There was a large wound to the base of the trunk due to previous limb failure on the north/west side.</p> <p>Poorly Pruned: The tree has been previously pruned at the base.</p> <p>Epicormic Growth: Because of the previous limb failure and pruning, the main trunk has formed three epicormic limbs, one limb to the north and two limbs to the south. The epicormic limb attachments seem to be attached well, at this time. However, these attachments will be weaker than the original limb attachments.</p> <p>Minor Deadwood: The deadwood was not heavy enough to signify a possible risk to the targets at this present time.</p> <p>Containerized Roots: The roots are restricted within a shallow soil cavity in the limestone rock ledge.</p>

Note: This Arboricultural Consultant advises the excavation for the proposed crossover must be **outside** the **1.94m** SRZ radius given around this tree. **No roots are to be severed or damaged, inside** the **1.94m** SRZ radius around this tree.

Tree No. 1 must be retained and not damaged during the construction of this project. The Tree Protection Zone (TPZ) of **2.64m** radius with alterations set out in the Tree Protection Plan minor encroachments on page 9. However, the Structural Root Zone (SRZ) of **1.94m** from the trunk must be maintained during the crossover and stairway works.

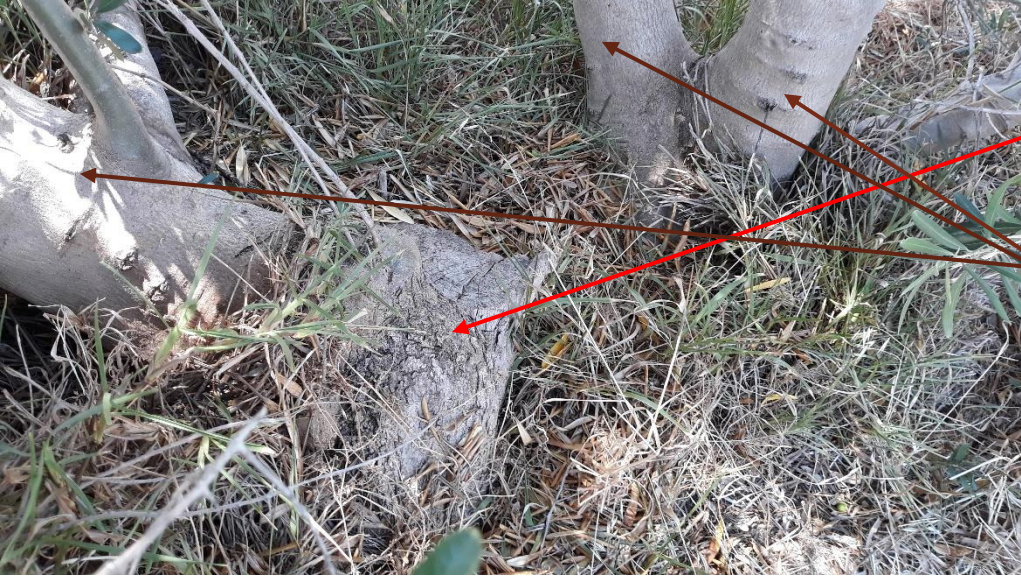
Shows the bark wound and the base of the three epicormic limbs

Tree Number	Recommendations for Tree Surgery Works
1	No tree surgery works required

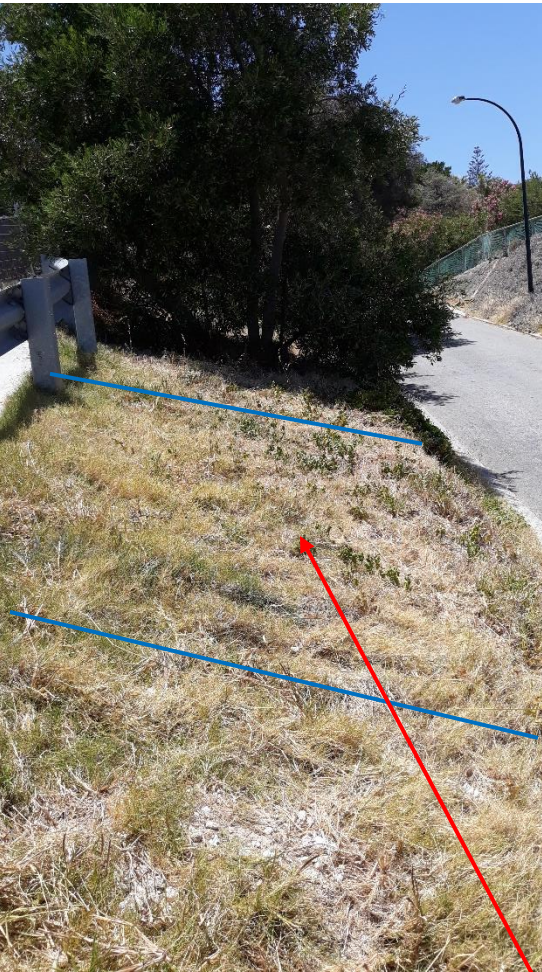
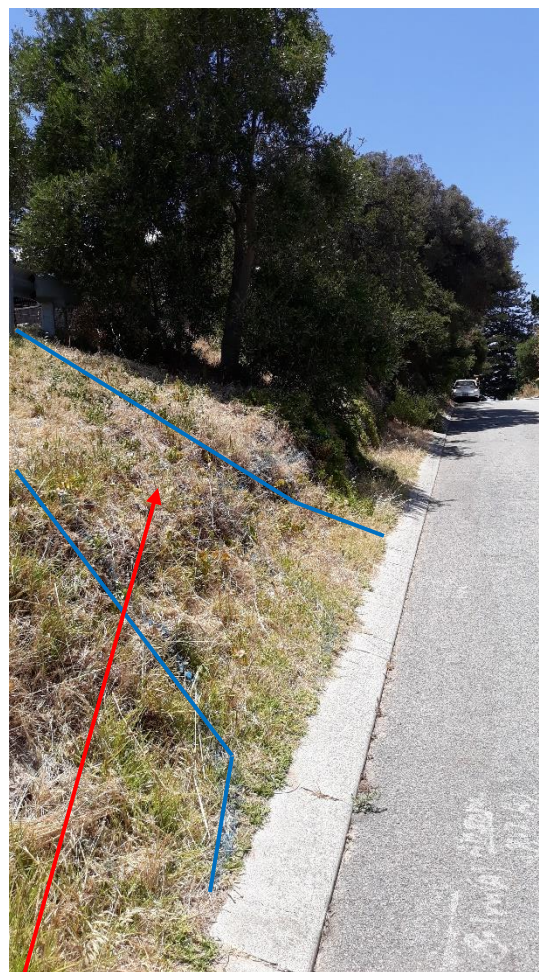
It is this Arboricultural Consultant’s opinion that a TPZ of Australian Standards recommendations is not always able to be achieved due to the **2.5m** distance from the tree to the edge of the crossover on the east side, and the **2.4m** distance from the tree to the pedestrian pathway on the north side., However the AS 4970-2009 details the recommended protection zone and must be demonstrated to ensure the tree’s survival and its structural stability remain intact. Where the construction of the recommended TPZ barrier is not possible and the impact of encroachment is probable, **this Arboricultural Consultant by prior inspection, must demonstrate that the tree would remain viable. Documenting any encroachment, taking photos and providing a Progress Report, in accordance with the (AS 4970-2009, “Sections 3.3.3 and 5.4.3”) is required.**

Shows the area of the proposed crossover

All mechanical excavation of the proposed crossover must be at least **2.376m** (10% less than the **2.64m** TPZ radius), away from the base of the trunk with all the exposed roots with a diameter of **less than 25mm** being cleanly severed for good wound occlusion. However, any roots **greater than 25mm** in diameter must not to be cut without authorisation from myself as a qualified Consulting Arborist. **Documenting the situation and/or any root damage, taking photos and providing a Progress Report,**

This Arboricultural Consultant recommends that myself as a qualified Consulting Arborist be present during the excavation of the proposed crossover. **This Arboricultural Consultant by prior inspection, must demonstrate that the tree would remain viable. Documenting any encroachment, taking photos and providing a Progress Report, in accordance with the (AS 4970-2009, “Sections 3.3.3 and 5.4.3”) is required.**
