COTTESLOE BEACH HOTEL, MARINE PARADE COTTESLOE - REPLACEMENT OF GLASS BLOCKS AT MARINE PARADE AND REPAIRS TO FOYER.

ADDENDUM TO THE 2003 HERITAGE ASSESSMENT REPORT

P1.0 Cottesloe Beach Hotel Repairs to Parade Entry DA Issue for Approval

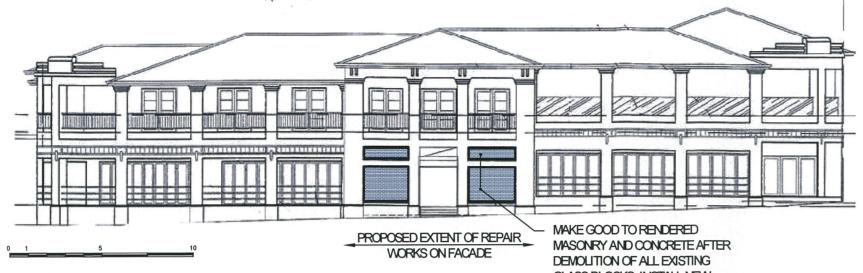
COTTESLOE BEACH HOTEL WESTERN ELEVATION 1:200 @A3 / 1:100@A1

DEMOLISH EXISTING DAMAGED
GLASS BLOCK INSTALLATION
COMPLETE AND MAKE GOOD TO
ADJACENT RENDERED MASONRY
AND CONCRETE STRUCTURE —
ON BOTH SIDES OF ENTRANCE
OPENING

INSTALL NEW GLAZING, POWDER
COATED FRAME IN INTERPON
ULTRIVA D2015 WARRANTED
POWDERCOAT FINISH CHARCOAL
YL238A GLAZED IN VIRIDIAN
6SMRTG-ARGON-CLRT ON BOTH
SIDES OF ENTRANCE OPENING

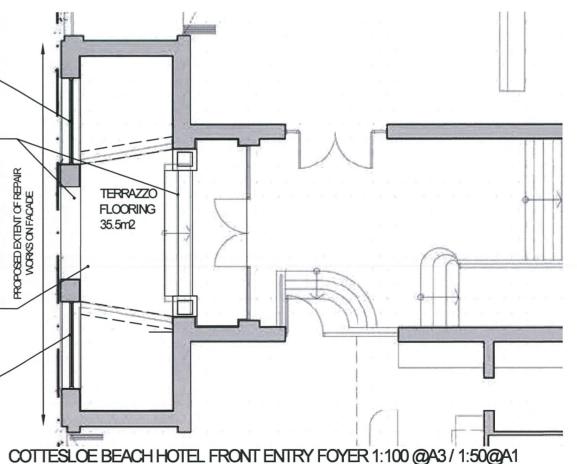
DEMOLISH EXISTING PLANTERS AND RETAINING WALLS, INSPECT AND CONFIRM FLOOR FINISH IS REPAIRABLE, REPAIR EXISTING TERRAZZO FLOOR FINISH TO MATCH ORIGINAL FINISHES
