Arborist Assessment and Report

Subject: Sugar Gum (*Eucalyptus cladocalyx*)

Location: 68 Napier Street, Cottesloe

Date: 24/03/2014

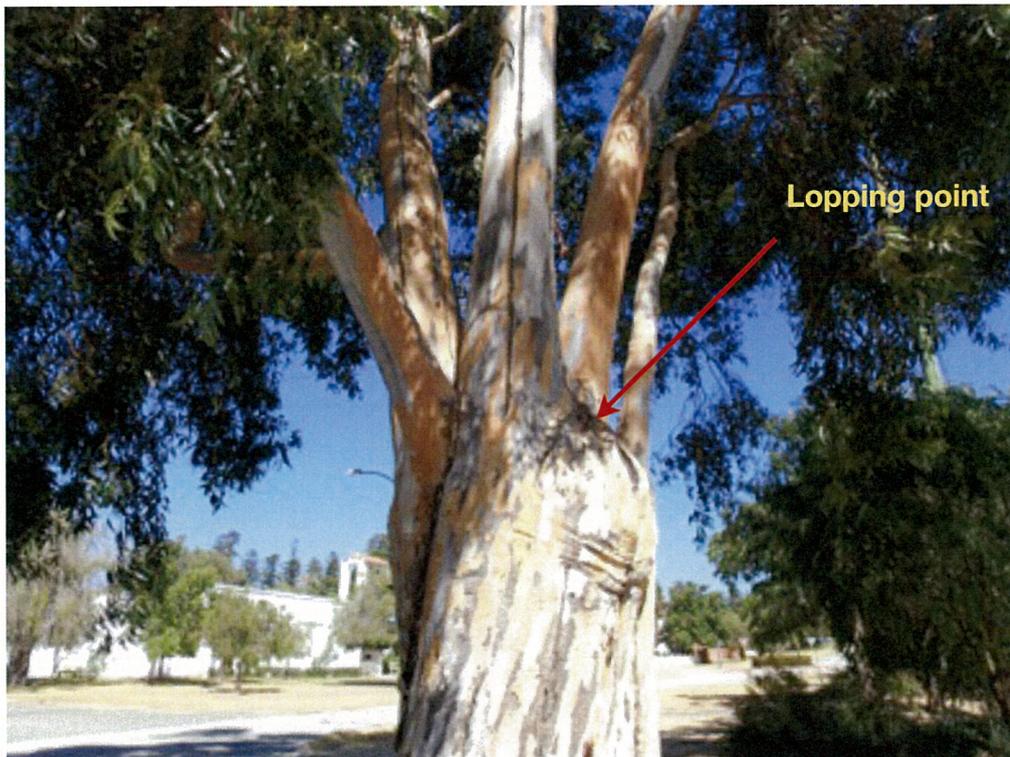
The tree shows good natural form above the point at which it was heavily lopped many years earlier. At the point of lopping the cambium has included completely. A good natural form with good upper limb spacing has subsequently developed. The trunk appears to have no cambium damage and there is no sign of bifurcated or subdominant stems.

The foliage mass and peripheral tip growth is all in good health with what would be considered a normal level of deadwood accumulating in the crown over the years. Some of this deadwood is now over 40mm in diameter which should be considered for removal.

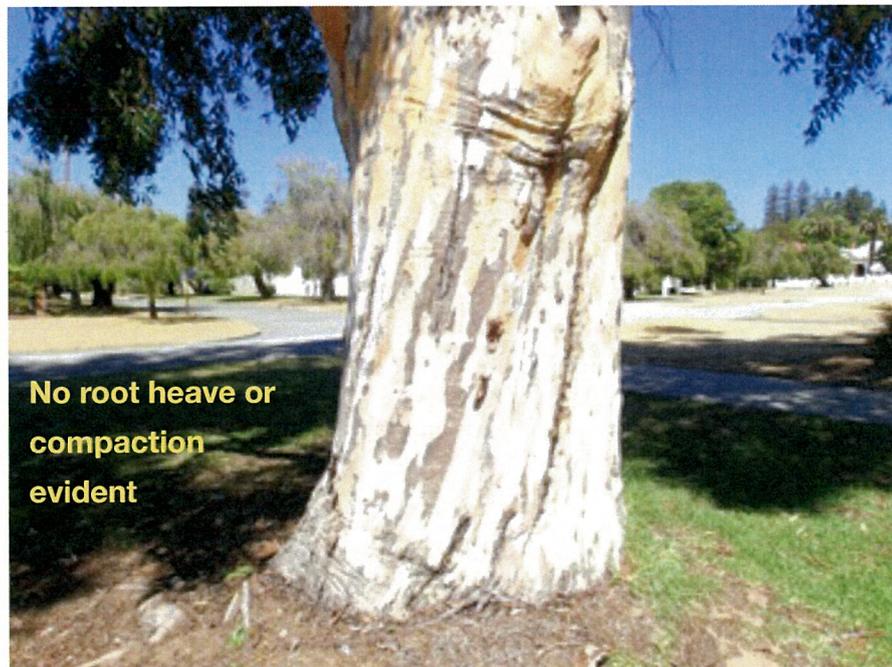
It is my opinion a tree of this significant size and proportions situated on the verge should be monitored and assessed annually. The tree has not had a crown thin or reduction to reduce the occurrence of upper limb failures for some time, and is therefore due for remedial and structural pruning.

There appears to be no root plate movement at this stage.

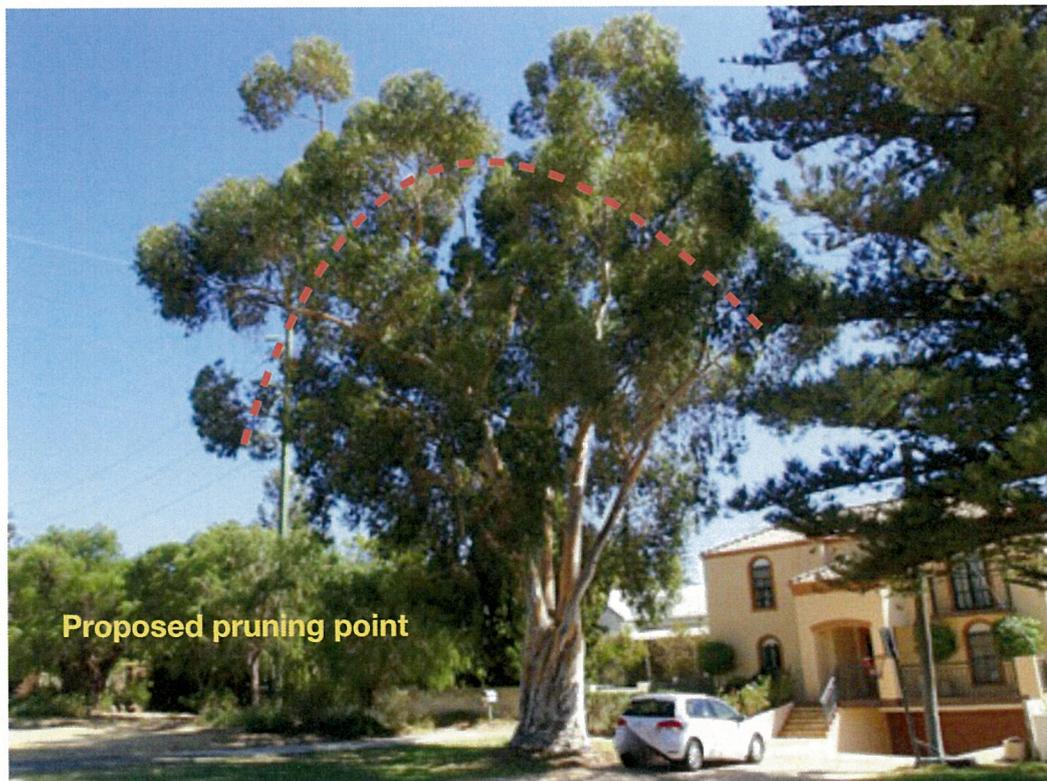
Proposed pruning point

This tree has not received canopy maintenance for some time.

- a. Implement a pruning program to address the volume of the crown's canopy.
- b. Structure prune by performing a crown reduction and thin to the second canopy at growth points to assist in reducing wind loading.
- c. Perform remedial prune to reduce deadwood and crossed limbs. Reduce lateral weight by thinning.
- d. Have an arborist re-inspected the tree annually.
- e. Pruning maintenance would generally need to be looked at on a 3 - 5 year basis.
