COTTESLOE FORESHORE RENEWAL
INFRASTRUCTURE REDUCTION STRATEGY

August 2017
Revision A

THE REPORTS INTENT

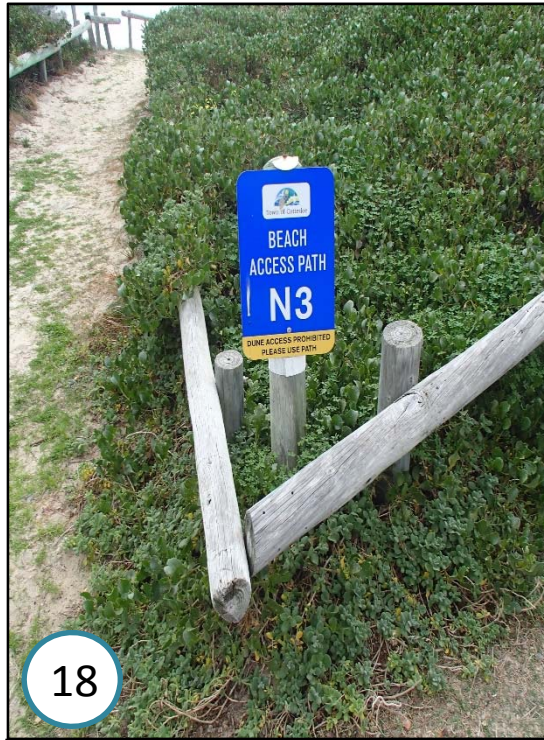
18

BEACH ACCESS SIGNAGE

Information shown is important as part of a beach safety initiative linked to Emergency services locational signage, however the aesthetics and material presentation will be reviewed.

Beach access signage may be consolidated with consistent message and materials/theming. The terminology is regimented and the wording can potentially be re-considered to better suit Cottesloe.

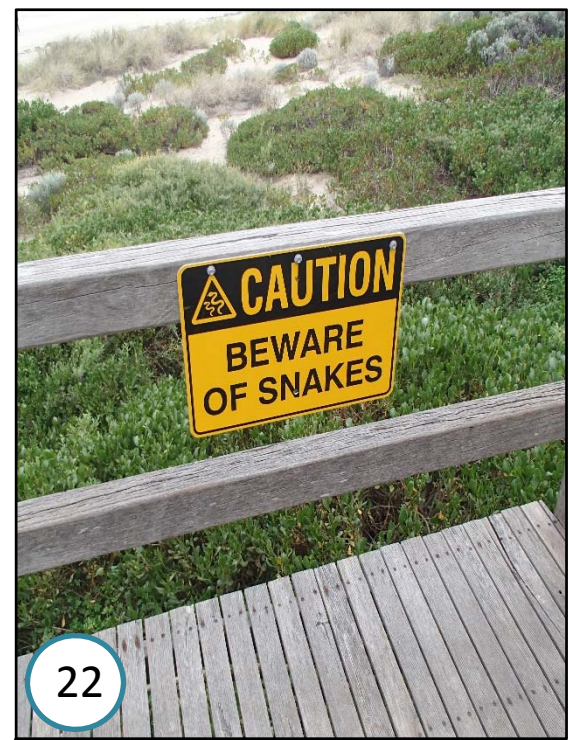
23

Educational signage is important to inform the public of their local environment. It is noted that this signage appears to be successful however it is of a separate character, form, colour and content to other signage

Signage to be consolidated to present a consistent signage strategy that maintains strong messaging and gives clear directions.

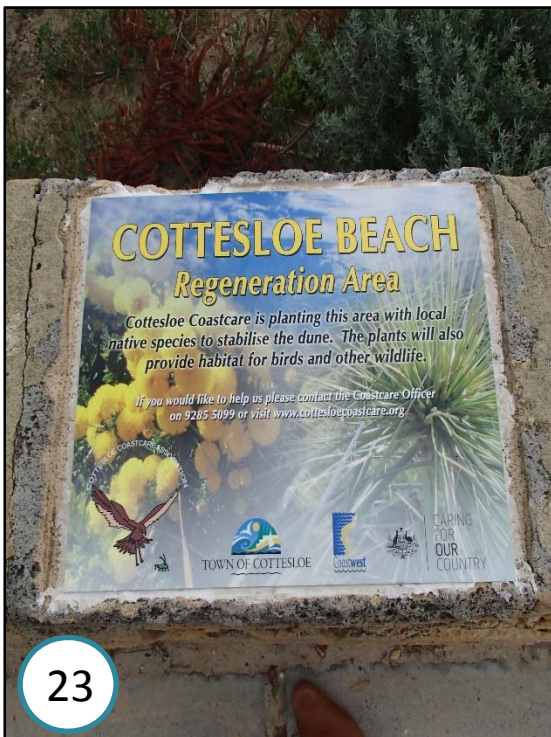
24

Dune signage is dated and worn.

The dune signage is to be consolidated with consistent message and materials/theming. There is the potential to incorporate messaging from Coast Care and Council including educational text regarding dune systems, species, fauna and habitat.

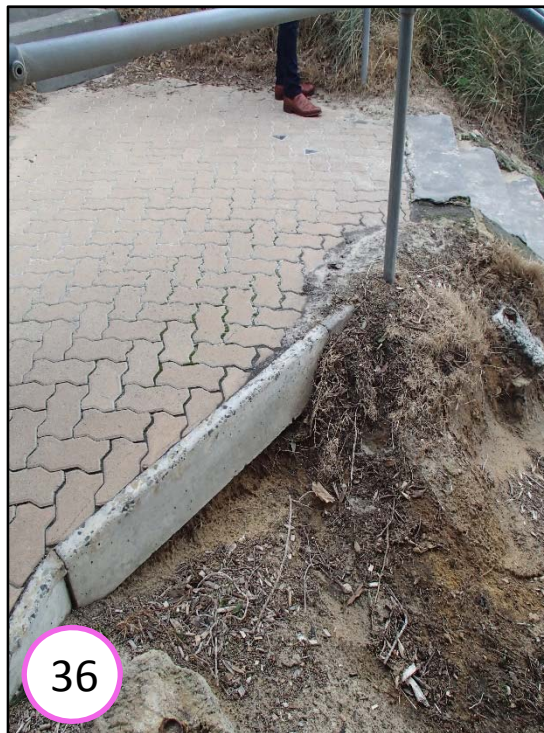
35

PAVING

The variety of paving materials is inconsistent along the foreshore promenade. The segmental brick paving is dated in its colour and form.

The paving materials are to be reviewed to provide easy access, consistency of material and a clear path hierarchy for users to avoid collisions or disputes.

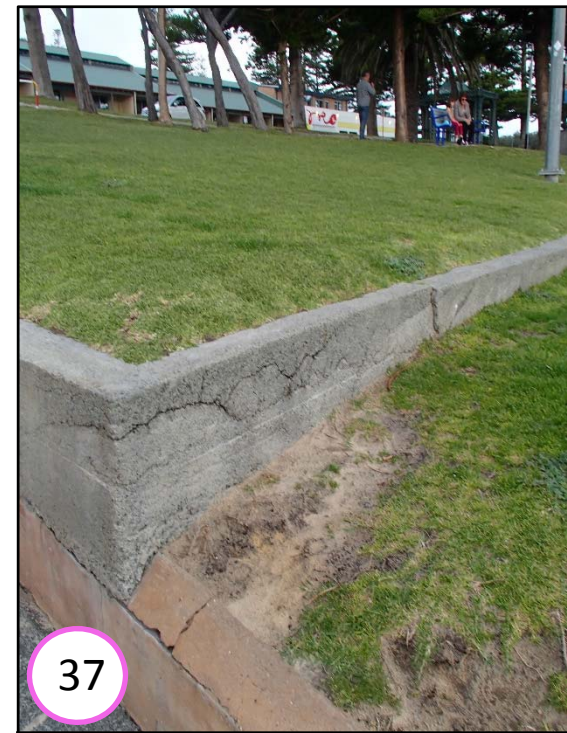
36

PAVING

The variety of paving materials is inconsistent along the foreshore promenade. The segmental brick paving is dated in its colour and form.

The paving materials are to be reviewed to provide easy access, consistency of material and a clear path hierarchy for users to avoid collisions or disputes. The paving in this instance is to be reviewed by structural engineer to assess if it presents any safety or erosion issues.

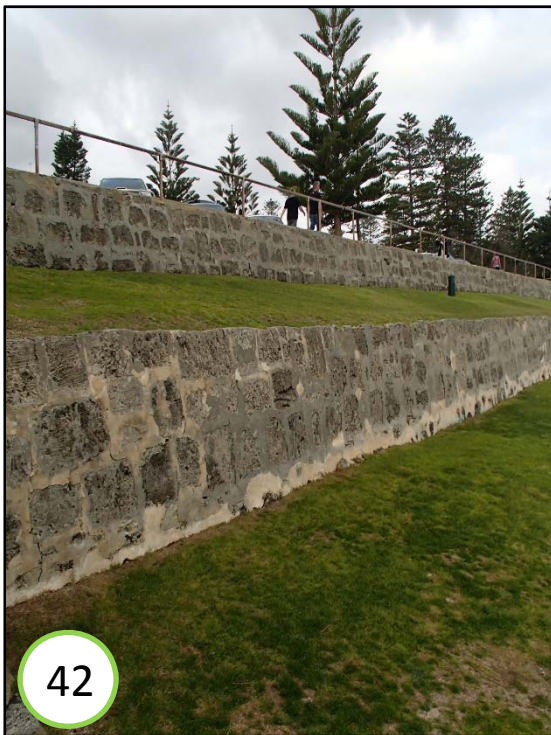
TERRACE WALLS

The terrace walls are popular and are in good condition.
