Arboricultural Advice

Site Inspection date: 4th of August 2021

Location: Torrens Court, Cottesloe

RE: Verge Tree Species Selection

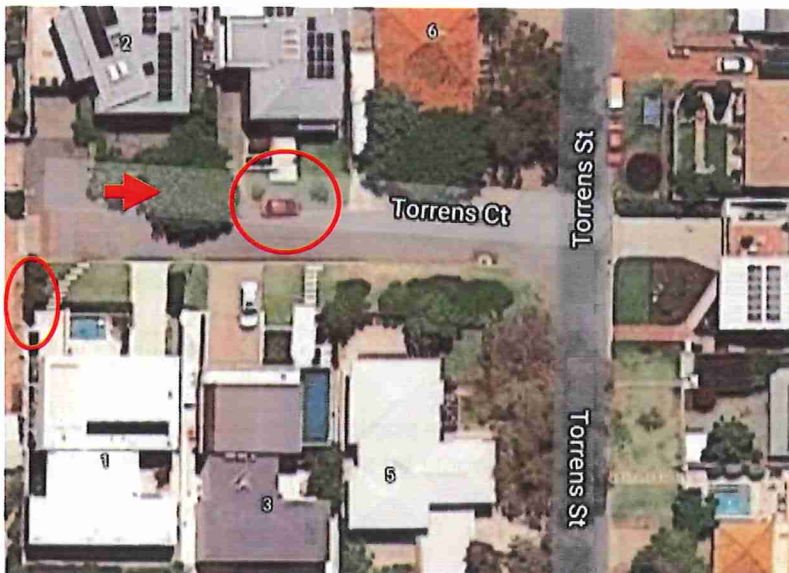
Figure 1 Displaying Torrens Court, Cottesloe and indicating the *Erythrina x sykesii* (Coral Tree) recently removed (arrowed) and remaining trees within the verge adjacent nos. 1 & 4 (circled). The existing *Agonis flexuosa* adjacent no 5 Torrens St is also evident

- Torrens Court appears to be the address of 5 residential properties - Nos. 1 - 4 in which the residences are oriented to the Torrens Court boundary and no. 6, which is oriented to Torrens St with a side boundary on Torrens Court. The property indicated as no. 5 appears to relate to Torrens Street (Figure 1).

- The species typically develops a broad crown and multiple main limbs developing low in the canopy to form the crown structure.
- *Agonis flexuosa* is listed as both the current and proposed street tree species for nearby Torrens Street and an example of the species is located adjacent no. 5 Torrens St near the intersection with Torrens Court (Figures 1 & 5).

Agonis flexuosa is considered by this consultant to be an inappropriate species for planting within the Torrens Court verge due to the width of both the roadway and verge and advises that the planting of the species in this location is likely to cause ongoing issues due to property encroachment, reduction of solar access, disruption of pavements and garden structures and decline of existing garden and lawn areas due to overshadowing.
