Indiana Teahouse Conservation Management Plan

April 2021 | 21-029

Indiana Teahouse, Cottesloe - Conservation Management Plan

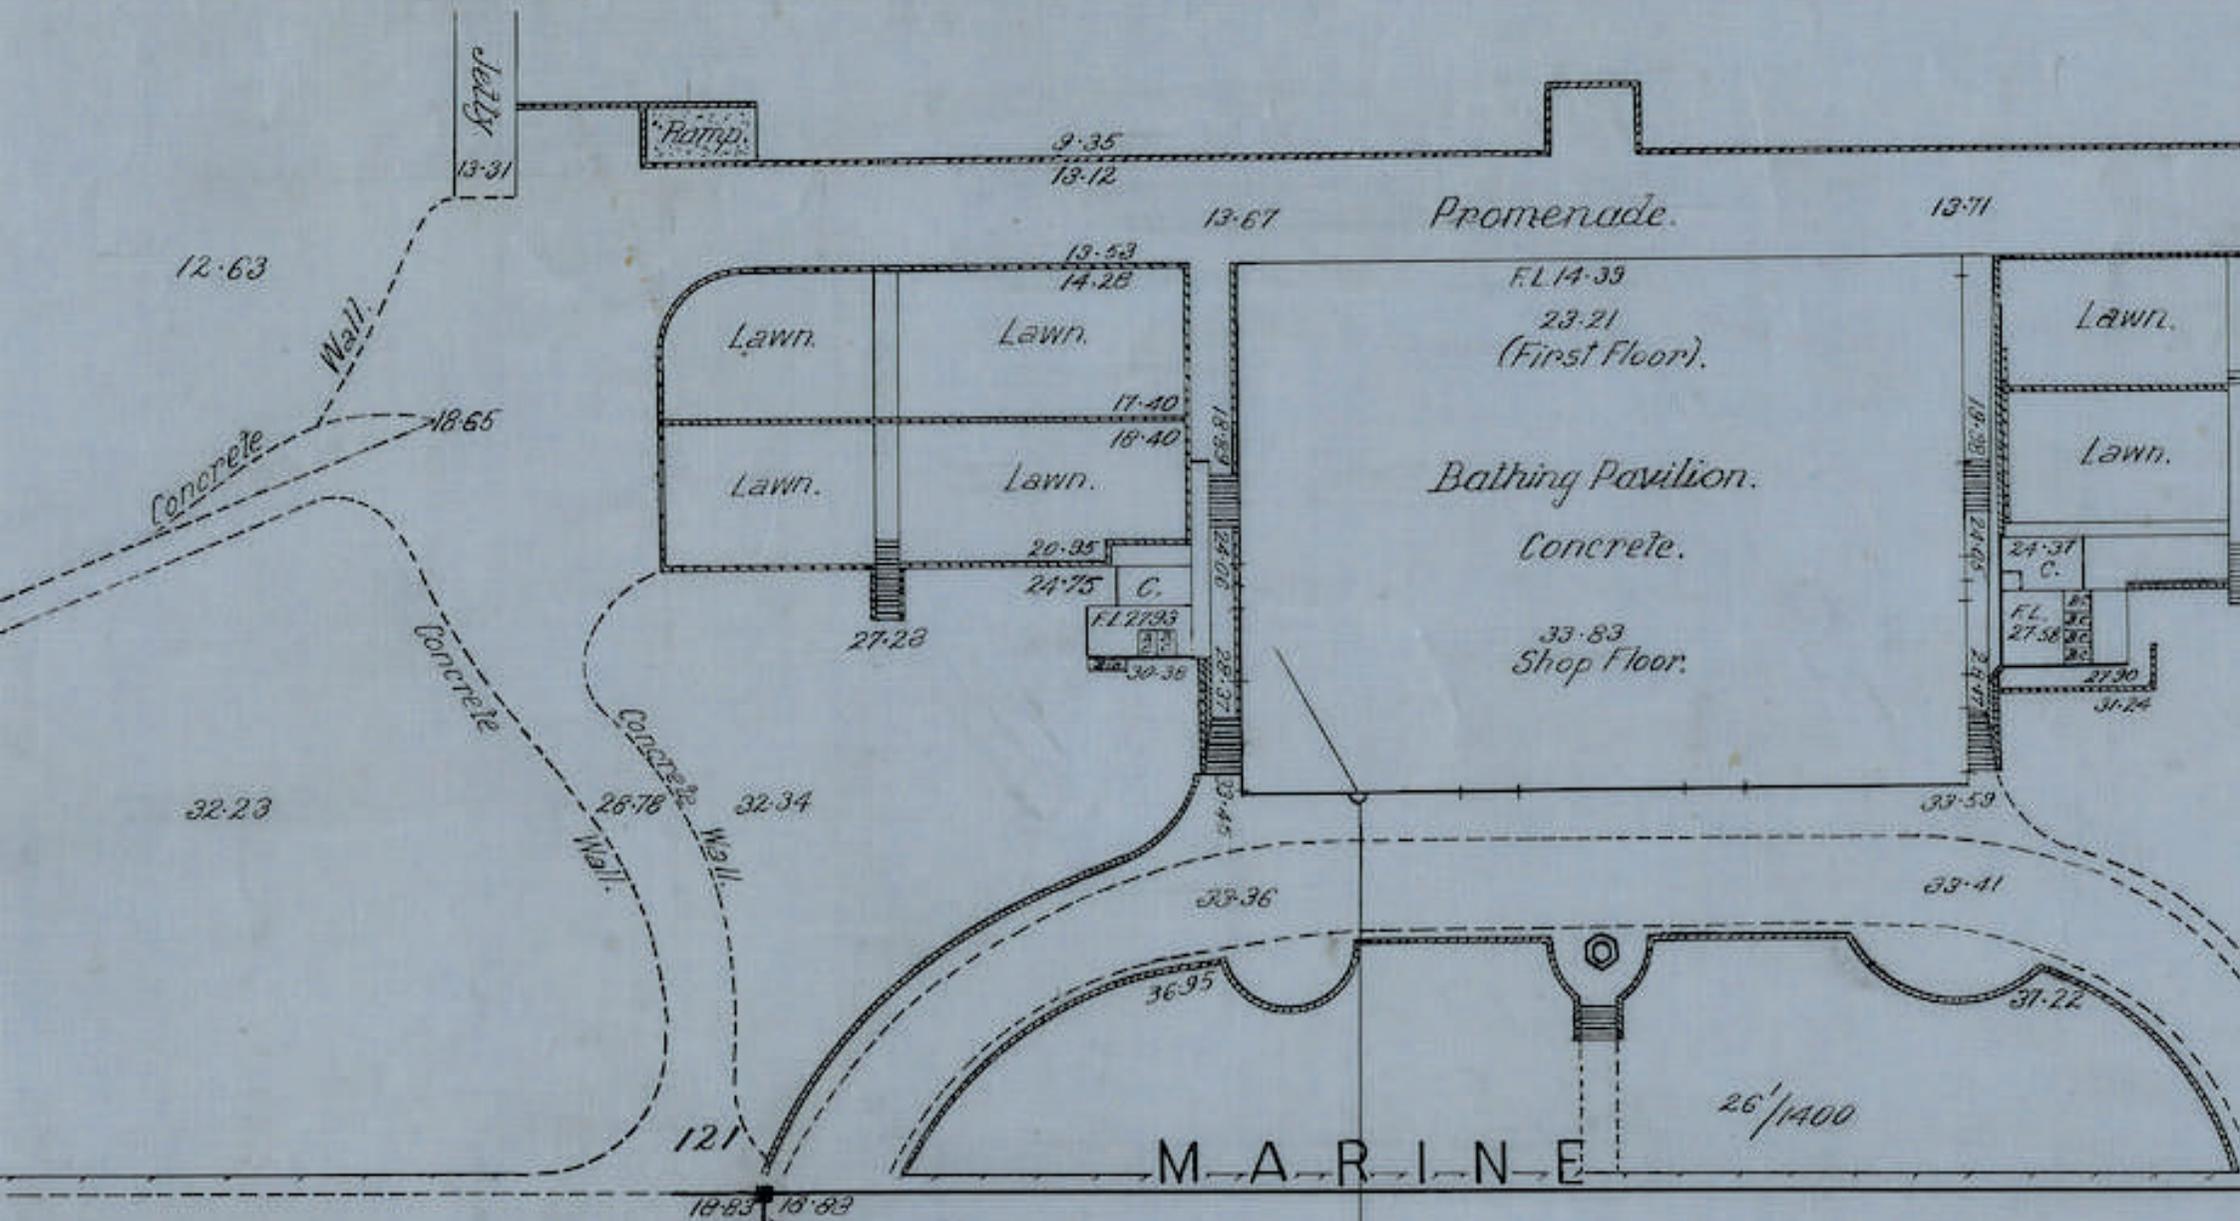
Figure 13. 1934 survey showing built structures. Note the limestone stairs, terraces, memorial fountain located in the forecourt, and the semi-circular walls; all still extant. (Cons 4156/1217, State Records Office)

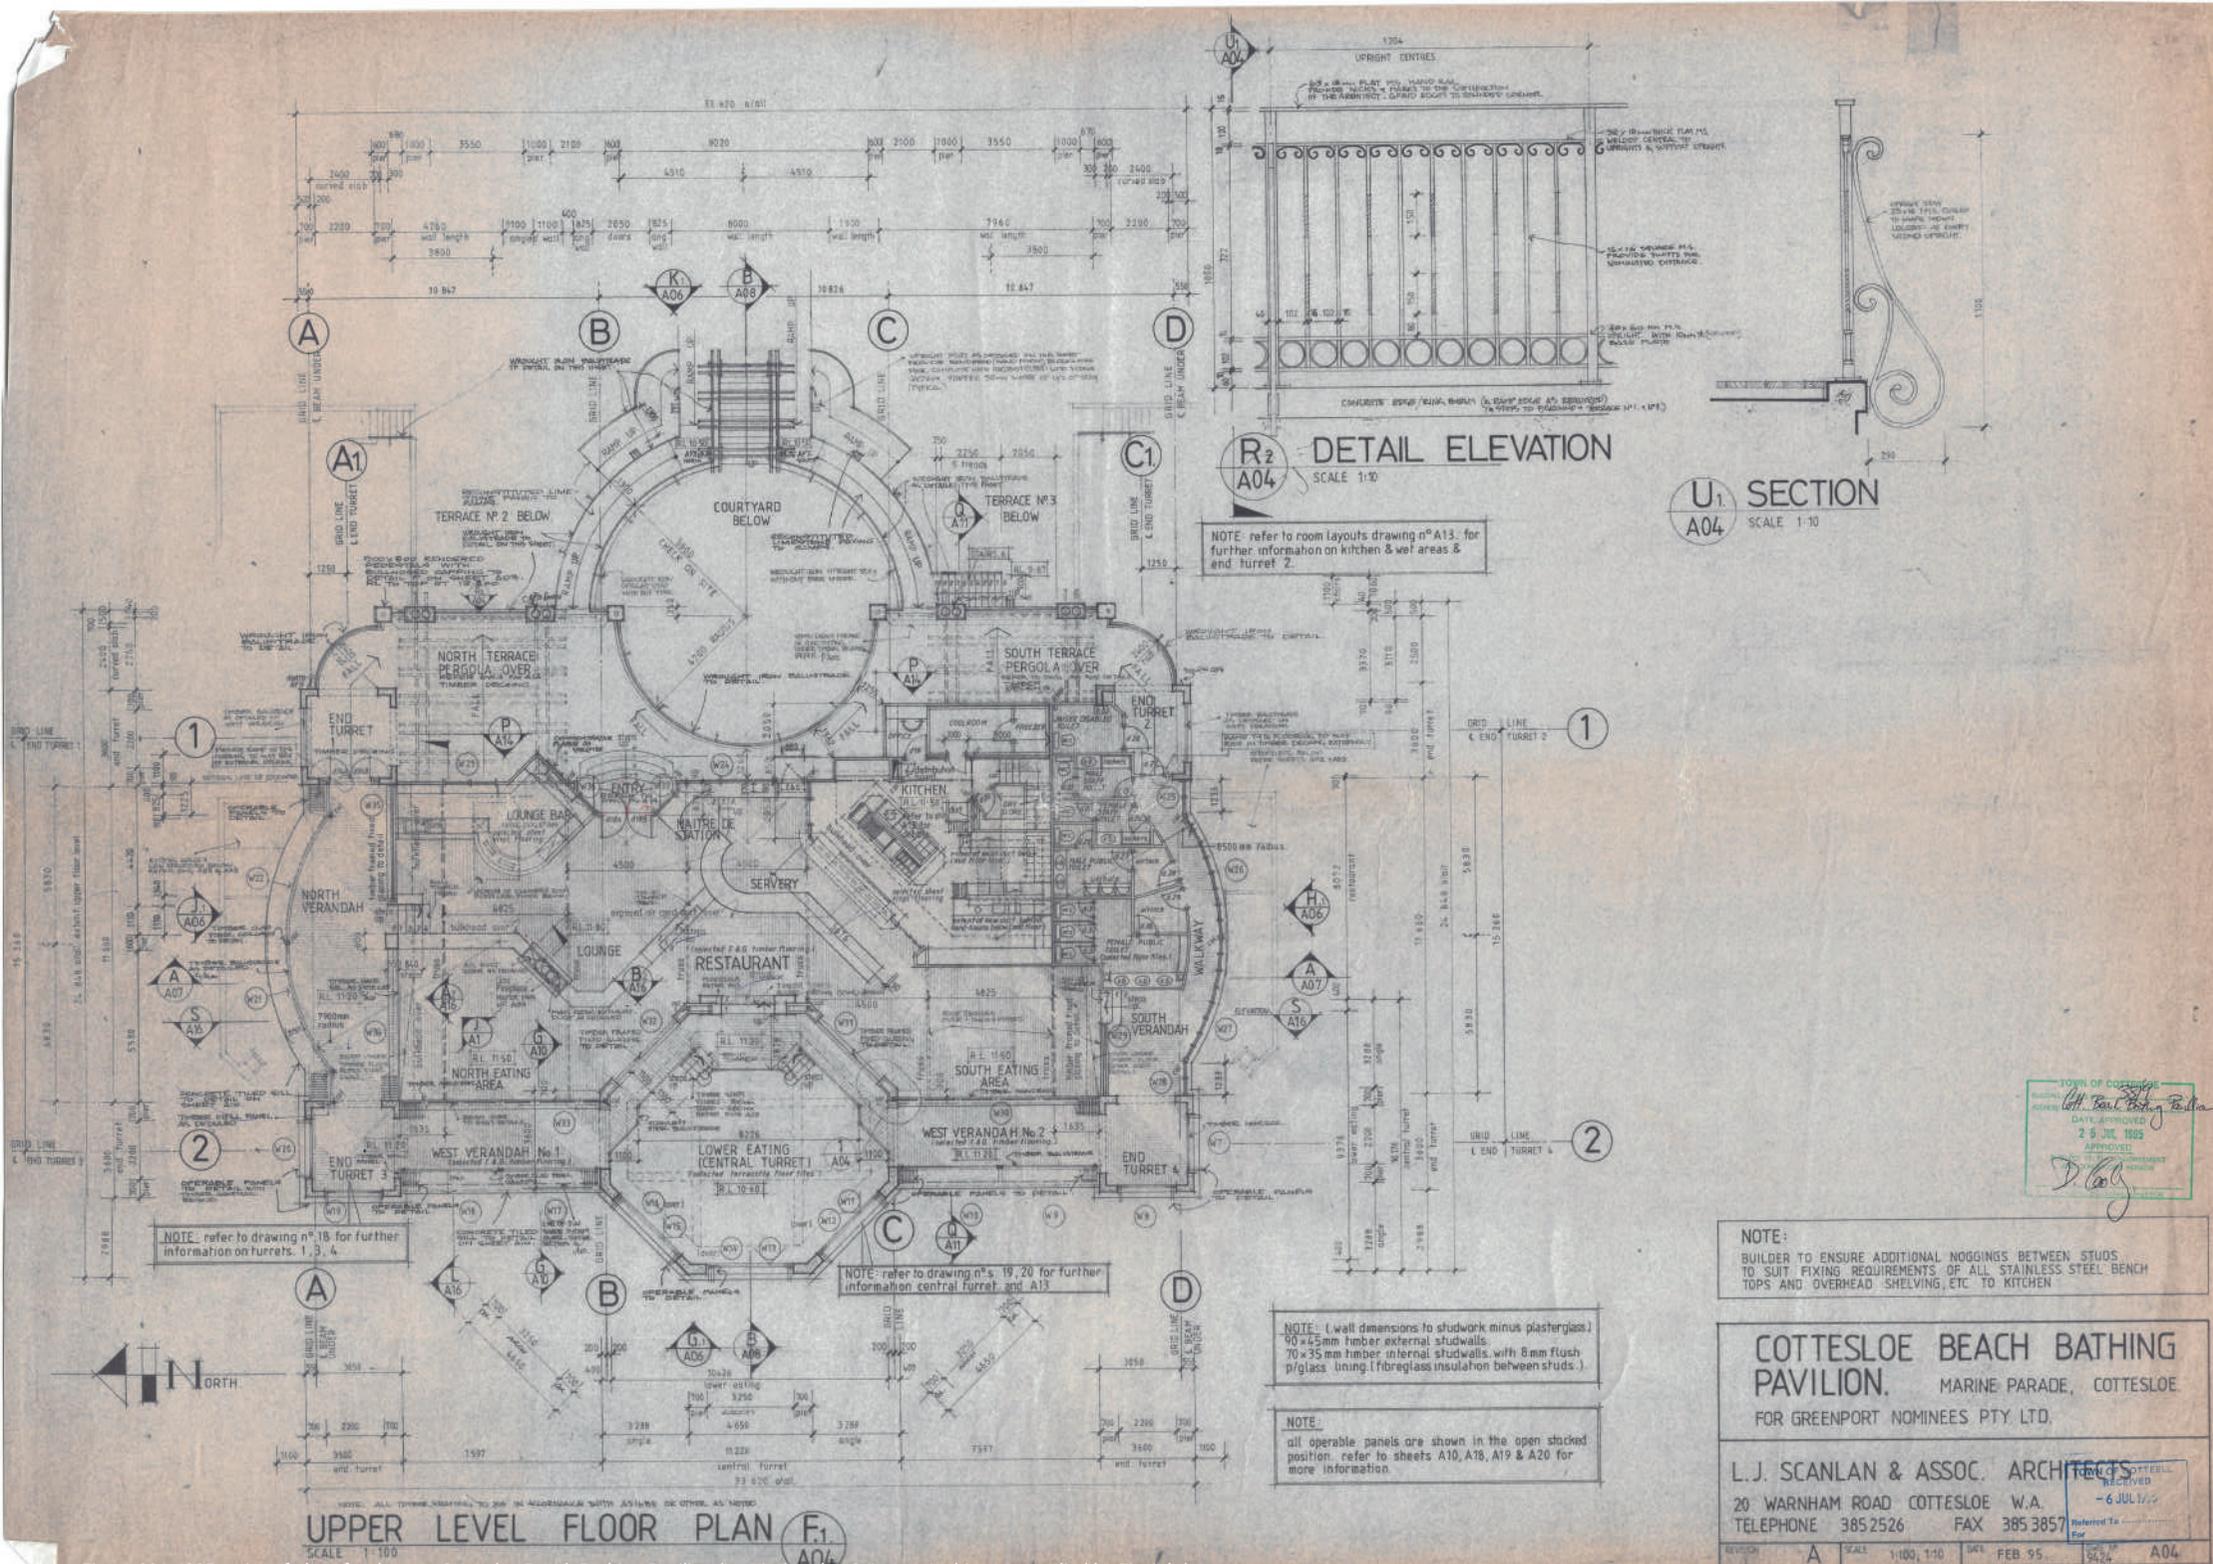
Figure 22. 1995 series of plans for the new Cottesloe Beach Bathing Pavilion (Laurie Scanlan & Assoc. Architects, supplied by Fiveight)

The new Cottesloe Beach Pavilion was officially opened on 20 November 1996 by the Mayor of Cottesloe Mr. Julian Donaldson. The building has become known by the name 'Indiana', as the restaurant on the upper floor was called 'Indiana Teahouse'. This was a nod to the first Indiana Tea House (c1913-c1931). (Refer to the series of plans at Figure 22, and Section 3.1 Sequence of Development plans)

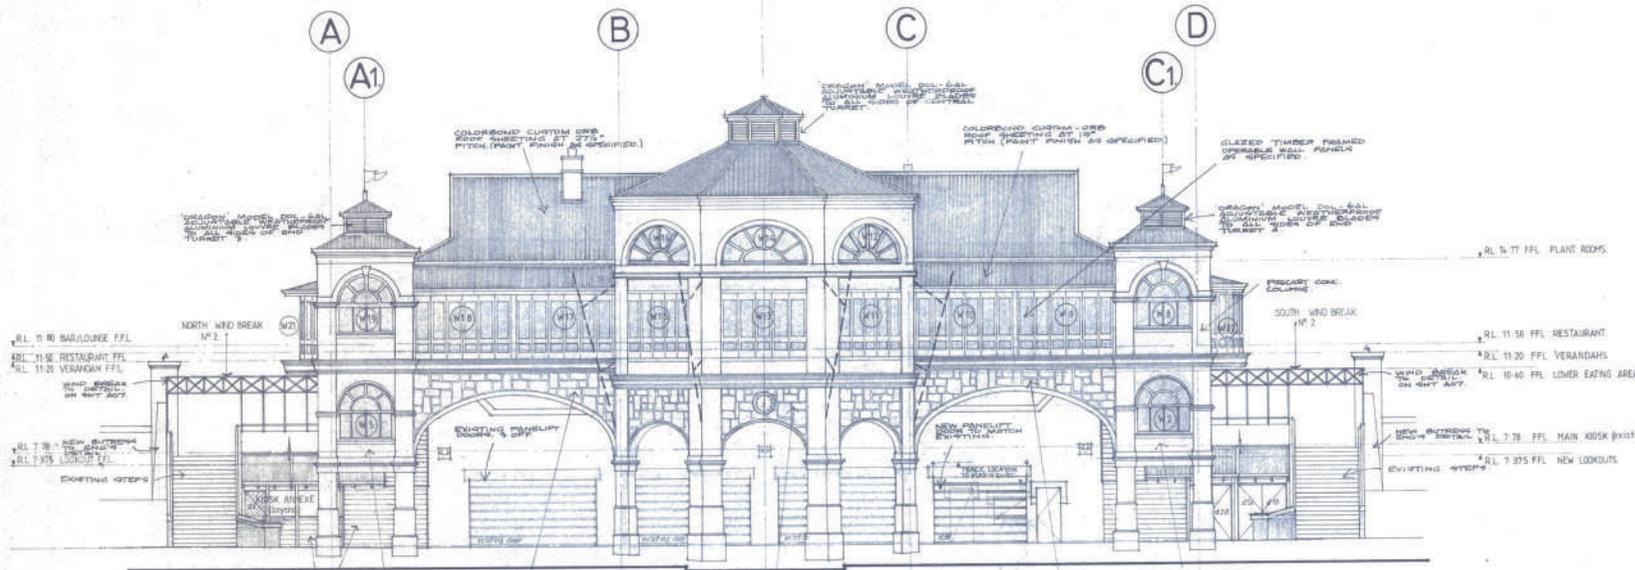
WEST ELEVATION. G.1. SCALE 1:100 A04

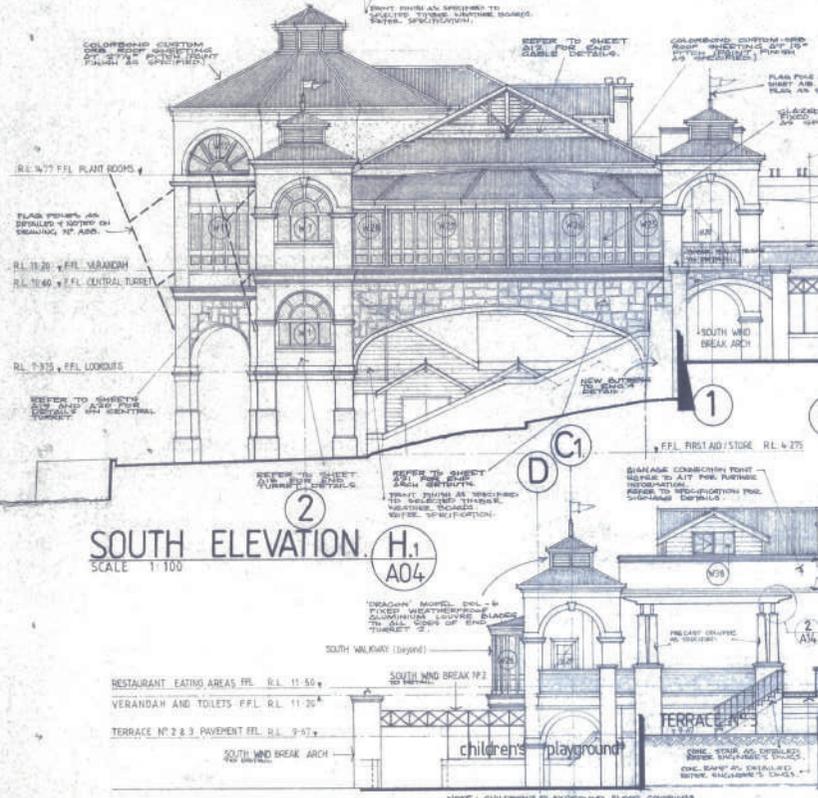
SOUTH ELEVATION. H.1. SCALE 1:100 A04

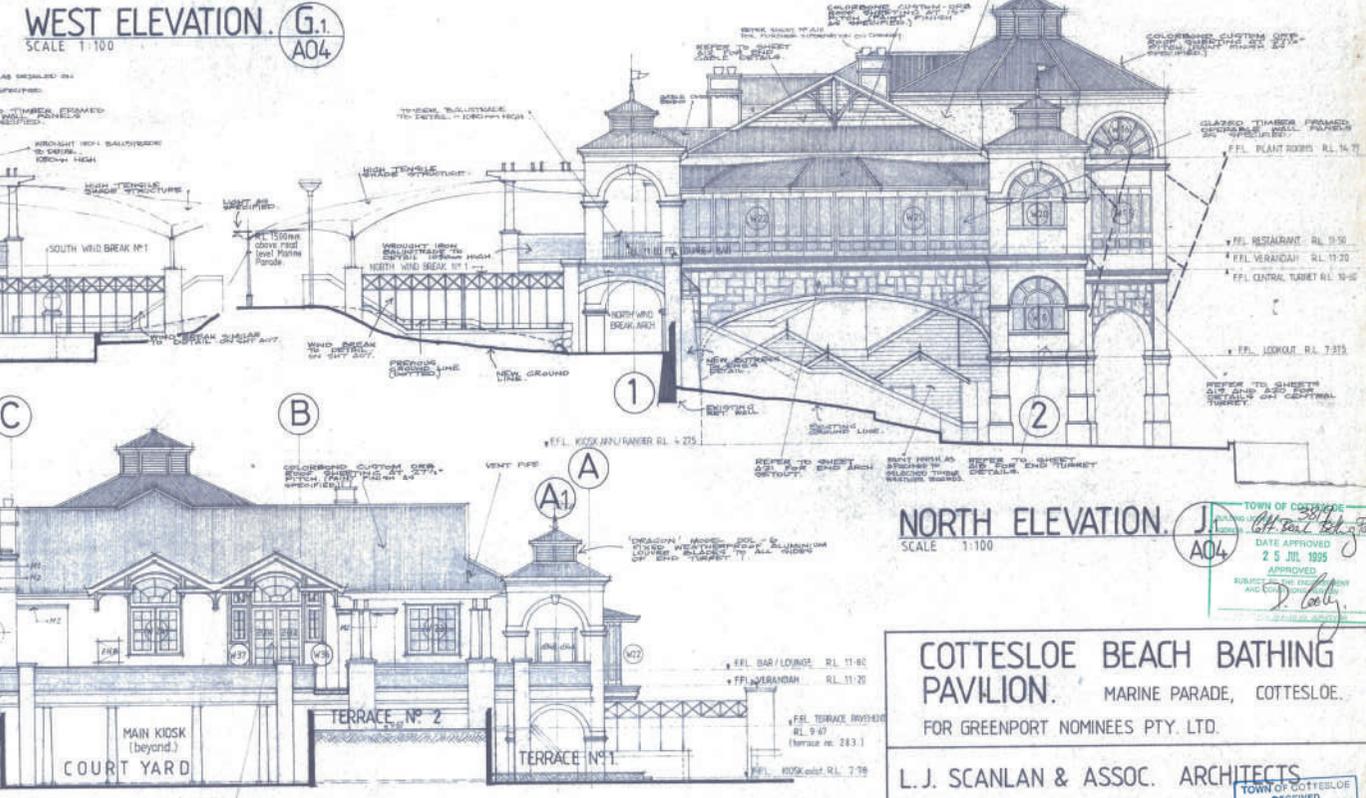
NORTH ELEVATION. J.1. SCALE 1:100 A04

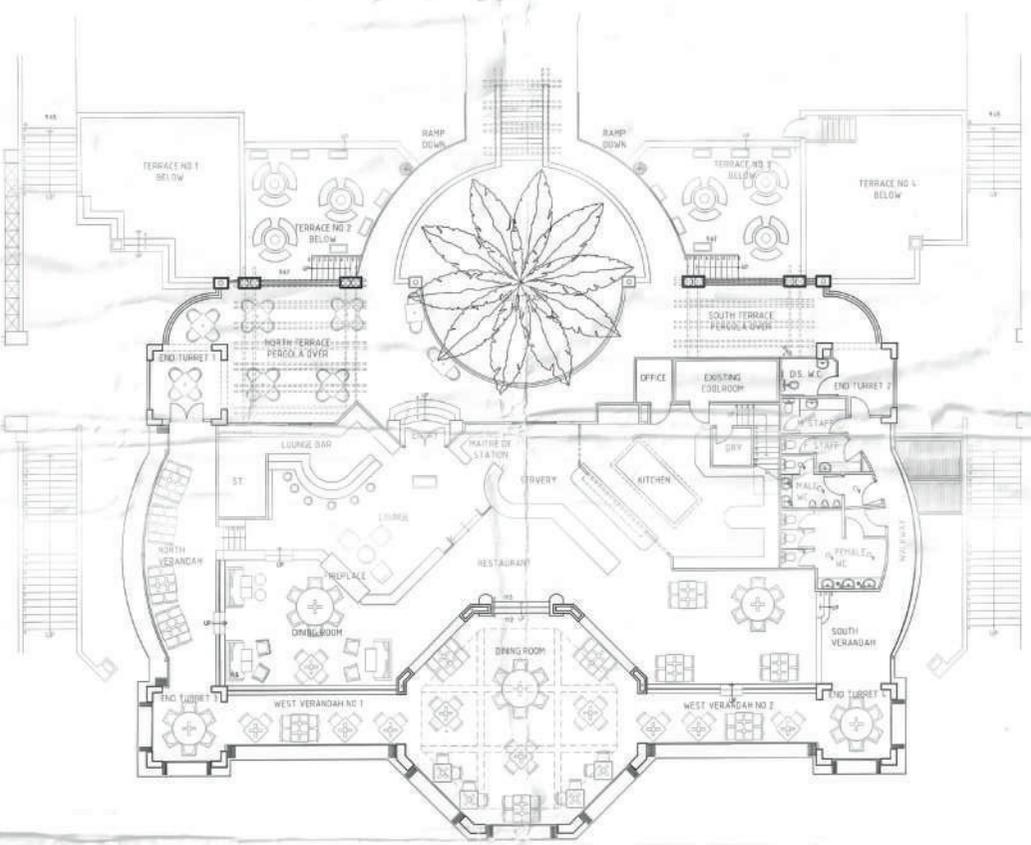
AS EXISTING UPPER/ RESTAURANT LEVEL FLOOR PLAN

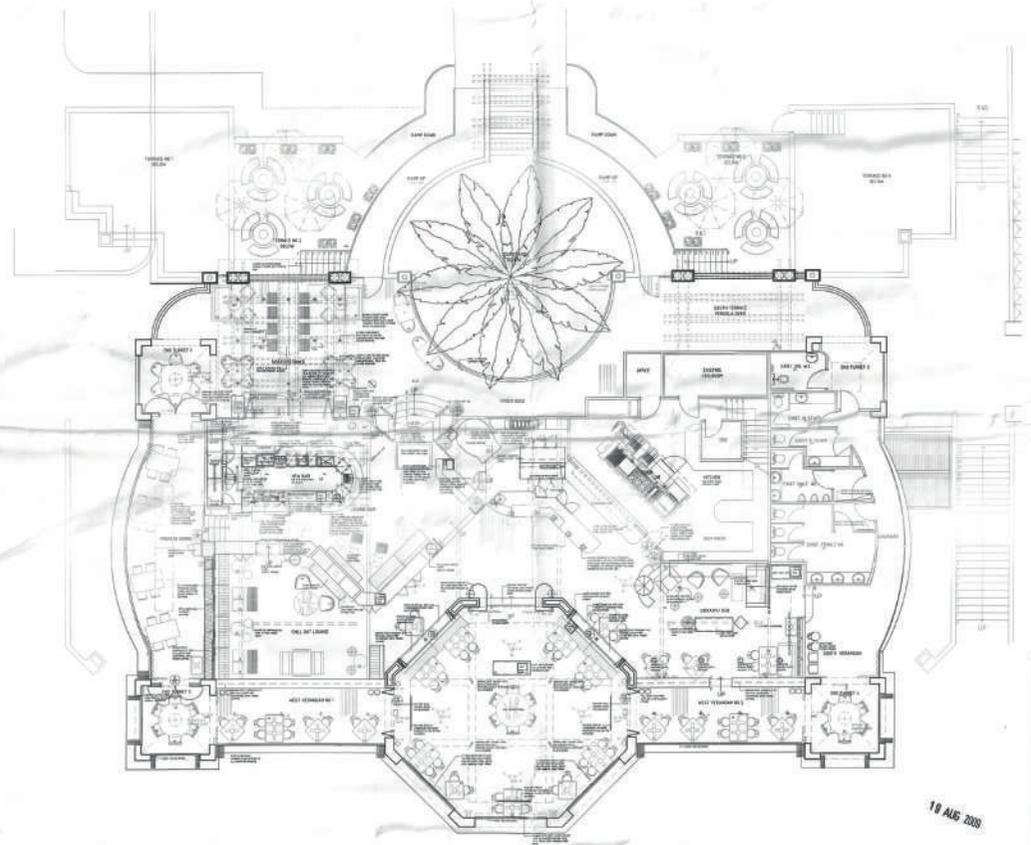
AS PROPOSED UPPER/ RESTAURANT LEVEL FLOOR PLAN

In 2009, the restaurant was refitted internally to design Consultant Scott Wilson at which time the central entry was moved slightly further north to accommodate a maître de station and a larger kitchen. Outdoor pergolas were erected over the terraces on the east elevation. The north and west verandah eating areas were modified and doors inserted to close off areas for **use** as separate function spaces. (Refer to plans Figure 24)

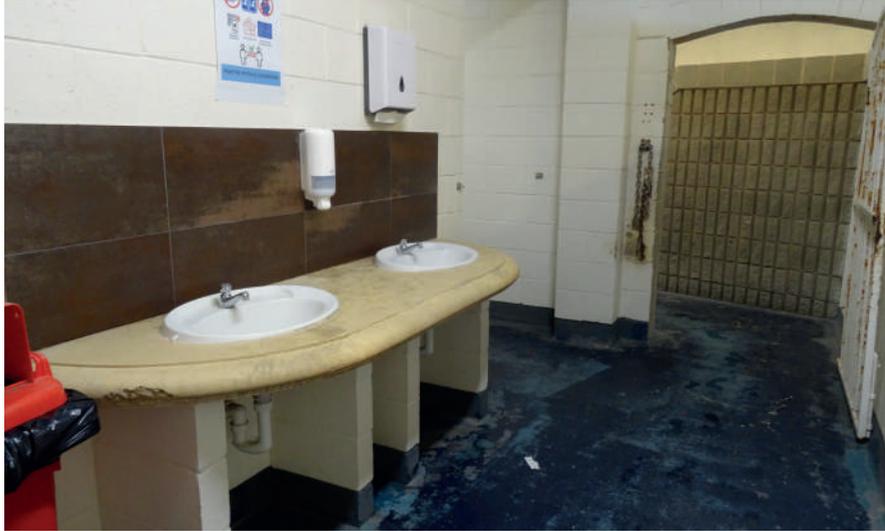
Figure 84. Women's changerooms looking towards the entry noting some rusting and deterioration of the fabric (element 2021)

Generally, the Indiana Teahouse building is in a good condition with no major indications of significant visual defect. Externally there are some signs of rust and general deterioration particularly to the older **fabric** of the 1983 section of the building, which are due to the effects of its coastal location. Overall however, **maintenance** of the **place** appears to have been generally sufficient to ensure its ongoing longevity. Further inspection would be required to ascertain whether there are any underlying structural concerns to **fabric** exposed to the harsh coastal conditions. Internally the **place** has remained relatively unchanged since the closure of the restaurant. The loft space was not accessed due to some concern with the structural integrity of the internal timber staircase, but otherwise internal areas appear to be in a relatively stable condition.

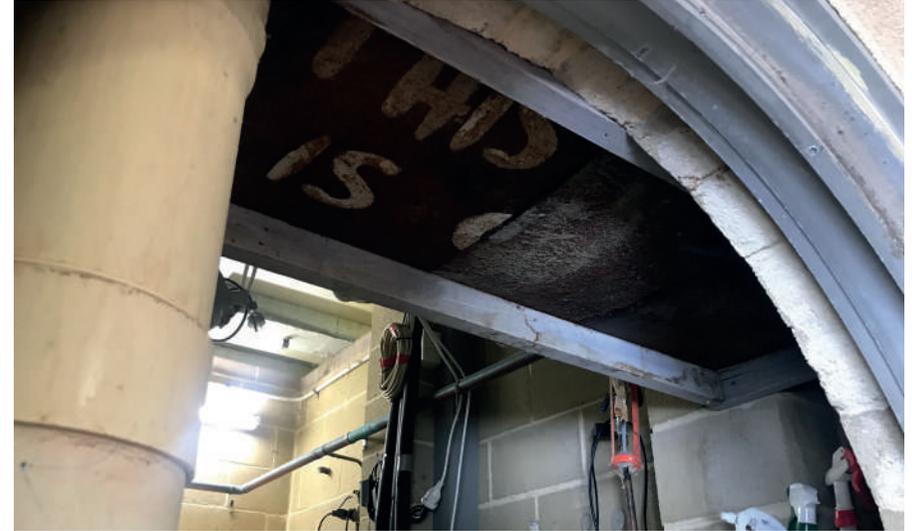
Figure 86. One of two original arched doorway openings to the eastern ground floor side of the 1983 structure which have been retrofit to house servicing and storage facilities (element 2021)

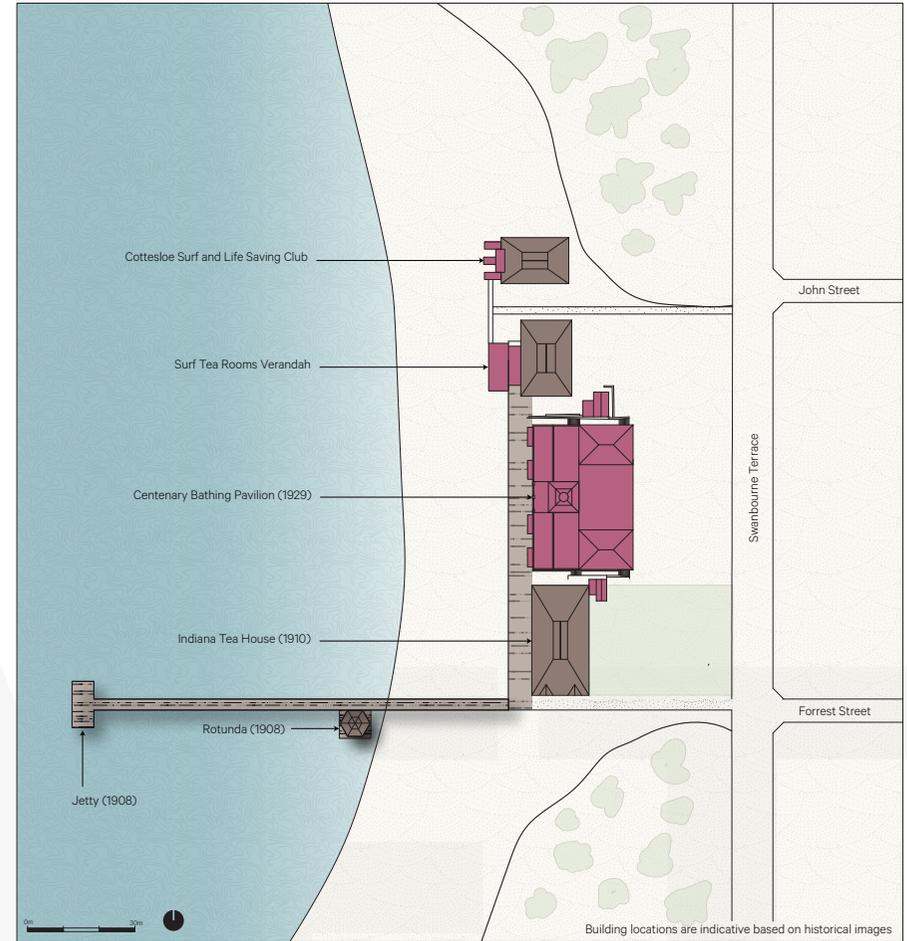
Figure 101. The site as at 1929 (element 2021)

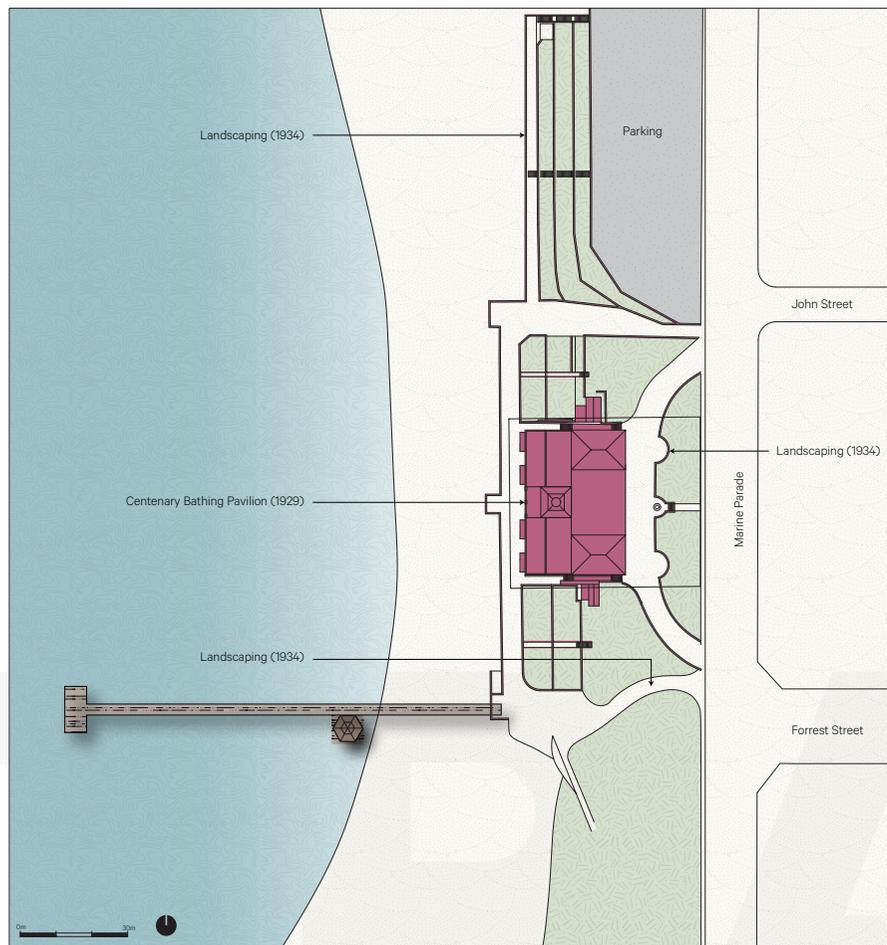
Figure 102. The site as at 1934 (element 2021)

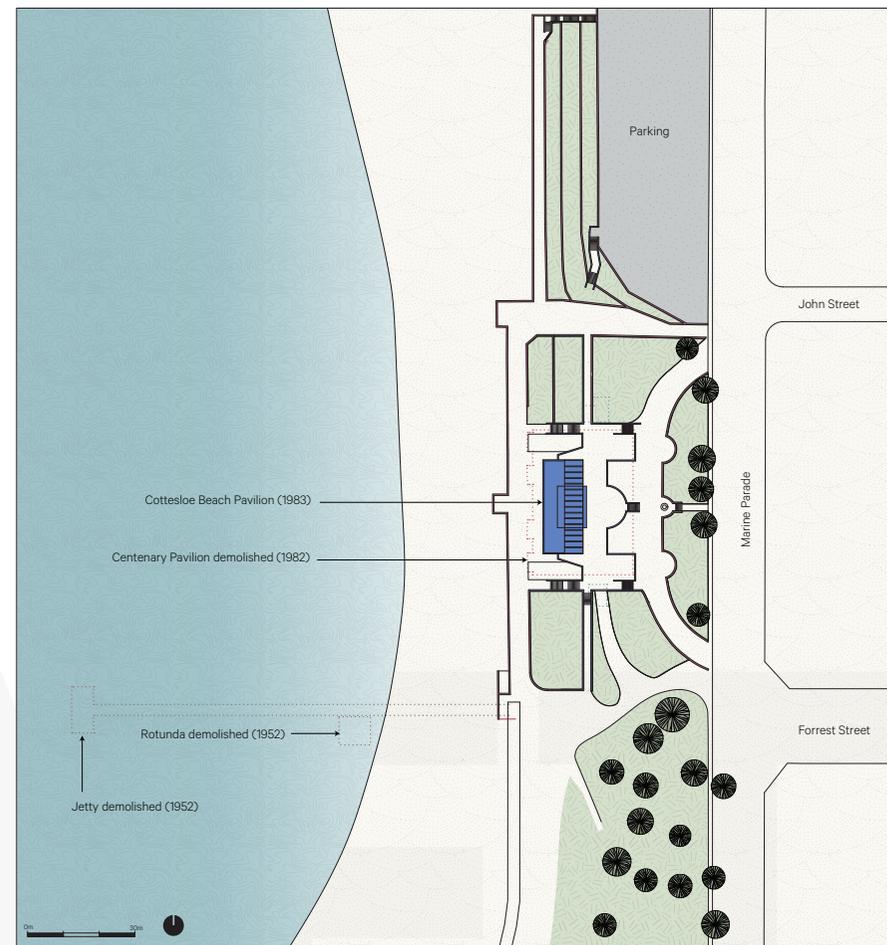
Figure 103. The site as at 1983 (element 2021)

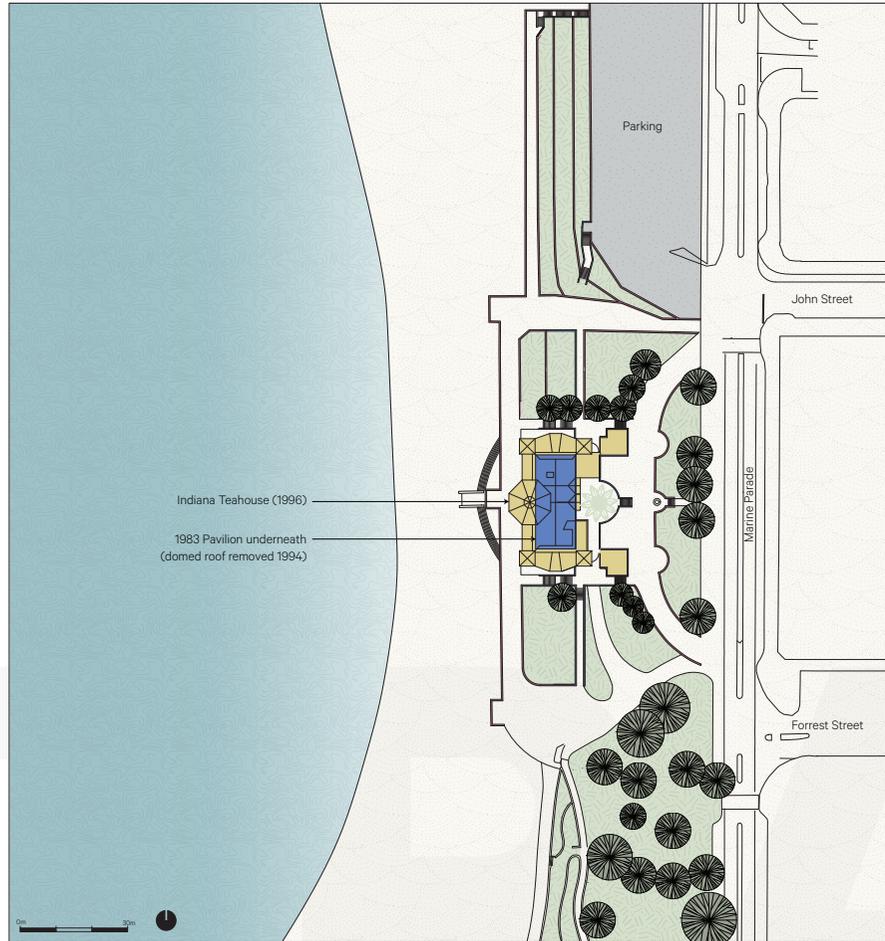
Figure 104. The site as at 1996 (element 2021)

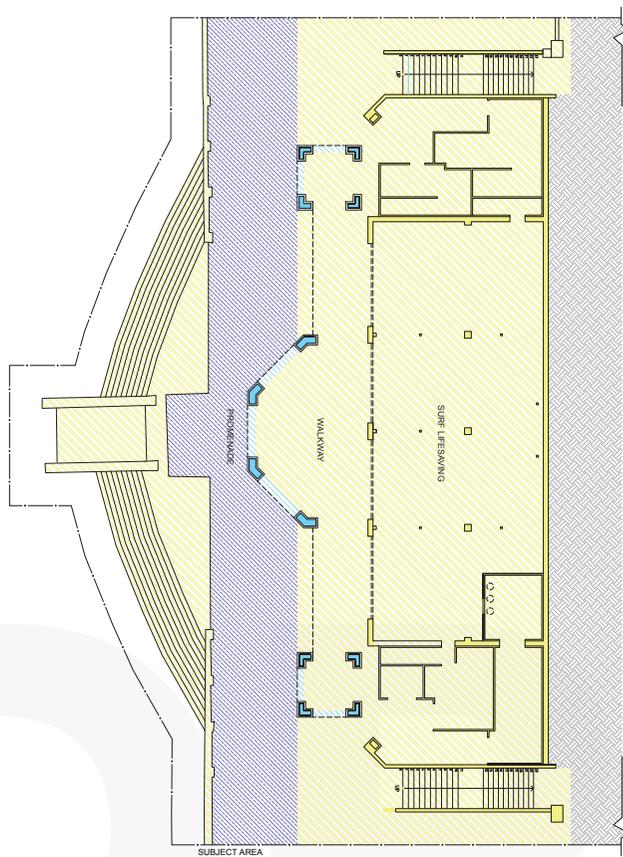
AS EXISTING PROMENADE

Figure 110. Significance Plans Promenade (element 2021)

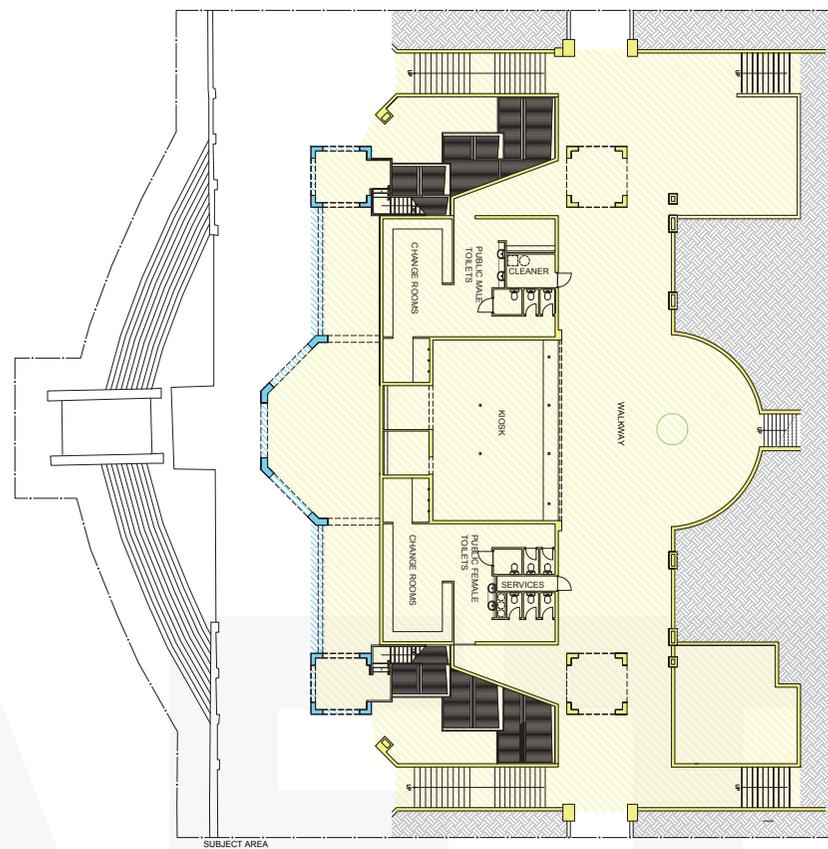
AS EXISTING GROUND

Figure 111. Significance Plans Ground (element 2021)

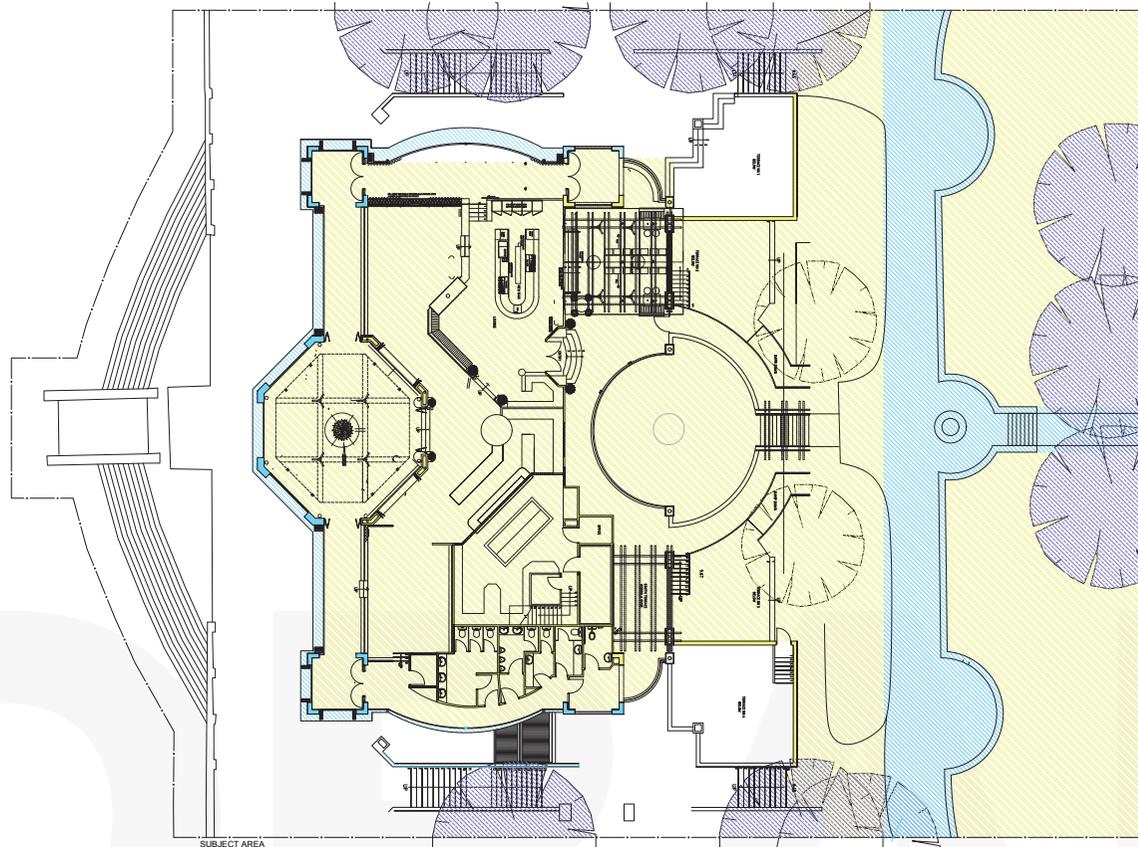
AS EXISTING UPPER

Figure 112. Significance Plans Upper (element 2021)

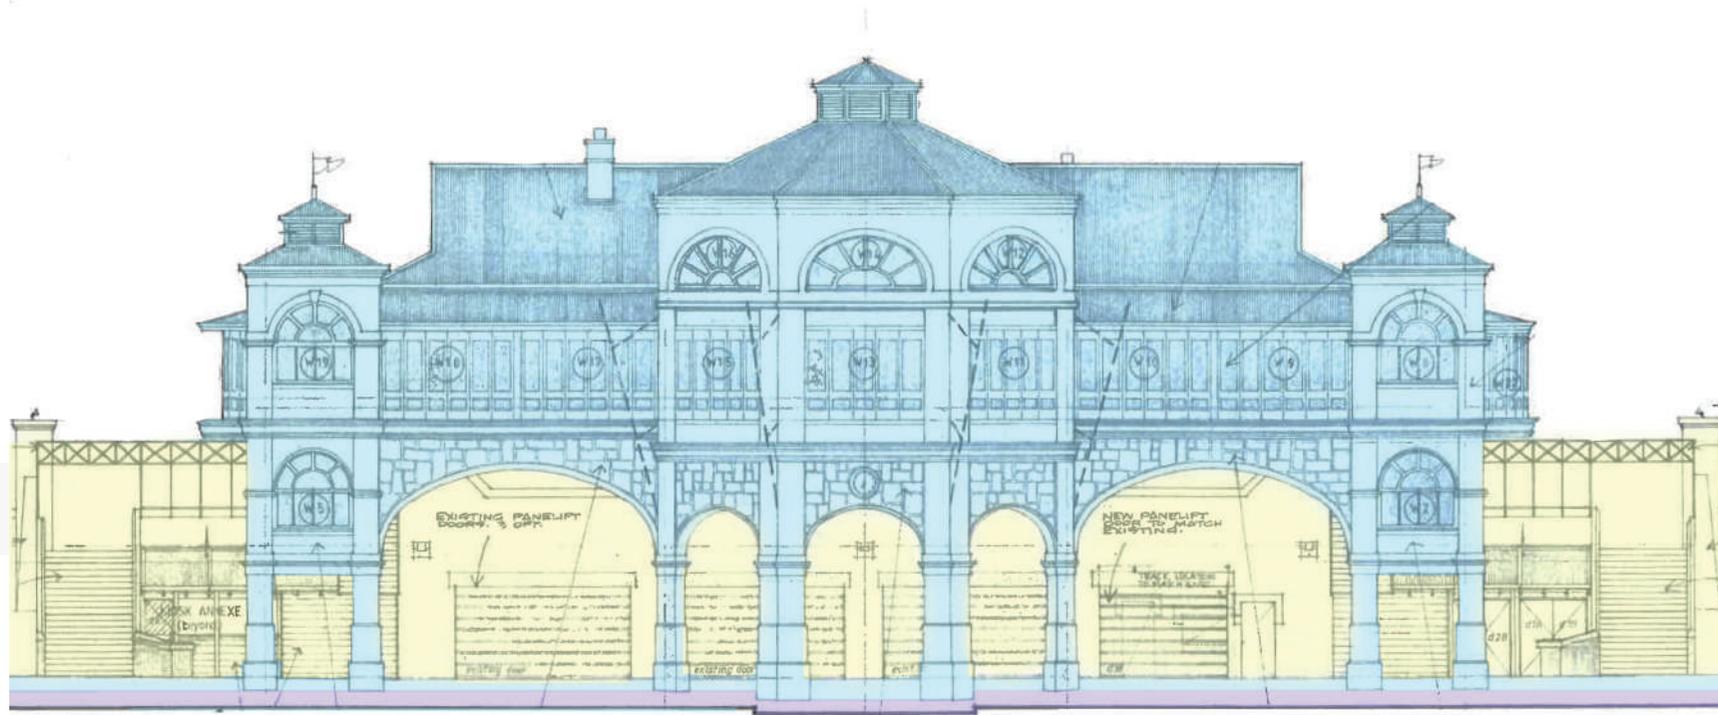
Figure 113. Significance Plans West Elevation (element 2021)
