## Appendix 4 - Visual Inspection of Retaining Walls Report

Prepared for  
Town of Cottesloe  
27 July 2016

CW933000-ST-R001  
Visual Inspection of Retaining Walls Along Cottesloe Foreshore

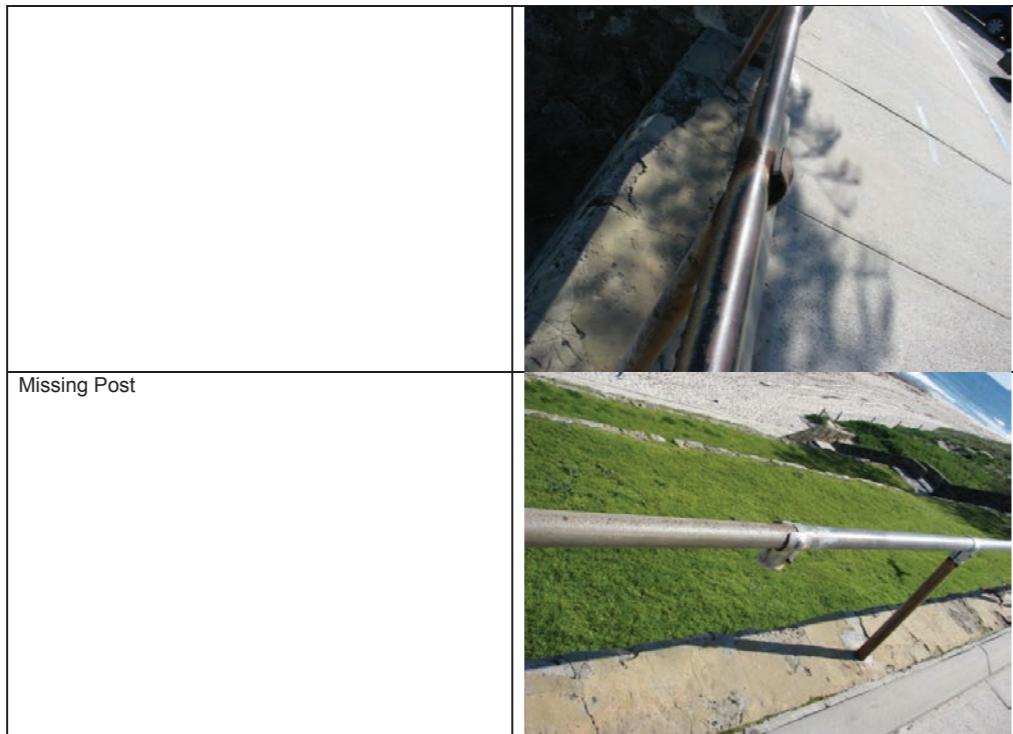
Typical Shrinkage crack on concrete retaining wall RW5

The concrete retaining wall RW5 was generally in good condition. Shrinkage cracks were observed along the height of the wall at regular intervals. Exposed reinforcement was observed at some location. This reinforcement is badly corroded and need to be replaced, and covered.
