Arboricultural Report

Tree Survey, Arboricultural Impact Assessment and Tree Protection Plan

Site Address: **(Lot 506), No. 20A Deane Street, Cottesloe W.A.**

Report Date: **20th January 2021**

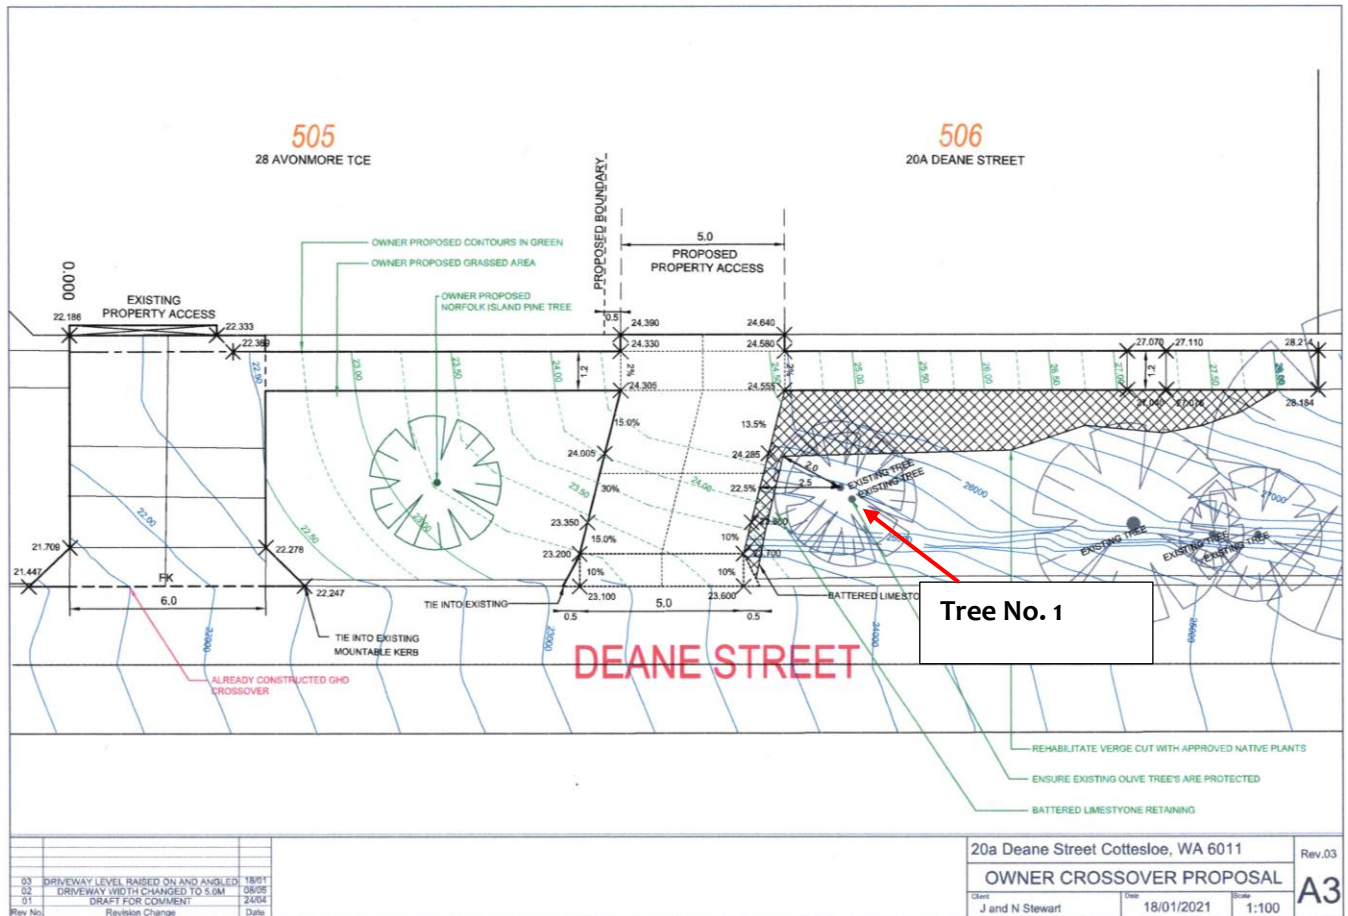
The Site Plans

Site Plans from “Mr R Stewart” 20/1/21.
Modified by P. Matthews 20/1/21.

It is this Arboricultural Consultant’s opinion that a TPZ of Australian Standards recommendations is not always able to be achieved due to the **2.5m** distance from the tree to the edge of the crossover on the east side, and the **2.4m** distance from the tree to the pedestrian pathway on the north side., However the AS 4970-2009 details the recommended protection zone and must be demonstrated to ensure the tree’s survival and its structural stability remain intact. Where the construction of the recommended TPZ barrier is not possible and the impact of encroachment is probable, **this Arboricultural Consultant by prior inspection, must demonstrate that the tree would remain viable. Documenting any encroachment, taking photos and providing a Progress Report, in accordance with the (AS 4970-2009, “Sections 3.3.3 and 5.4.3”) is required.**

Note: This Arboricultural Consultant advises the excavation for the proposed crossover must be **outside** the **1.94m** SRZ radius given around this tree. **No roots are to be severed or damaged, inside** the **1.94m** SRZ radius around this tree.

All mechanical excavation of the proposed crossover must be at least **2.376m** (10% less than the **2.64m** TPZ radius), away from the base of the trunk with all the exposed roots with a diameter of **less than 25mm** being cleanly severed for good wound occlusion. However, any roots **greater than 25mm** in diameter must not to be cut without authorisation from myself as a qualified Consulting Arborist. **Documenting the situation and/or any root damage, taking photos and providing a Progress Report,**
