P7984 Cottesloe Beach Pylon Conservation Management Plan

Prepared for
The Town of Cottesloe
By

April 2019

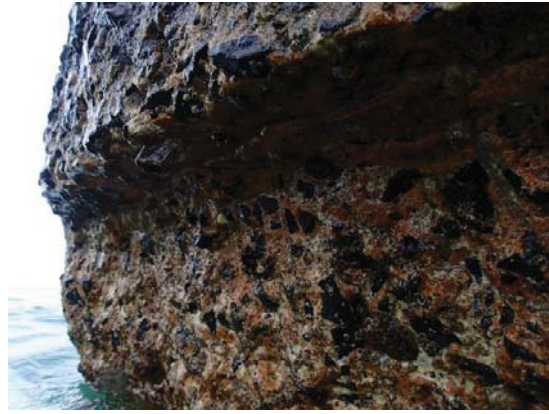
The top section of the pylon that typically sits above the height of the water is relatively uniform as a cylindrical shape with a circumference of 4.8 m (Figure 2-1). There is some cracking though this top section however there are no areas of significant concrete loss. It appears that a repair to the upper part of this section may have been previously undertaken. Where the pylon meets the waterline there are significant apparent losses of concrete resulting in a scalloped appearance to the pylon through this section. The losses are not uniform, but it appears that on the whole the concrete has cracked away down to a layer of re-enforcing bar (rebar) that was originally embedded around 200 to 250 mm below the surface of the concrete. Although not entirely uniform, the result is that the pylon roughly tapers from a circumference of 4.8 m above the waterline, to a circumference of 4.3 m 600 mm below the waterline. Please note that for ease of reference in this report the area where the pylon transitions from sectional concrete loss to no sectional loss has been referred to as "the surface". The following photographs (Figure 2-2 through Figure 2-4) illustrate these concrete losses at the waterline and resulting scalloping of the pylon.

Figure 2-2 Concrete loss at waterline

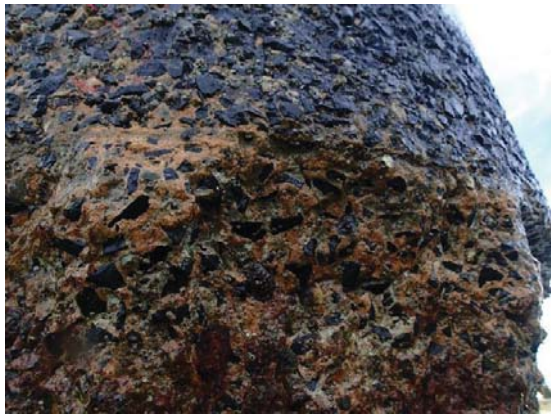
Figure 2-3 Concrete loss at waterline

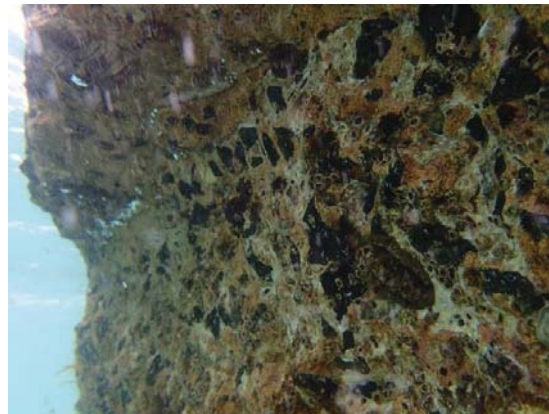
Figure 2-4 Concrete loss at waterline

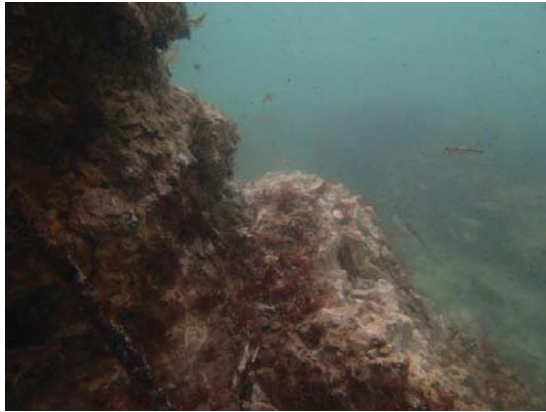
Below the waterline, the pylon has a relatively uniform circumference of between 4.2 to 4.3 m which continues down to 1.6 m below the surface. At this point the pylon tapers outwards but also has significant losses of material, making the structure very uneven. At 1.8 m below the surface, the outside circumference of the pylon is 4.75 m, 2 m below the surface it is 6.05 m, 2.2 m below the surface it is 6.8 m and 2.4 m below the surface it is 8.2 m. Note that these measurements are subject to variation, depending on which parts of the structure are included or excluded. There appears to be a rebar framework throughout the top of the tapered section, but in some areas the rebar sits out from the concrete. All measurements were taken on the outside of the rebar to better determine the original measurements of the pylon. The following photographs (Figure 2-5 through Figure 2-10 below) illustrate the loss of concrete material and exposed rebar throughout the top of the tapered section.

Figure 2-5 Rebar through top of tapered section

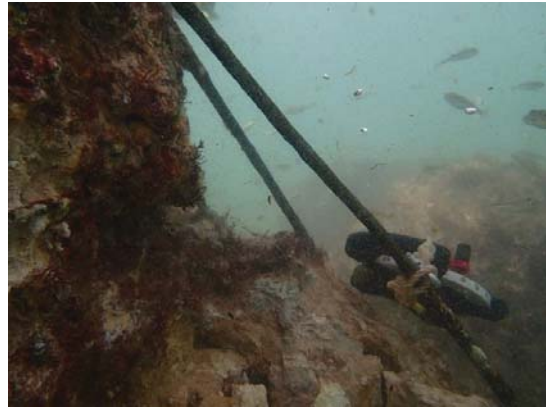
Figure 2-6 Rebar through top of tapered section

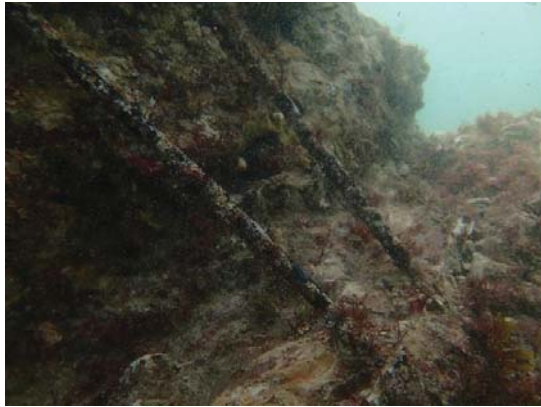
Figure 2-7 Rebar through top of tapered section

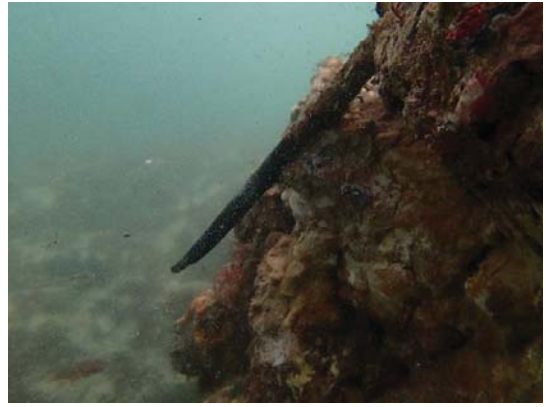
Figure 2-8 Rebar through top of tapered section

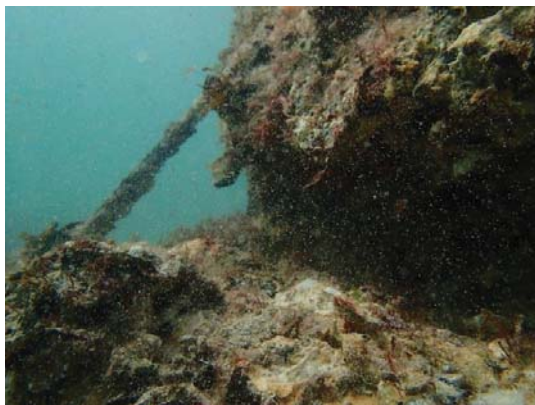
Figure 2-9 Rebar through top of tapered section

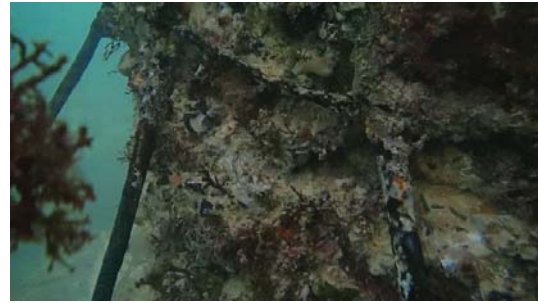
downwards but also taper out on an angle. These tapered pieces originally terminated in a steel ring and pieces of this ring are still visible. With the exception of the tapered section, it appears that the concrete has predominantly cracked away down to the rebar but not further (in some areas the rebar is slightly proud). The following photographs (Figure 2-15 through Figure 2-20 below) illustrate the rebar still evident in the structure.

Figure 2-16 Part of ring visible at top of taper

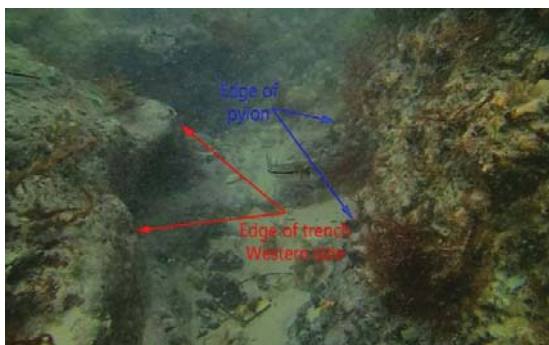
Figure 2-23 Trench Western side

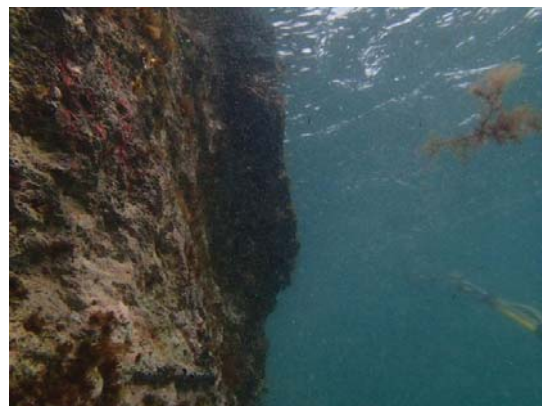
Figure 2-36 Pylon below scalloping at waterline

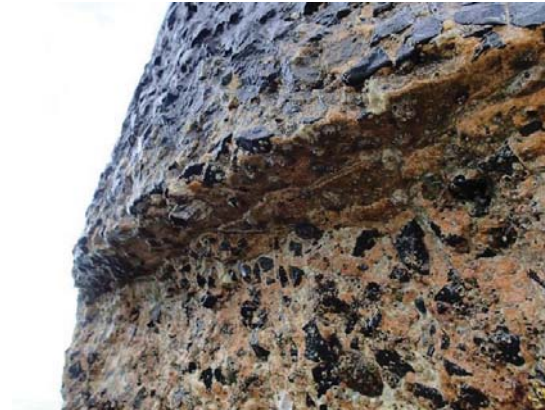
Figure 2-38 Cream mortar with blue metal aggregate above waterline

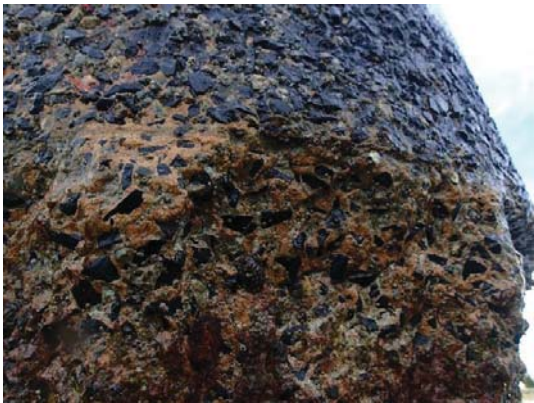
Figure 2-39 Exposed blue metal aggregate above waterline

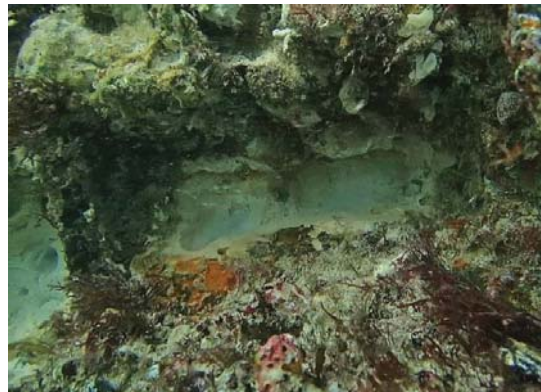
Figure 2-44 Soft clay-like material through rebar tapered section
