COTTESLOE FORESHORE RENEWAL  
INFRASTRUCTURE REDUCTION STRATEGY

August 2017  
Revision A

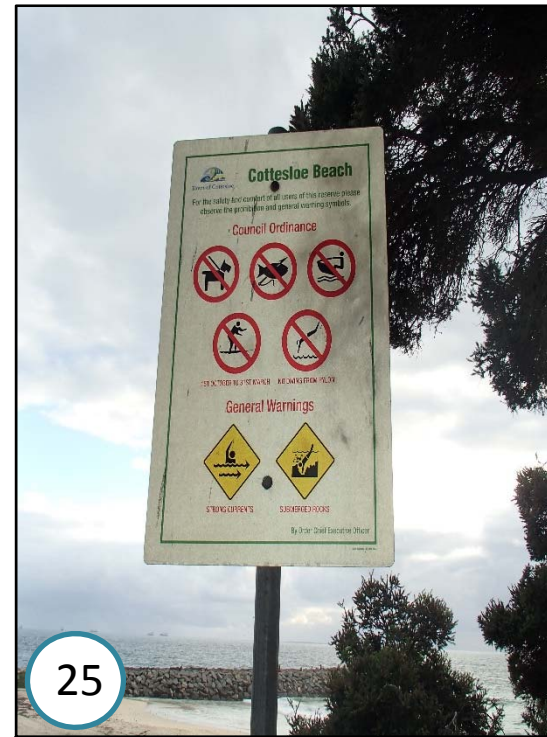
Dune signage is dated and worn.

The dune signage is to be consolidated with consistent message and materials/theming. There is the potential to incorporate messaging from Coast Care and Council including educational text regarding dune systems, species, fauna and habitat.
