Arborist Assessment and Report

Subject: Tree: Norfolk Island Pine (*Araucaria heterophylla*)

Location: Out side 52 Forrest St Cottesloe

Date : 21/1/2014

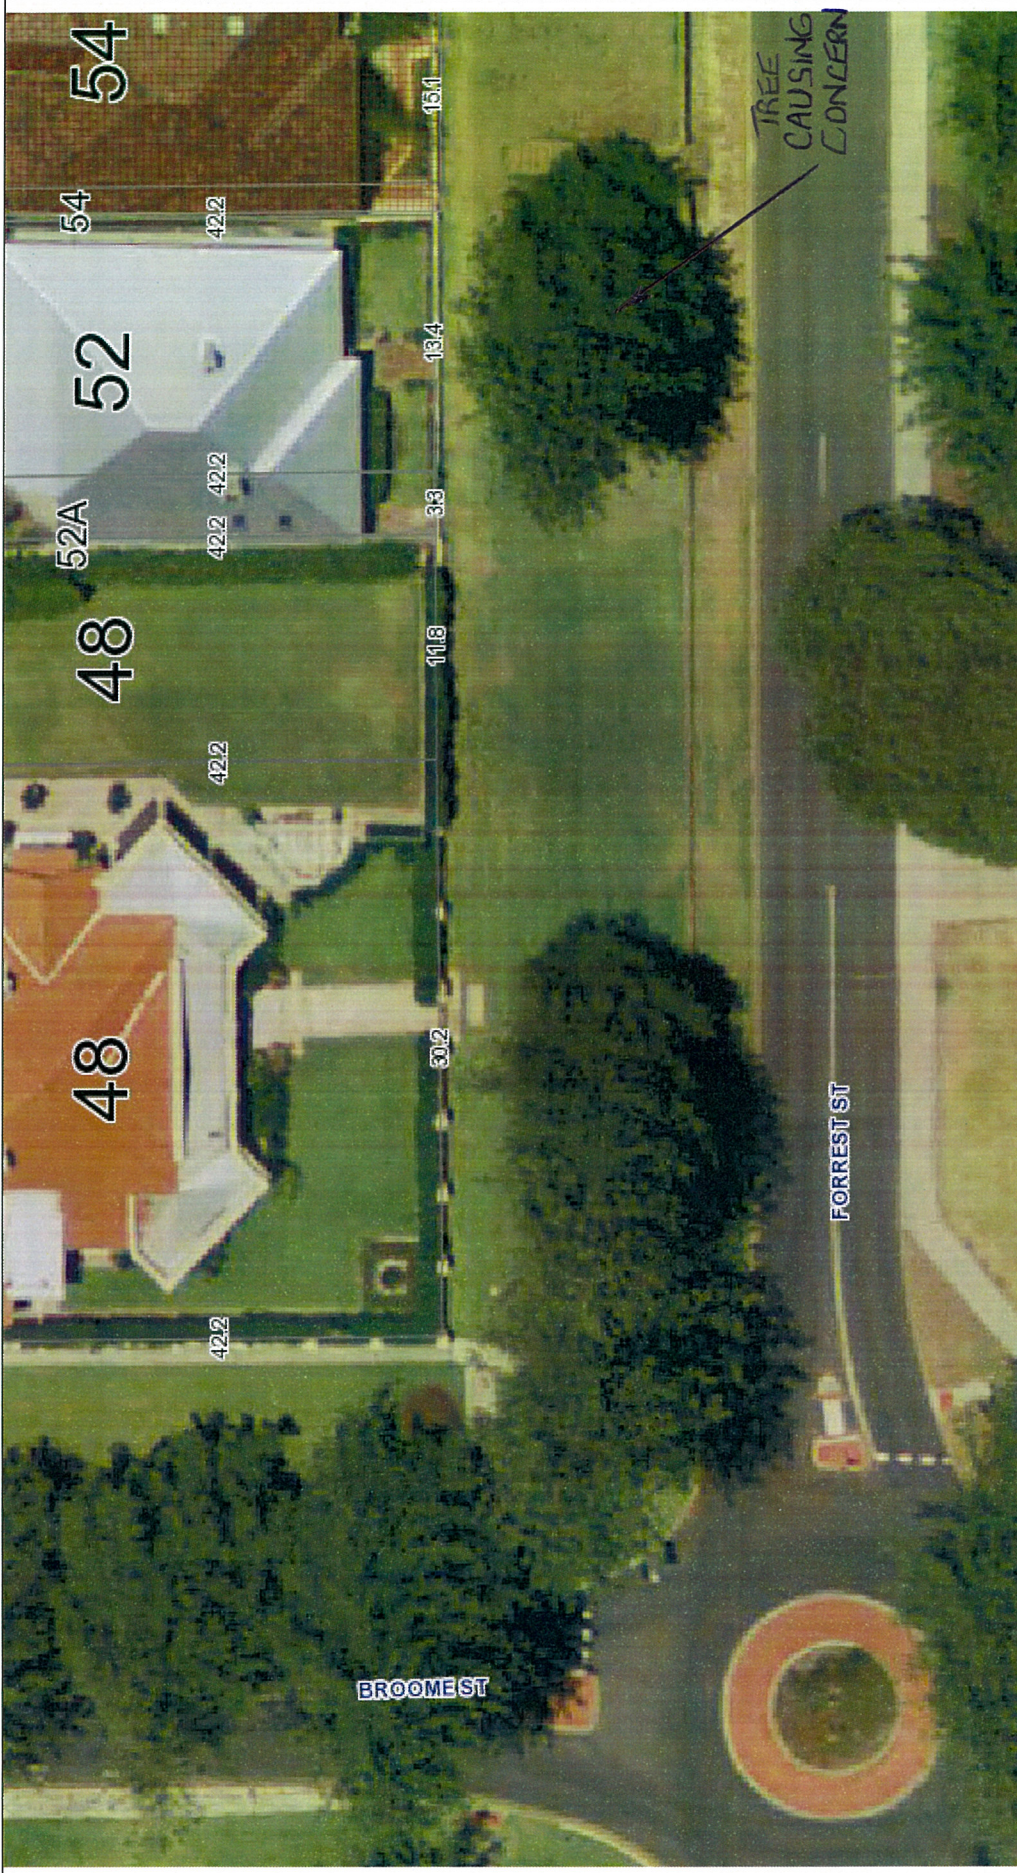
RE: Norfolk Pine on Council Verge : 52/54 Forrest Street, Cottesloe

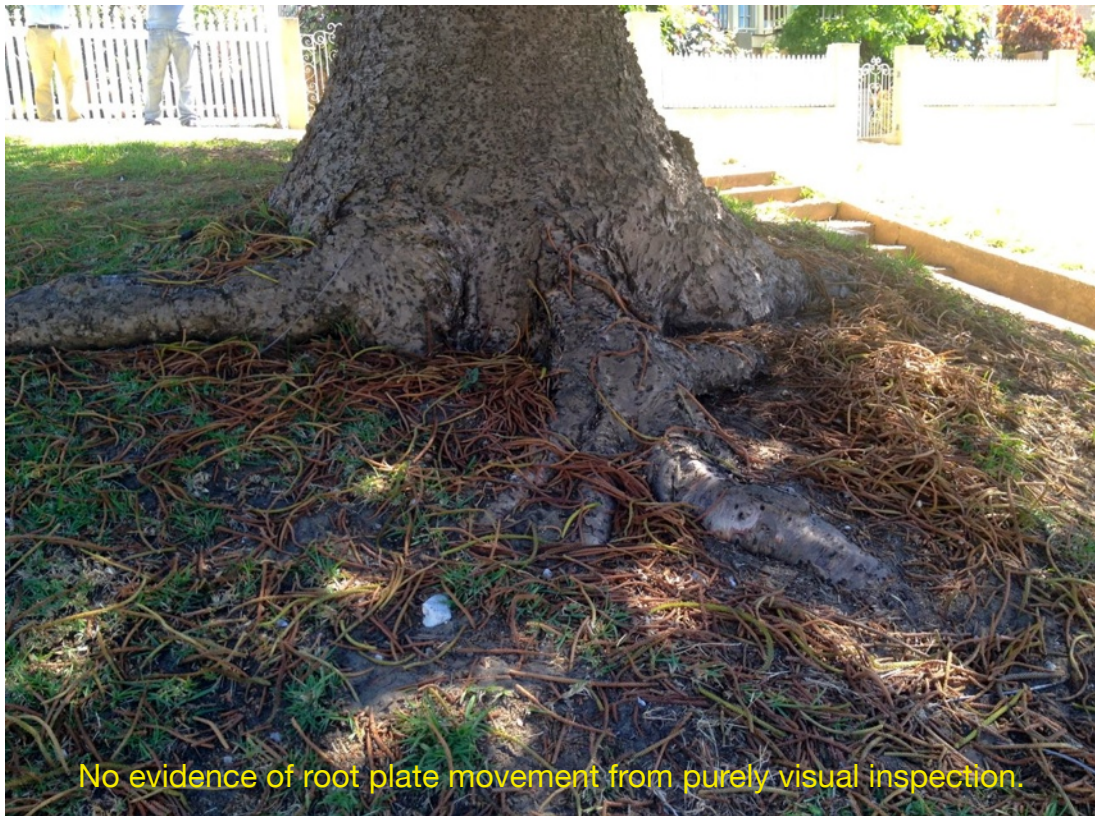
The structural form of this tree shows a lean to the north up to 20 m and then for the remaining 8 m or so of the top is vertical. This vertical growth habit is a correction at some point in the trees life and is evident in the photo.

The complete integrity of the root zone around the trees is unknown however going by the health and vigour of the canopy it would suggest a healthy vascular system and in turn a healthy root system. Evidence of this can be taken from large expansion cracks in the adjacent walls and path caused by the expanding root system.

Accelerometer or tilt sensor would need to be fitted to this tree and one of the neighbouring trees in the street of the same basic dimensions as a direct comparison.

Re Inspect this tree for health and vigour on a six-month basis.
