Feasibility Stage

Road Safety Audit

North Cottesloe Primary School – Railway St KissnRide

Town of Cottesloe

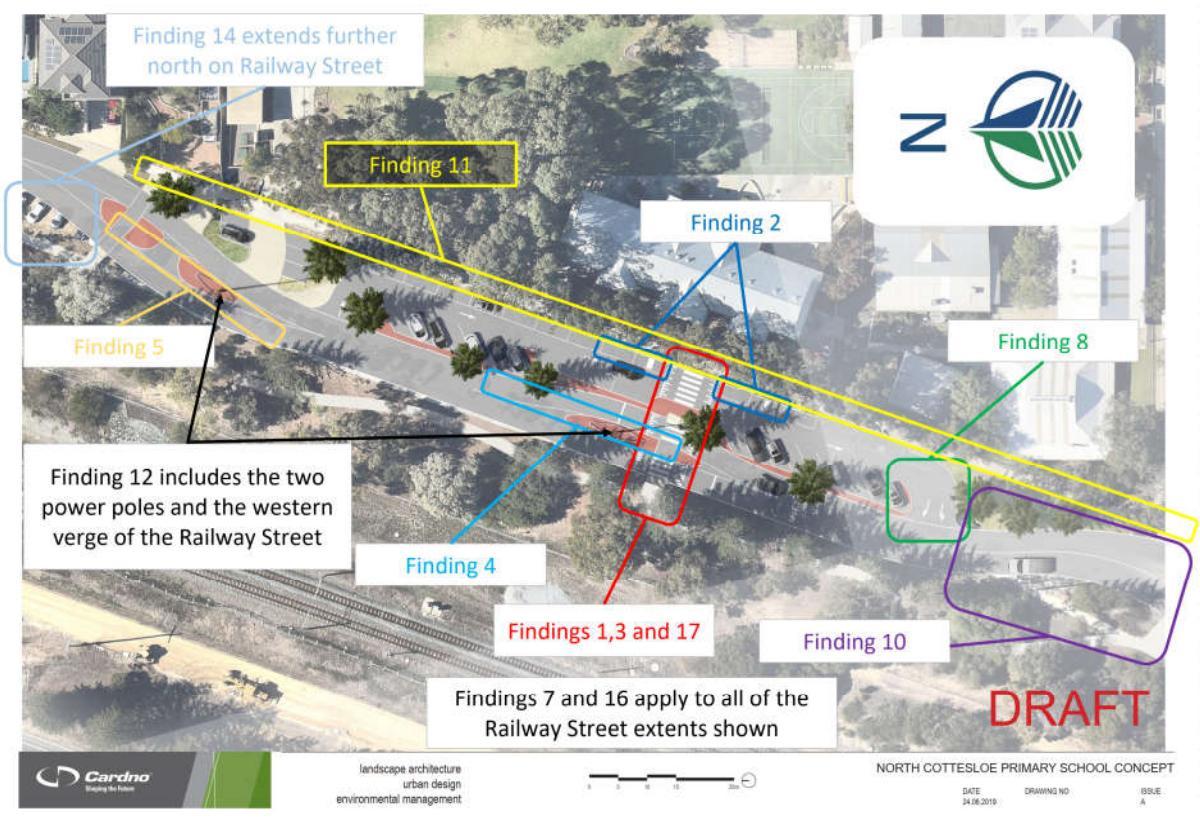
Figure A1: Site plan showing the audit finding locations along Railway Street

Site plans annotated to indicate the locations of the audit findings have been provided at Appendix A.

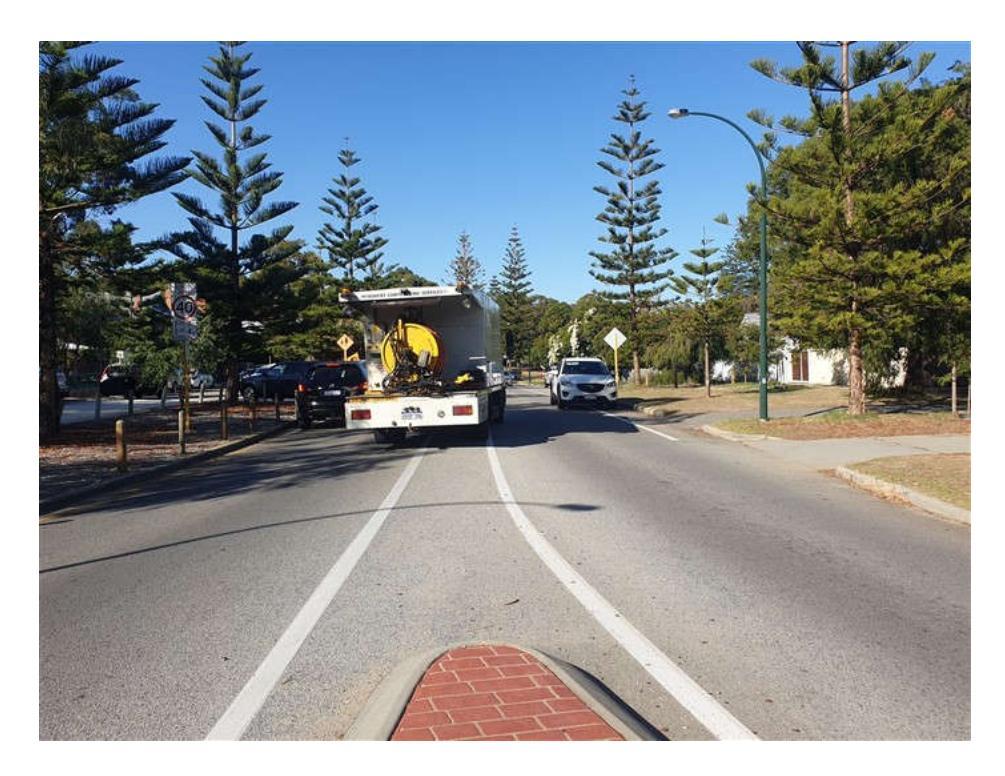
Photo 1: Vehicles were observed driving contra-flow to get past illegally standing vehicles on Eric Street shortly before and after school closing time.

ltem	Description	Audit Finding and Recommendation	Response (Project Manager to agree / disagree, provide reason for disagreeing, and detail proposed actions and comments)
6	Road user non- compliance with existing parking controls on Eric Street	During the afternoon site inspection, the audit team identified several vehicles illegally standing on the eastbound lane of Eric Street, between the Eric Street / Railway Street roundabout and the entry to the existing KissnRide facility on Eric Street. This included vehicles standing within the roundabout and appeared to contribute to queues of vehicles extending to the western side of the Curtin Avenue intersection. This issue effectively gridlocked traffic on Eric Street as well as Railway Street in the vicinity of both existing KissnRide facilities, resulting in some drivers proceeding contraflow as well as mounting roundabout splitter island and central annulus areas to try to pass the standing vehicles. This increases the risk of driver frustration resulting in a range of crash types including rear end, side swipe, head-on and high severity crashes between pedestrians and vehicles at the roundabout. (IMPORTANT: MODERATE) Justification Refer to Photos 1 & 2 at Appendix D of the audit report. The effect of vehicles illegally standing on Eric Street was to exacerbate significant congestion approximately 15 minutes prior to, and for 15 minutes following, the close time siren for the North Cottesloe Primary School. The restriction of traffic flows eastbound on Eric Street also severely restricted the opportunity for other drivers to complete an anticlockwise circulatory movement around the school when access into either KissnRide facilities, now and following the implementation of any upgrades. Anticlockwise circulatory traffic movements around the school are already possible by utilising Eric Street, Mann Street, Grant Street and Railway Street.

2. For as long as the Eric Street KissnRide facility remains in service;	* Agree with recommendation 2.
		 the existing parking restrictions on Eric Street need to be enforced to deter drivers from standing illegally. Drivers seeking to utilise a KissnRide facility need to be educated in the need to circulate anti-clockwise around the school if access into a KissnRide facility is unavailable, instead of blocking traffic by queuing at a KissnRide entry point. Improve the conspicuity of parking controls in place along Eric Street by repainting the yellow edge line and placing addition No Standing signs at the start and finish of the restricted section. 	* Point 2 in relation to the anti-clockwise circulation will need to be clarified to specify going around the block.

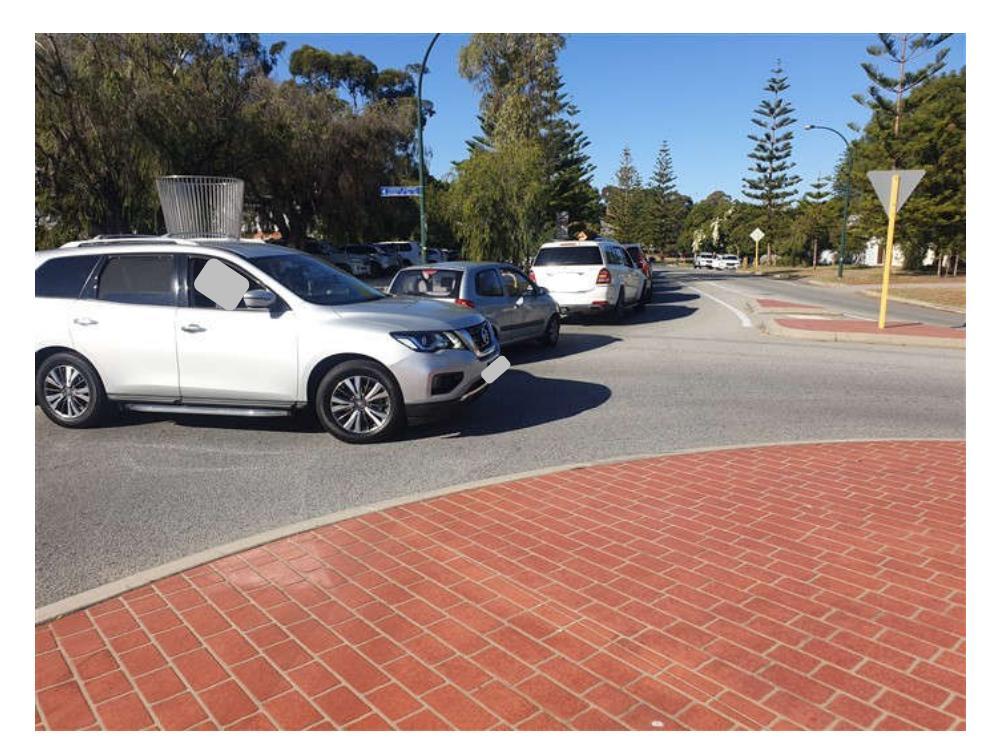
Photo 2: The driver of the vehicle at the left of this photo is trying to turning left from Railway Street onto Eric Street. Vehicles were observed mounting the roundabout splitter island to get past the illegally standing vehicles shown in the eastbound lane of Eric Street.

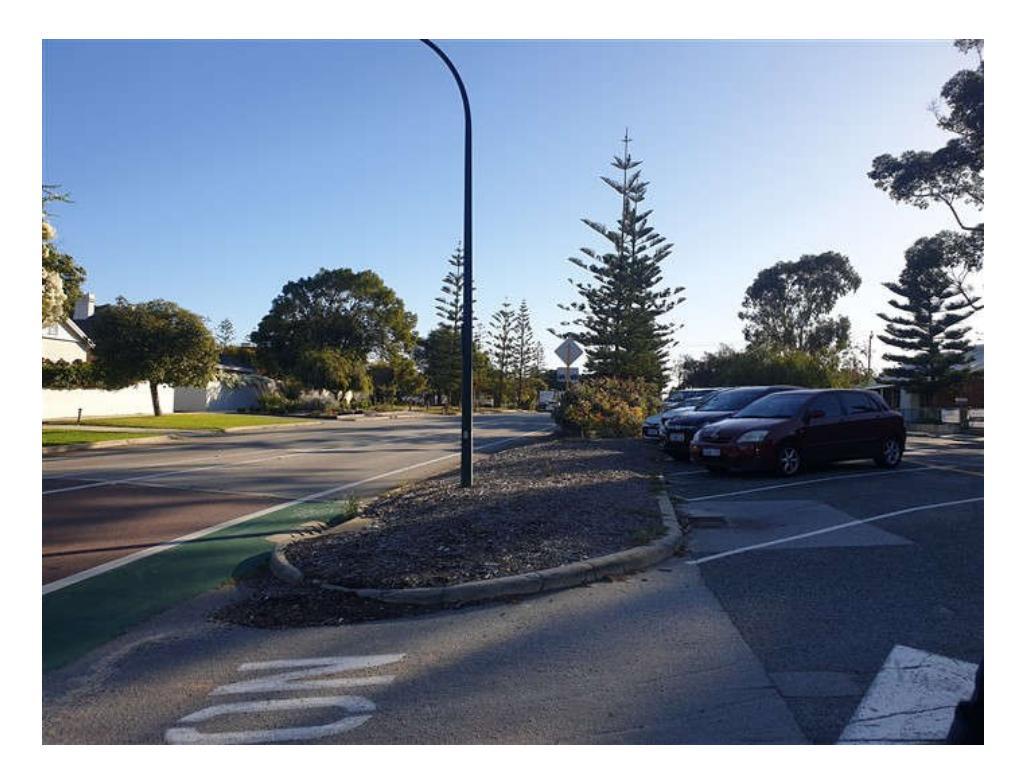
Photo 3: Sight distance to the west along Eric Street from the KissnRide exit is restricted by the Banksia trees.

ltem	Description	Audit Finding and Recommendation	Response (Project Manager to agree / disagree, provide reason for disagreeing, and detail proposed actions and comments)
9	Sight lines at the Eric Street KissnRide exit	 Safe Intersection Sight Distance is not achieved at the Eric Street KissnRide exit. Sight lines to the west are restricted by the Banksia trees located a short distance to the west of the exit. This can result in drivers; Encroaching into the cycle lane on Eric Street to improve their sight lines to approaching eastbound traffic on Eric Street and Possibly accelerating rapidly from the exit to avoid approaching eastbound traffic, potentially conflicting with pedestrians at the facility immediate east of the exit, or even coming into direct contact with the median island (including the grab rail). The lack of sight distance at the exit can result in a variety of crash types including right angle, side swipe, rear-end, loss of control hit object and pedestrian versus vehicle crashes with potentially high severity outcomes. (IMPORTANT: LOW) Justification Refer to Photo 3 at Appendix D of the audit report. Austroads Guide to Road Design Part 4 A (Unsignalised and signalised intersections) Table 3.2 indicates that for a design speed of 60km/hr (maximum posted speed limit of 50km/hr), 123m is the required Safe Intersection Sight distance assuming a reaction time of 2.0 seconds. Currently available sight distance is approximately 65m. Recommendations If the exit is to remain, prune the Banksia trees from the north verge of Eric Street in order to provide and maintain Safe Intersection Sight Distance at the exit.

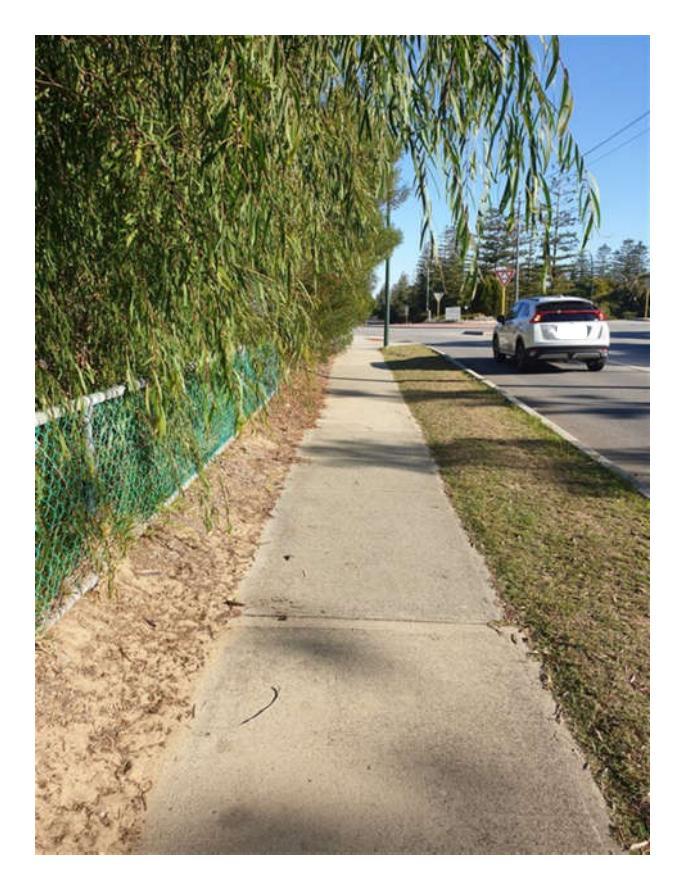
Photo 4: Footpath running along the east verge of Railway St. Note the path width and also the foliage encroaching over the footpath.

Item	Description	Audit Finding and Recommendation	Response (Project Manager to agree / disagree, provide reason for disagreeing, and detail proposed actions and comments)
11	Footpath along the eastern verge of Railway Street	The concrete footpath along the eastern verge of Railway Street (between the Eric Street roundabout and Greenham Street) is approximately 1.2m wide. Between the path and the school boundary fence is sand (approximately 0.5m) and the section between the path and the trafficable lane is grassed (width varies). Numerous shrubs and tree branches overhang the footpath in this section. The audit team noted a significant number of pedestrians and cyclists utilising this footpath immediately after school closing time. Path users were observed encroaching onto the areas adjacent to the footpath on several occasions to make room for other path users. Encroaching onto uneven or soft ground, particularly for young cyclists or pram users, can result in falls or collisions. (IMPORTANT: LOW) Justification Refer to Photo 4 at Appendix D of the audit report. Recommendations 1. Pave either side of the footpath (between the Railway Street kerbline and the school property boundary) to reduce the risk falls or collisions involving path users. 2. Under prune the foliage along the footpath to establish and maintain a minimum clearance of 2.5m for allow path users to proceed without having to avoid foliage.	* Agree with recommendation

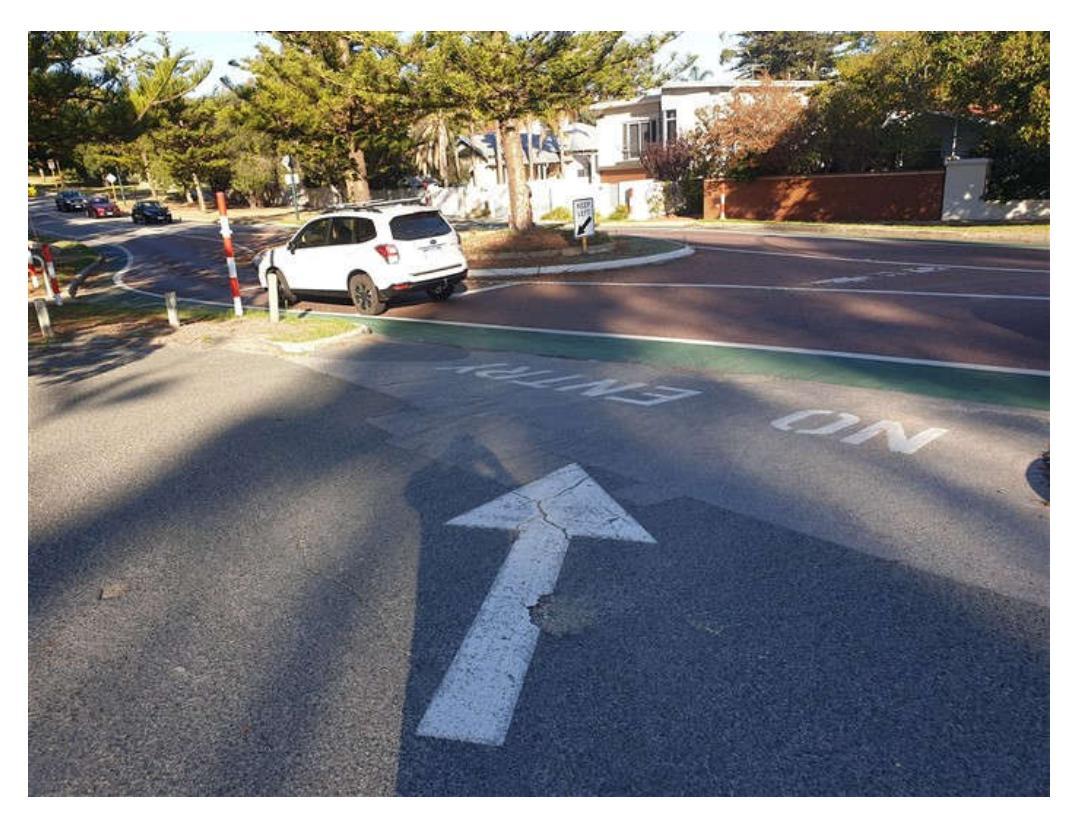
Photo 5: Multiple tow ball strikes evident and wide lane width at the Eric Street KissnRide exit.

Item	Description	Audit Finding and Recommendation	Response (Project Manager to agree / disagree, provide reason for disagreeing, and detail proposed actions and comments)
13	Geometry of the Eric Street KissnRide exit	The vertical geometry of this exit is poor, with evidence of multiple vehicles having their tow ball grind against the trafficable surface. This may reduce traction or destabilise a vehicle accelerating onto Eric Street from the exit, resulting in a variety of crash types. (LOW) Justification Refer to Photo 5 at Appendix D of the audit report. Recommendation If the exit is to remain, safety can be improved by re-grading the exit vertical geometry and narrowing the exit lane width while maintaining a minimum angle of intersection with Eric Street of 70 degrees. Note: This may require some retaining structures or the loss of one parking bay.

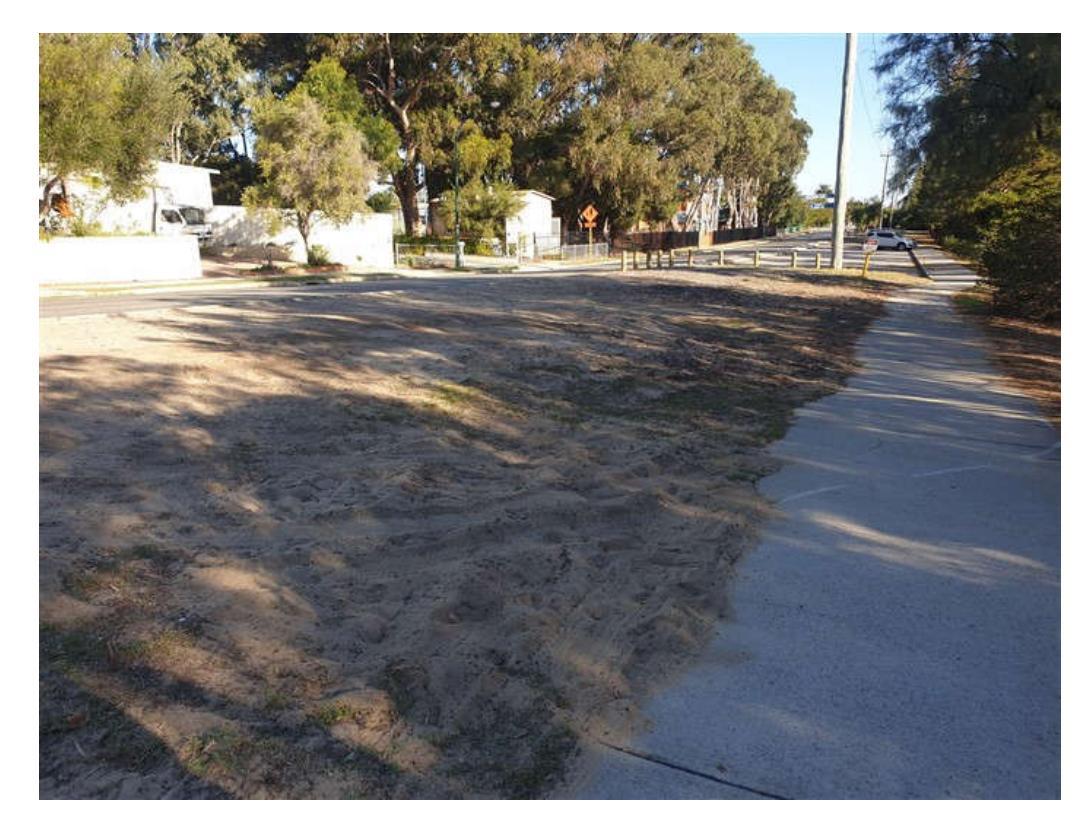
Photo 6: Soft, uneven surface of the informal parking area on the west verge of Railway Street, north of the proposed KissnRide facility.

ltem	Description	Audit Finding and Recommendation	Response (Project Manager to agree / disagree, provide reason for disagreeing, and detail proposed actions and comments)
14	Verge parking to the north of the proposed KissnRide facility on Railway Street	The west verge of Railway Street immediately to the north of the angle parking area is utilised as an informal 90-degree parking area. It appears that this is being utilised by some caregivers of the Pre- primary school. The surface of the area where this informal parking is occurring is undulating soft sand and grass. The variability of surface texture and profile could result in a driver skidding or moving abruptly, possibly causing a crash with other vehicles or pedestrians, resulting in a high severity injury. (IMPORTANT: LOW) Justification	
		 Refer to Photo 6 at Appendix D of the audit report. There is mountable kerbing at this location and it is expected that informal parking will continue following the implementation of a KissnRide facility on Railway Street, unless measures are taken to prohibit this parking. It was noted that the action of vehicles driving on the soft sand is pushing sand onto the adjacent footpath, also creating the risk of instability for cyclist using the path, and an ongoing maintenance issue for the Town of Cottesloe. Recommendation 1. Determine whether parking will continue to be permitted on the west verge of Railway Street, to the north of the proposed KissnRide facility. 	* Agree with recommendation.

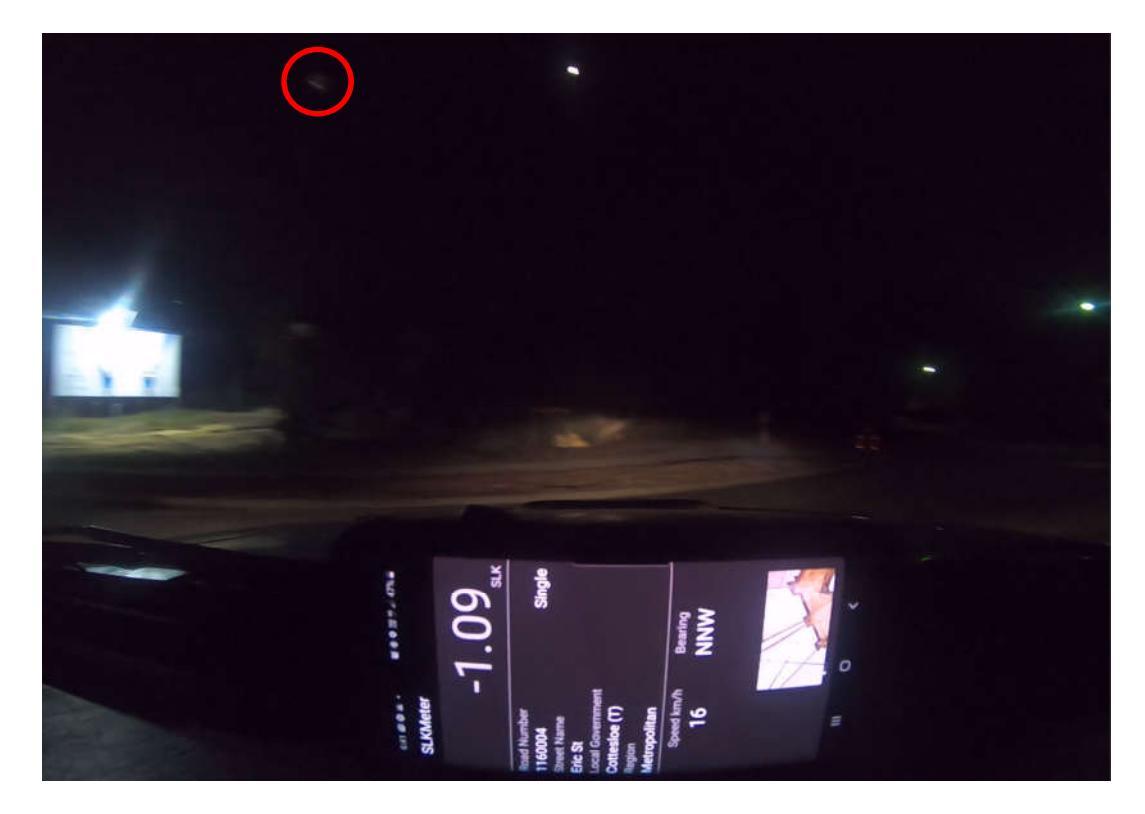
Photo 7: View from the roundabout northwards showing the poor delineation at the NW quadrant of the Eric St / Railway St roundabout due to the faulty street light (indicated in the red circle).

ltem	Description	Audit Finding and Recommendation	Response (Project Manager to agree / disagree, provide reason for disagreeing, and detail proposed actions and comments)
15	Street light not working	The street light located at the north west quadrant of the Eric Street / Railway Street roundabout was not working at the time of the audit night inspection. The departure leg from the roundabout heading northwards on Railway Street approaching the proposed KissnRide upgrade was poorly delineated as a result, increasing the possibility of loss of control crashes and pedestrian versus vehicle crashes. (IMPORTANT: LOW) Justification Refer to Photo 7 at Appendix D of the audit report. Recommendation Repair the faulty luminaire.	* Agree with recommendation.

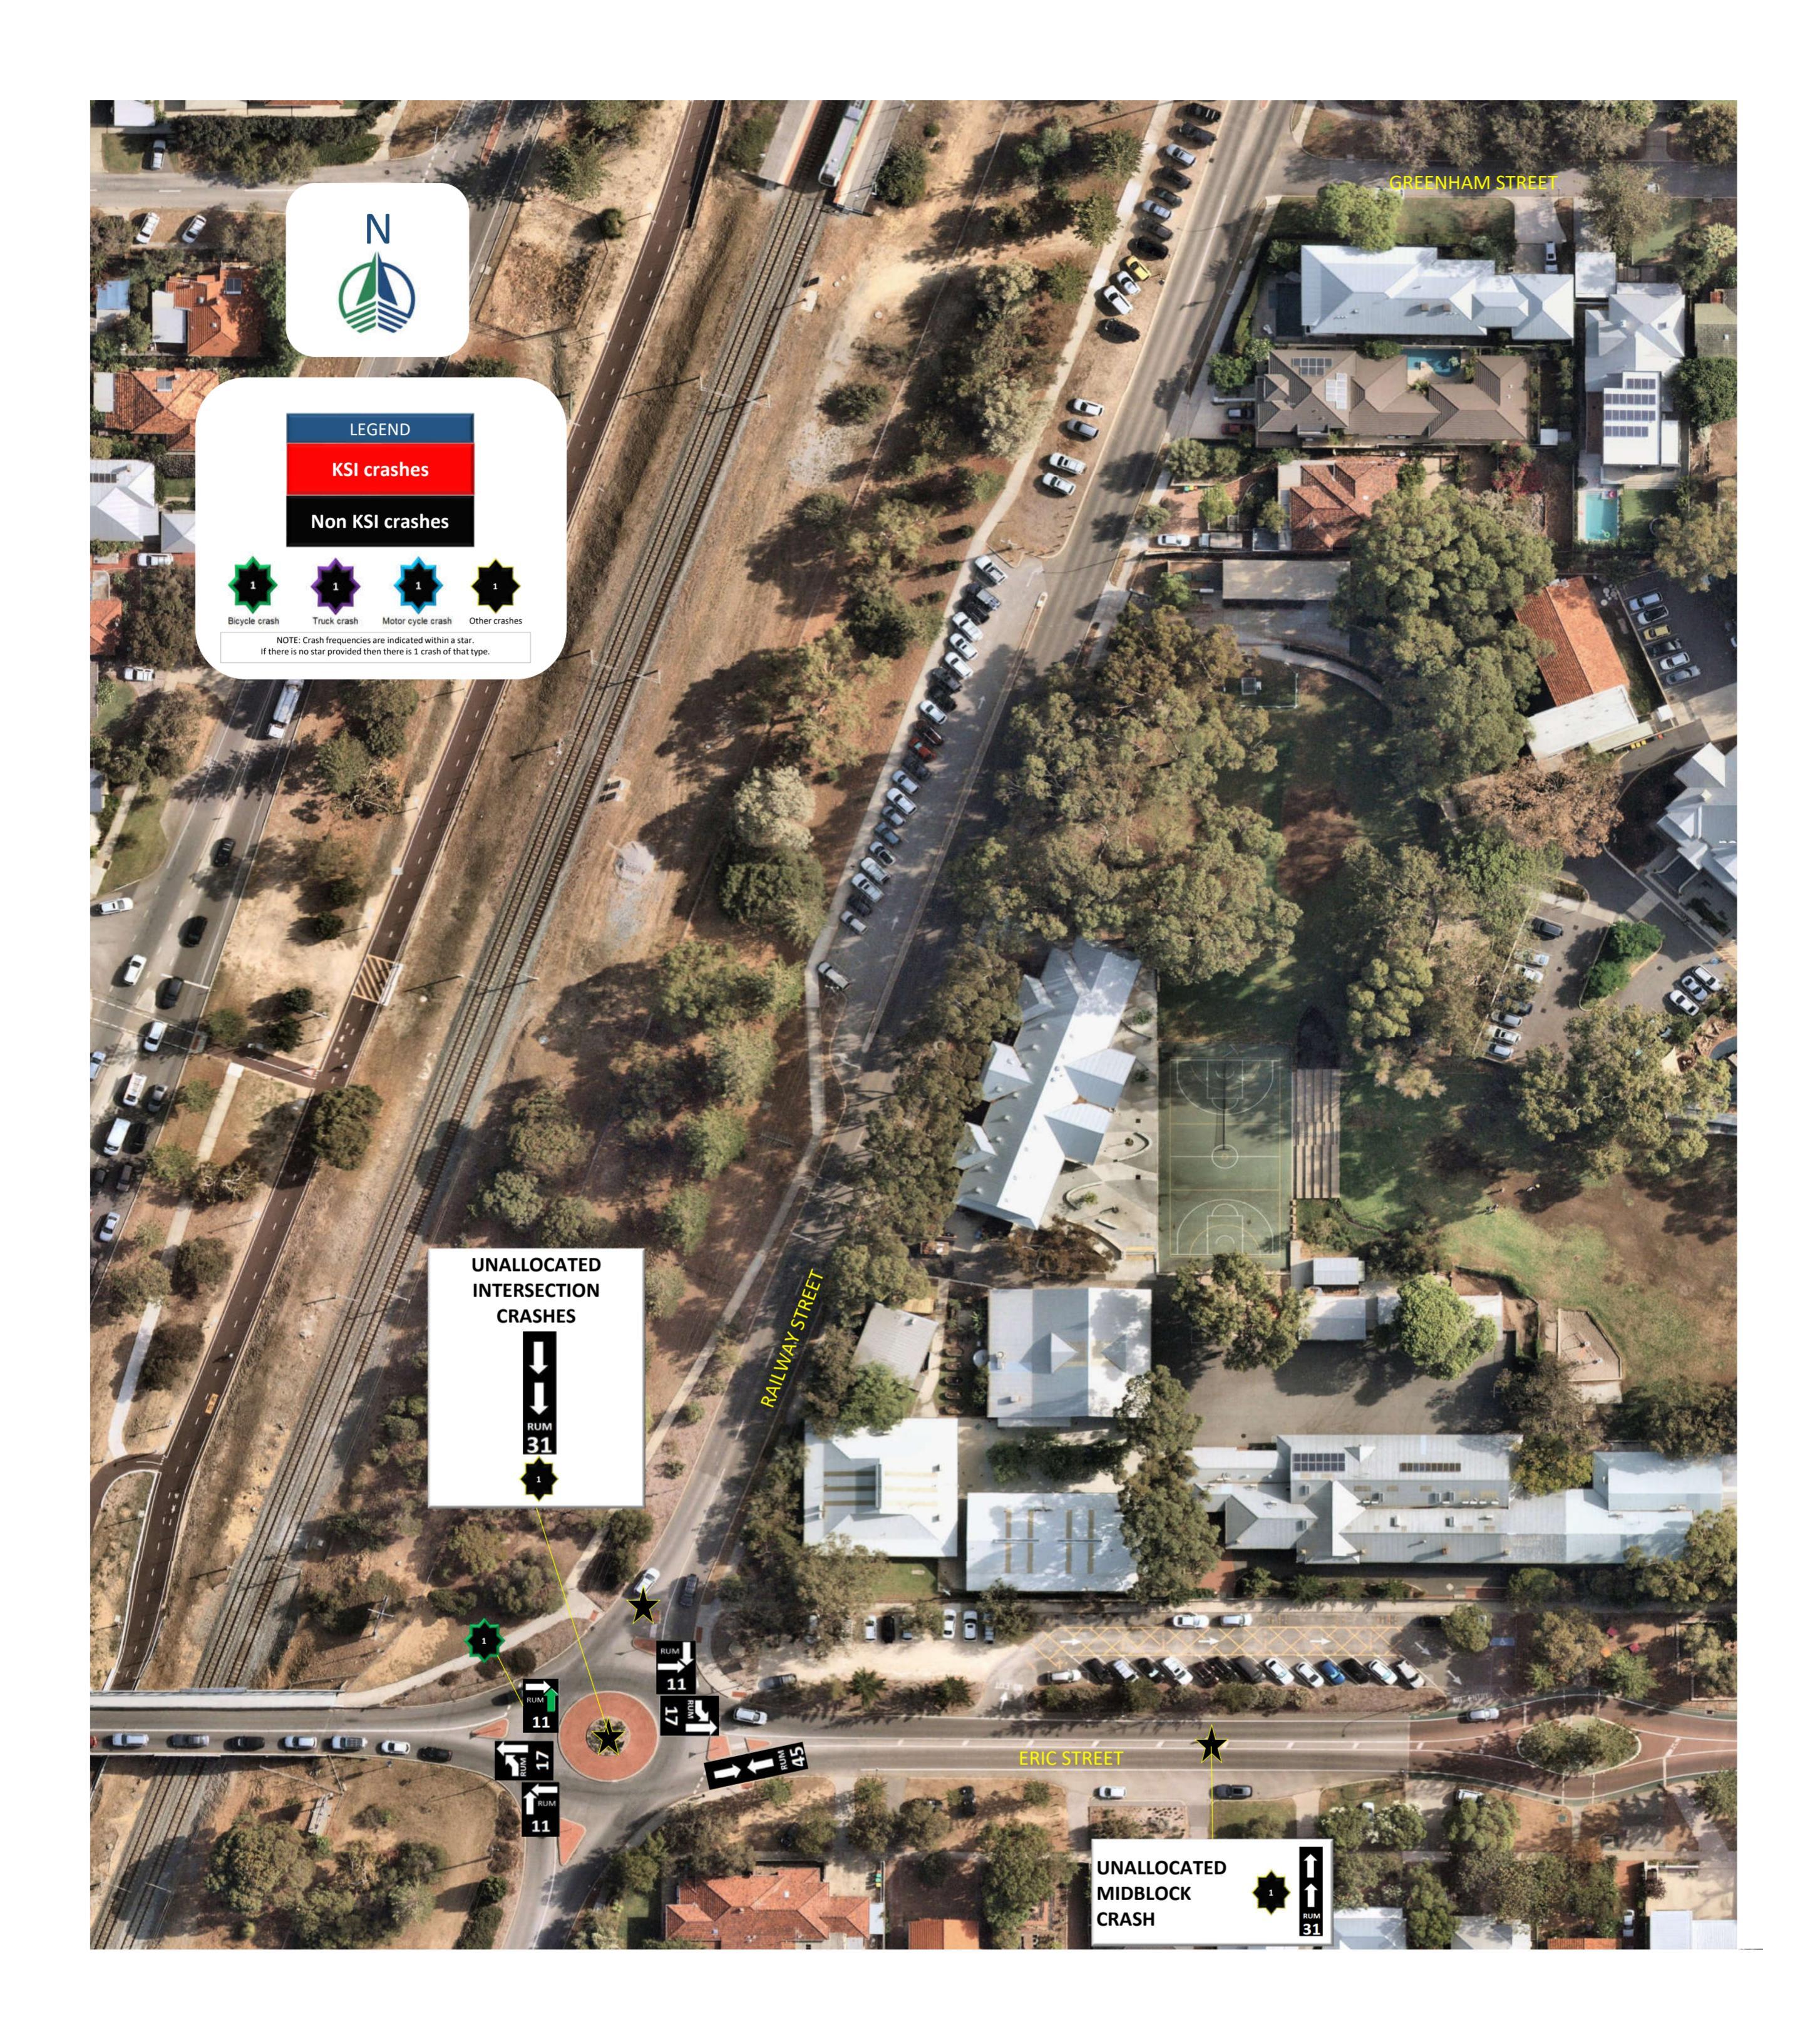
Collision diagram

- Three RUM 11 right-angle crashes at the Railway Street / Eric Street roundabout, one involving a bicycle.
- Two RUM 17 Thru-left crashes at the Eric Street roundabout.
- One RUM 45 (Reversing rear-end) crash on the eastern Approach of Eric Street to the roundabout.
- One unallocated RUM 31 (Rear-end) crash at the roundabout, and another immediately west of the slow point island.

These crashes occurred predominantly outside school drop off and pick up hours (mostly late afternoon) and in dry weather conditions.

RAILWAY ST, ERIC ST TO GREENHAM ST AND ERIC ST, RAILWAY ST TO SLOW POINT NEAR GORDON ST, COTTELSOE COLLISION DIAGRAM 205 TO 2019 REPORTED CRASHES
