COTTESLOE FORESHORE TYPICAL FENCING DETAILS

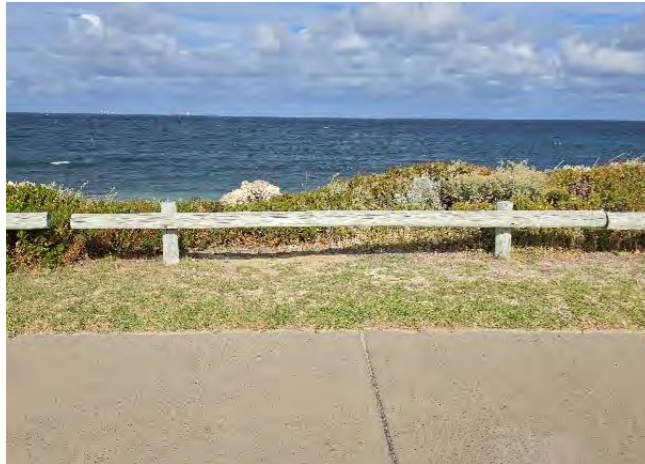
FIGURE 01: LOW KOPPER LOGS

NOTE:
TYPICALLY 300 MM ABOVE THE GROUND AND MADE OF TREATED PINE LOGS OR AN EQUIVALENT MATERIAL

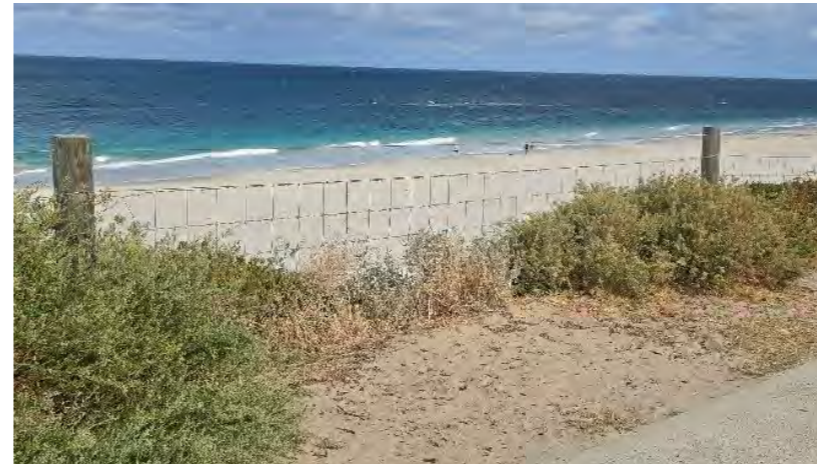
FIGURE 03: POST AND HORSE WIRE

NOTE:
TYPICALLY, THE POSTS ARE 1 M HIGH WITH A SPAN OF 3 M. THE WIRES ARE WHITE PLASTIC-COATED TO PROVIDE VISUAL WARNING, AND THE POSTS ARE MADE OF TREATED PINE LOGS OR AN EQUIVALENT MATERIAL

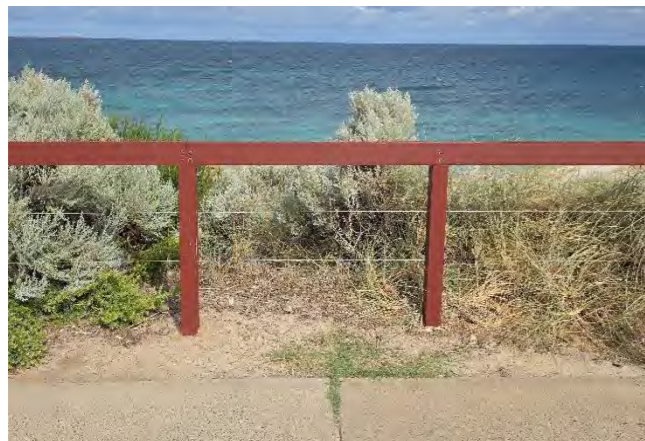
FIGURE 02: TREATED WOOD

NOTE:
TYPICALLY, THE POSTS ARE 1 M IN HEIGHT WITH A HORIZONTAL BAR CONNECTING THE TOPS OF TWO POSTS SPACED AT 1.5 M. THE POSTS ARE MADE FROM TREATED MERBAU OR AN EQUIVALENT MATERIAL. TWO METAL WIRE SPANS (NOT PLASTIC-COATED) ARE INSTALLED BELOW THE TOP TIMBER RAIL
