SEA VIEW GOLF CLUB COMMITTEE MEETING – 29 JULY 2024

Sea View Golf Course

Clubhouse Site Condition Investigation Report

BUILDING SERVICES CONDITION REPORT ELECTRICAL, HYDRAULIC AND MECHANICAL SERVICES

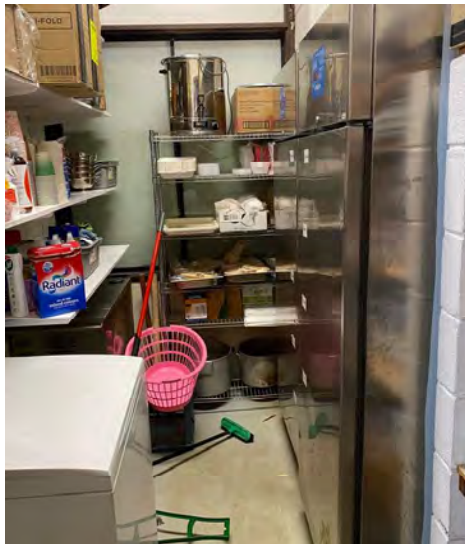
Bar, Cool Room and back-of-house Store & Laundry	Condition	<p>The existing bar is in fair condition though it is noted to be aged, with various areas displaying superficial damage.</p> <p>The Cool Room was not accessed for inspection.</p> <p>The Laundry and Store are reasonably maintained, though excessive stored items rendered a detailed assessment difficult.</p>
	Functionality	<p>The location and extents of the existing bar serves the Dining Area well without detracting from the ocean views.</p> <p>The Cool Room was not accessed for inspection, though it was noted that no usage light or audible alarm was apparent.</p> <p>The Laundry, Store and back-of-house passage contained many stored items. It was noted that a fridge was located immediately adjacent to a washing machine. It was also noted paper cups and other utensils were being stored immediately adjacent an open packet of clothes detergent and other cleaning products. Cupboards in the back-of-house passage appeared to contain dry food storage. It is therefore apparent that the storage needs of the Club exceed the available storage space currently provided.</p>

Laundry products stored adjacent to cutlery and utensils

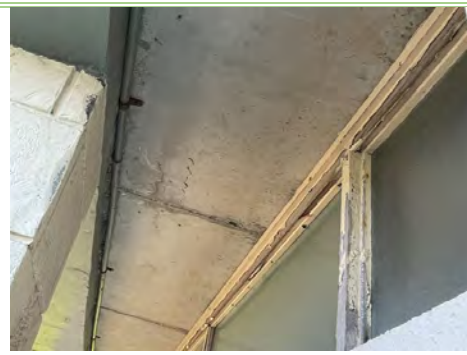
Figure 3: Drummy slab soffit

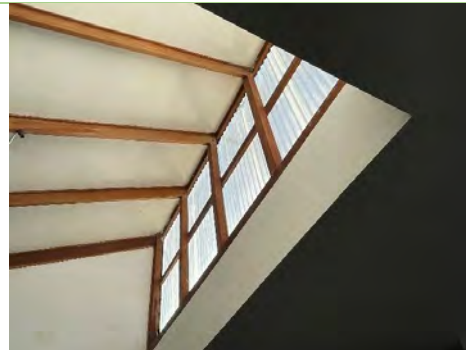
Figure 43: Roof Skylight Timber Frames

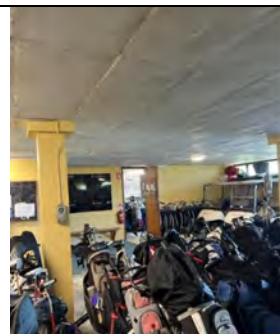
Inadequate Lighting in Buggy Store

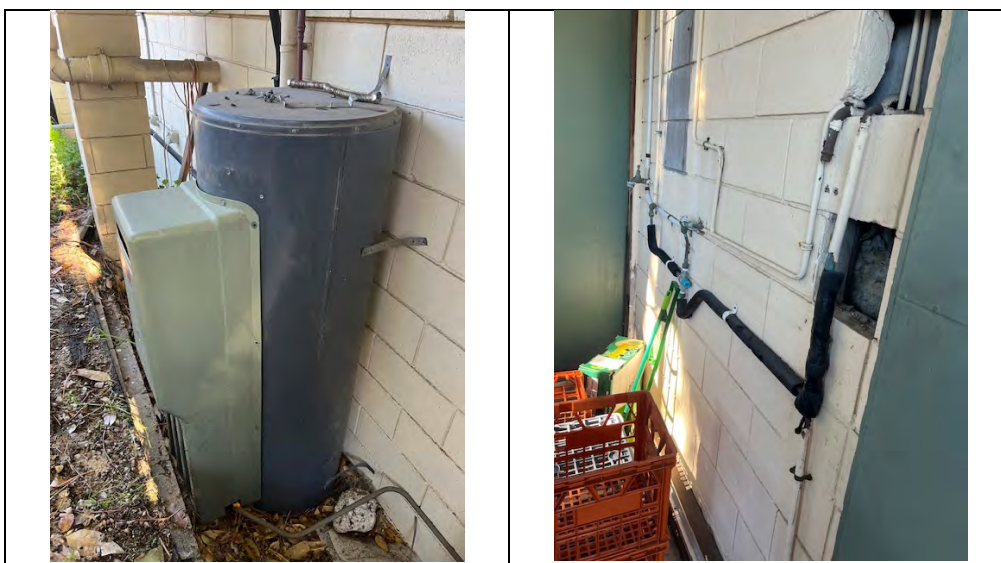
Condition – pipes visually appear to be in good condition, albeit some sections have been replaced and some exposed sections are untidy and out of square. Thermostatic mixing valves appear to be in good condition and a label on the hot water unit indicates an install date of 13th April 2023, but unsure to which valve it applies. The service history of the valves is not known. The hot water unit was manufactured in April 2015 and is 9 years of age, with no evidence of it being serviced.

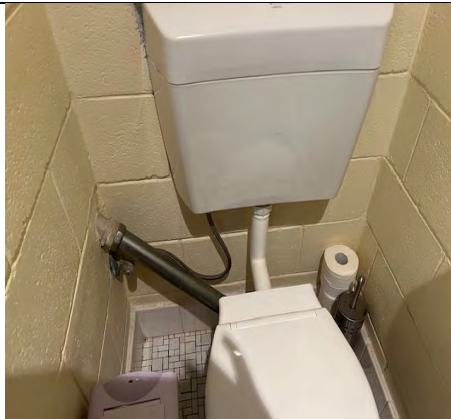
Staff toilet with waste pipe from hand wash basin

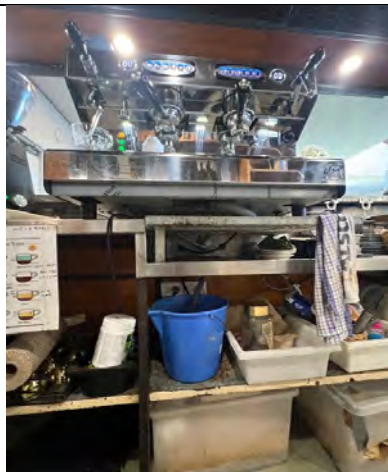
Coffee machines drain into the bucket
