P7984 Cottesloe Beach Pylon Conservation Management Plan

Prepared for
The Town of Cottesloe
By

April 2019

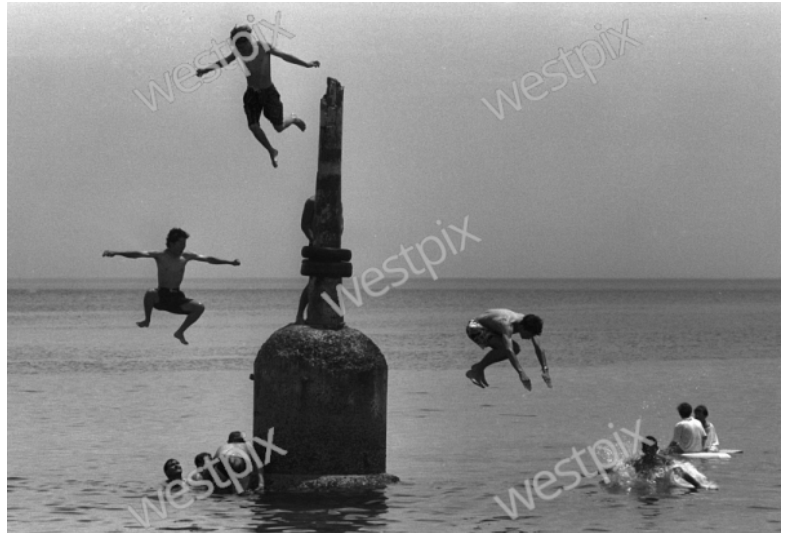
Figure 16: View of Pylon, 1990
Courtesy Westpix, online image TWA 0061445.

Despite the harsh conditions the Cottesloe Beach Pylon remained resolutely in place although the mast gradually reduced in size over the years. The image at Figure 16 shows the broken masthead and how swimmers placed tyres over the mast to enable climbing to the top. Amongst some members of the community, climbing the pylon and diving off it is was a 'rite of passage' that led to the continued popularity of the pylon.

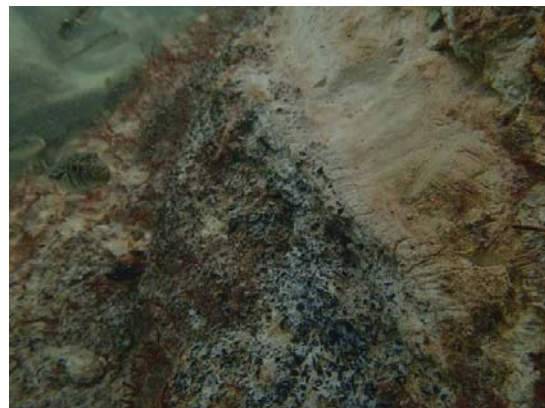
The rebar taper ends 2 m below the surface with the vertical steel pieces originally tying into a circular horizontal piece. There are only a couple of small sections where this horizontal piece still remains. Below this horizontal rebar the foundation of the pylon continues to taper outwards unevenly, and appears to be composed of discrete types of concrete and aggregate mixes. Much of the concrete and aggregate below the rebar taper is soft and crumbly, and the pylon is very uneven at this point due to loss of original concrete material. No rebar was found in this section and the divers were able to remove material from several areas of this section by hand (refer to the videos). The following photographs (Figure 2-11 through Figure 2-14 below) illustrate the condition of the pylon below the tapered rebar section.

Figure 2-12 Soft concrete on lower taper

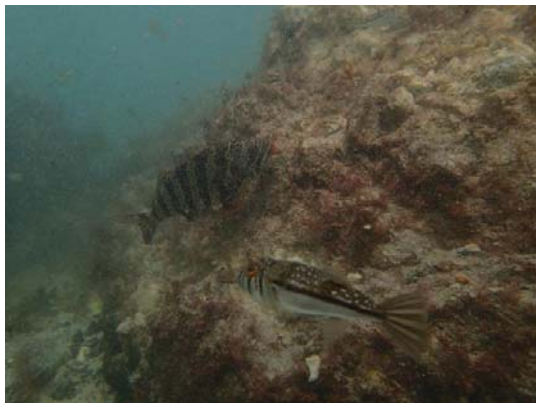
Figure 2-13 Lower section of taper

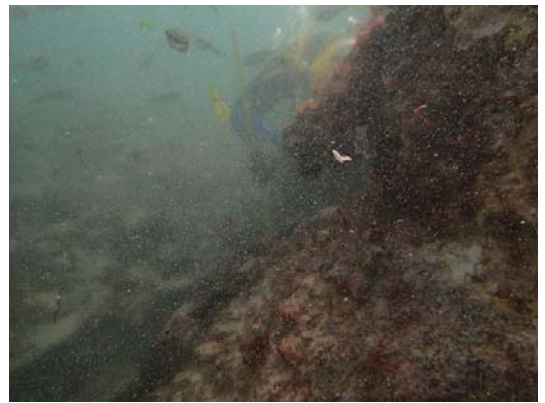
Figure 2-14 Lower section of taper

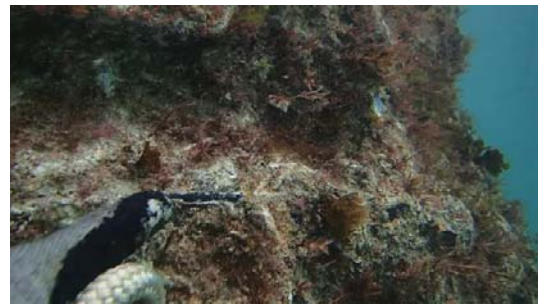
Figure 2-18 Ring visible in cylindrical section

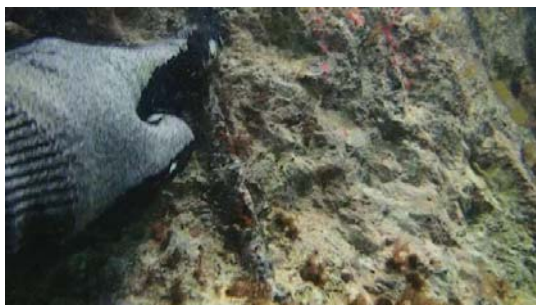
Figure 2-19 Vertical bar in cylindrical section
